**DEPARTMENT OF TRANSPORTATION**

Contract #: 04-0120F4Cty: SF/ALA Rte: 80 PM: 13.2/13.9File #: 1x.28**WELDING INSPECTION REPORT****Resident Engineer:** Pursell, Gary**Address:** 333 Burma Road**City:** Oakland, CA 94607**Report No:** WIR-013463**Date Inspected:** 26-Apr-2010**Project Name:** SAS Superstructure**OSM Arrival Time:** 1100**Prime Contractor:** American Bridge/Fluor Enterprises, a JV**OSM Departure Time:** 1930**Contractor:** American Bridge/Fluor Enterprises, a JV**Location:** Job Site

<b>CWI Name:</b>	William Sherwood and Barry Drake			<b>CWI Present:</b>	Yes	No	
<b>Inspected CWI report:</b>	Yes	No	N/A	<b>Rod Oven in Use:</b>	Yes	No	N/A
<b>Electrode to specification:</b>	Yes	No	N/A	<b>Weld Procedures Followed:</b>	Yes	No	N/A
<b>Qualified Welders:</b>	Yes	No	N/A	<b>Verified Joint Fit-up:</b>	Yes	No	N/A
<b>Approved Drawings:</b>	Yes	No	N/A	<b>Approved WPS:</b>	Yes	No	N/A
				<b>Delayed / Cancelled:</b>	Yes	No	N/A
<b>Bridge No:</b>	34-0006			<b>Component:</b>	Orthotropic Box Girder

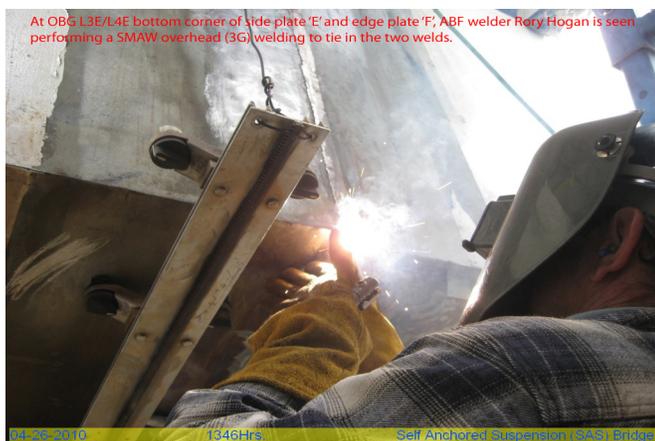
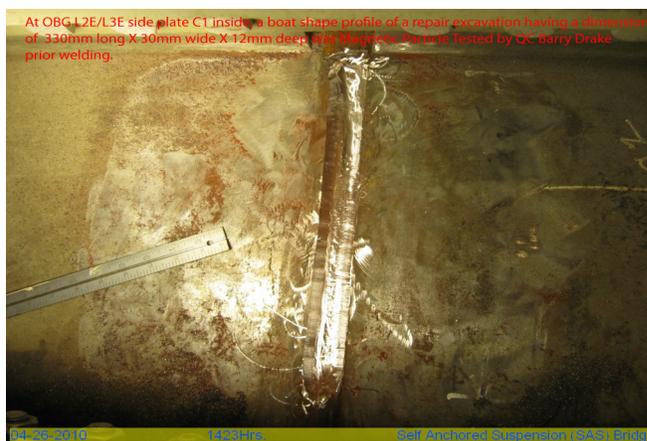
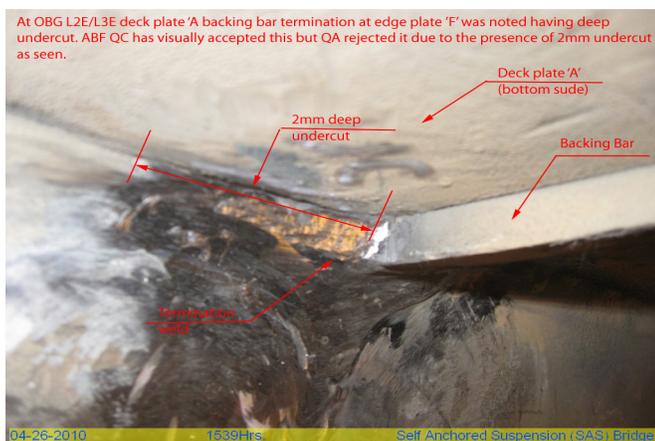
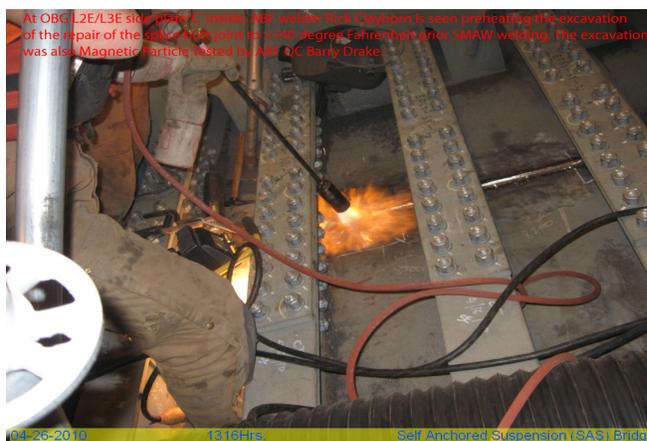
At OBG L1E/L2E deck plate 'A' inside, QA randomly observed ABF/JV qualified welder James Zhen ID #6001 perform overhead termination welding from one end of deck plate 'A' backing bar to edge plate 'F'. The welder was observed welding in the overhead (4F) position using Shielded Metal Arc Welding with E7018H4R, 1/8" diameter electrode. The welding being made is a termination and connection from one end of the deck plate 'A' backing bar to the edge plate 'F' in reference to Request For Information (RFI) ABF-RFI-002097R00 dated March 19, 2010. The termination welding on this location was monitored by ABF QC William Sherwood. At the end of the shift, welding was still continuing.

At OBG L1E/L2E edge plate 'B' (bottom corner), QA also randomly observed ABF/JV qualified welder Chun Fai Huang ID #3426 perform CJP welding of the splice butt joint and tied it into the 'C' plate. The welder was observed welding in the horizontal (2G) position using Shielded Metal Arc Welding with E7018H4R, 1/8" diameter electrode. The welding on this location was monitored by ABF QC William Sherwood and was still continuing at the end of the shift.

At OBG L2E/L3E side plate 'C' inside, QA randomly observed ABF/JV qualified welder Rick Clayborn ID #2773 perform CJP groove welding repair. The welder was observed welding in the 3G (vertical) position utilizing Shielded metal Arc Welding (SMAW) with 1/8" and 5/32" diameter E7018H4R electrode implementing welding

procedure ABF-WPS-D15-1000-Repairs. The weld repairs were excavated to a boat shape and the plates were preheated to more than 140 degree Fahrenheit using propane gas torch prior welding. During the shift, ABF QC Barry Blake was noted monitoring the welder. Prior welding, the excavations that were welded were tested using Magnetic Particle Testing (MT) by ABF QC Barry Blake. During the shift, the welder has completed four repairs and was working on the fifth repair at the end of the shift.

At OBG L3E/L4E bottom corner of side plate 'E' and edge plate 'F' outside, QA also randomly observed ABF qualified welder Rory Hogan perform overhead and vertical welding. The overhead welding was done to tie in the vertical weld to the overhead weld and also as initial weld when they do the overhead (4G) FCAW-G back welding of the splice butt joint. The welder was noted using Shielded Metal Arc Welding (SMAW) with E7018H4R, 1/8" diameter electrode. QA performed a parameter check on the current and was noted to be 128 amperes. QA also noted Jim Cunningham monitoring the welder and his welding parameters.
