Contract #: 04-0120F4Cty: SF/ALA Rte: 80 PM: 13.2/13.9File #: 69.28**WELDING INSPECTION REPORT****Resident Engineer:** Pursell, Gary**Address:** 333 Burma Road**City:** Oakland, CA 94607**Report No:** WIR-013480**Date Inspected:** 11-Apr-2010**Project Name:** SAS Superstructure**OSM Arrival Time:** 1900**Prime Contractor:** American Bridge/Fluor Enterprises, a JV**OSM Departure Time:** 700**Contractor:** Zhenhua Port Machinery Company, Ltd (ZPMC), Changxing Island **Location:** Shanghai, China**CWI Name:** See Below**CWI Present:** Yes No**Inspected CWI report:** Yes No N/A**Rod Oven in Use:** Yes No N/A**Electrode to specification:** Yes No N/A**Weld Procedures Followed:** Yes No N/A**Qualified Welders:** Yes No N/A**Verified Joint Fit-up:** Yes No N/A**Approved Drawings:** Yes No N/A**Approved WPS:** Yes No N/A**Delayed / Cancelled:** Yes No N/A**Bridge No:** 34-0006**Component:** OBG**Summary of Items Observed:**

On this date CALTRANS OSM Quality Assurance (QA) Inspector, Mr. Paul Dawson, arrived on site at the Zhenhua Port Machinery Company (ZPMC) facility at Changxing Island, in Shanghai, China, for the purpose of monitoring welding and fabrication of the San Francisco / Oakl

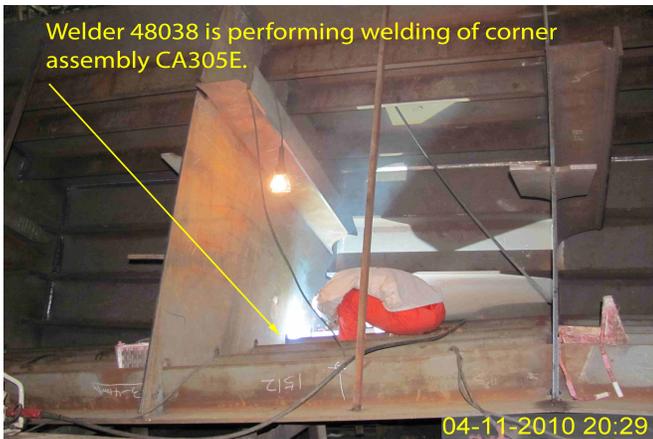
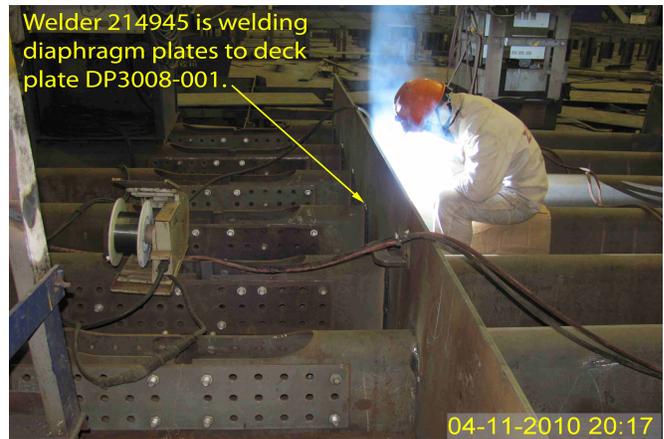
This QA Inspector observed ZPMC welder Mr. Wang Changmin, stencil 047864 is using shielded metal arc welding process to complete OBG segment 10AW side plate to corner assembly overhead 4G weld repairs near panel point PP86. This observation was made near the end of the shift and no weld repair documentation was available. This QA Inspector observed a welding current of approximately 150 amps and the welding electrodes are being stored in a heated portable electrode storage oven. This QA Inspector observed that Mr. Wang Changmin appears to be certified to make this weld. Items observed on this date appeared to generally comply with applicable contract documents.
