DEPARTMENT OF TRANSPORTATION

Quality Assurance and Source Inspection

Contract #: 04-0120F4Cty: SF/ALA Rte: 80 PM: 13.2/13.9File #: 1x.28**WELDING INSPECTION REPORT****Resident Engineer:** Pursell, Gary**Address:** 333 Burma Road**City:** Oakland, CA 94607**Report No:** WIR-013485**Date Inspected:** 28-Apr-2010**Project Name:** SAS Superstructure**OSM Arrival Time:** 1100**Prime Contractor:** American Bridge/Fluor Enterprises, a JV**OSM Departure Time:** 1930**Contractor:** American Bridge/Fluor Enterprises, a JV**Location:** Job Site

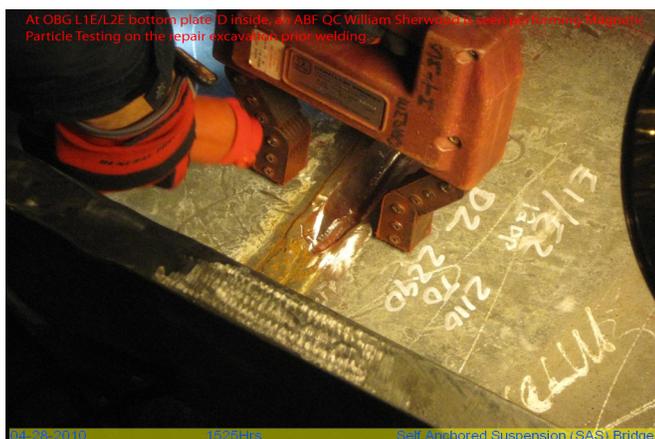
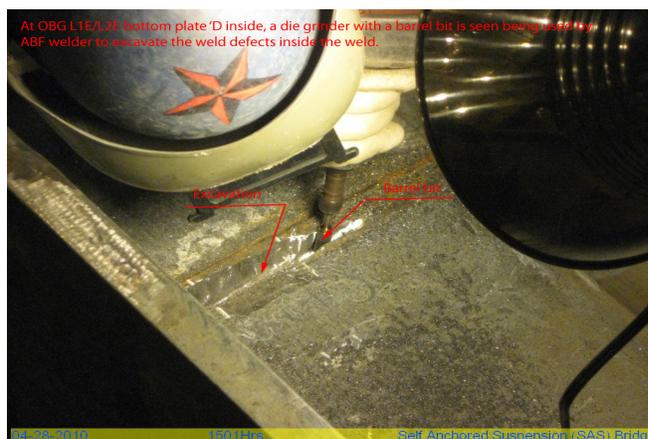
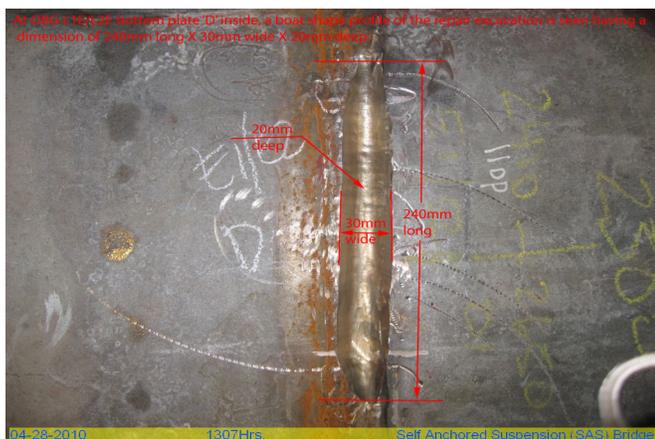
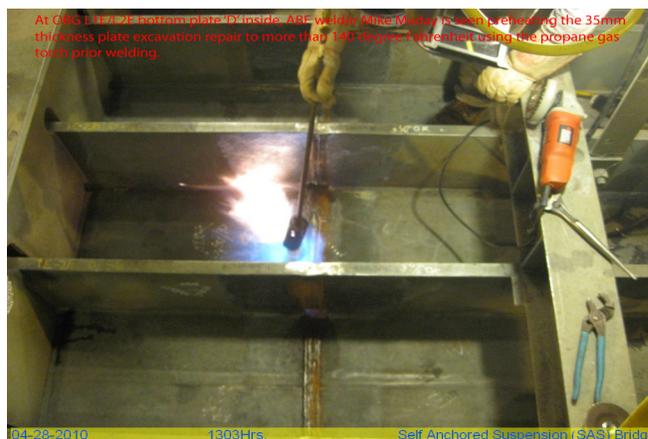
At OBG L1E/L2E bottom plate 'D' inside, QA randomly observed ABF/JV qualified welder Mitch Sittinger perform CJP groove welding repair. The welder was observed welding in the 1G (flat) position utilizing Shielded Metal Arc Welding (SMAW) with 1/8" diameter E7018H4R electrode implementing welding procedure ABF-WPS-D15-1000-Repairs. The weld repairs were excavated to a boat shape having a dimension of 240mm long X 30mm wide X 20mm deep and the plates were preheated to more than 140 degree Fahrenheit using propane gas torch prior welding. During the shift, ABF QC William Sherwood was noted monitoring the welder. Prior welding, the excavation was tested using Magnetic Particle Testing (MT) by ABF QC William Sherwood. During the shift, the welder has completed two welding repairs and was working on the third repair at the end of the shift.

QA randomly observed ABF/JV qualified welders Rory Hogan (ID #3186) and Jeremy Dolman (ID #5042) perform CJP groove (splice) back welding fill to cover pass on Orthotropic Box Girder (OBG) L3E/L4E plate 'E' (3500mm to 7500mm / outside). The welders were observed welding in the 4G (overhead) position utilizing a dual shield Flux Cored Arc Welding (FCAW-G) with E71T-1M, 1/16" diameter wire electrode and implementing Caltrans approved Welding Procedure Specification (WPS) ABF-WPS-D15-3110-4. The welder was using a track mounted welder holder assembly that is remotely controlled. The joint being welded has the backing bar gouged using the Esab Plasma Arc machine and was ground smooth. The gouged and ground splice butt joint was also

Non Destructive Testing (NDT) tested using the Magnetic Particle Testing (MT). The splice joint was preheated and maintained to greater than 150 degree Fahrenheit using Miller Proheat 35 Induction Heating System located at the other side of the plate prior/during welding and the vicinity was properly protected from wind. During welding, ABF Quality Control (QC) Jim Cunningham was noted monitoring the welding parameters of the welder. At the end of the shift, welding in this location was still continuing.

At OBG L3E/L4E side plate 'C' outside, two ABF personnel were observed performing back gouging on the splice butt joint of 'C' plate. The personnel were using Esab plasma arc gouging machine mounted to a track. During the shift, gouging of the backing bar and some of the base metal were not complete and will continue tomorrow.
