**DEPARTMENT OF TRANSPORTATION**

Contract #: 04-0120F4Cty: SF/ALA Rte: 80 PM: 13.2/13.9File #: 69.28**WELDING INSPECTION REPORT****Resident Engineer:** Pursell, Gary**Address:** 333 Burma Road**City:** Oakland, CA 94607**Report No:** WIR-013539**Date Inspected:** 22-Apr-2010**Project Name:** SAS Superstructure**OSM Arrival Time:** 700**Prime Contractor:** American Bridge/Fluor Enterprises, a JV**OSM Departure Time:** 1900**Contractor:** Zhenhua Port Machinery Company, Ltd (ZPMC), Changxing Island **Location:** Shanghai, China

**Bridge No:** 34-0006**Component:** Tower Components**Summary of Items Observed:**

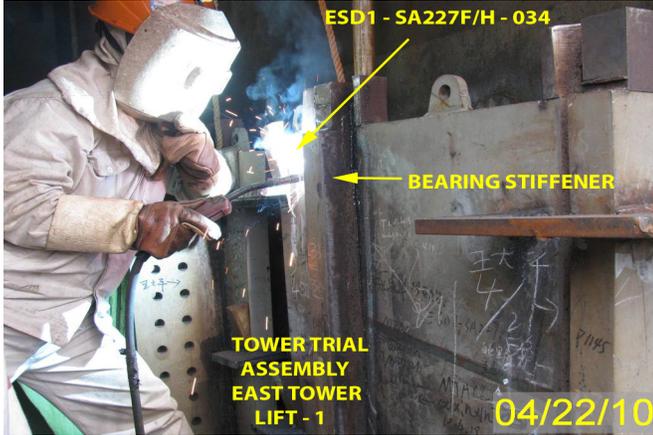
Weld joint # 034 located on East Tower Lift-1 Bearing stiffener ESD1 – SA227F/H. Welder is identified as 049220. ZPMC Quality Control (QC) Inspector is identified as Fu Wei Min. The welding variables recorded by QC appeared to comply with the WPS – B – T – 2333 – Tc – P4 – F.

(See attached photo)
