**DEPARTMENT OF TRANSPORTATION**

Contract #: 04-0120F4Cty: SF/ALA Rte: 80 PM: 13.2/13.9File #: 1.28**WELDING INSPECTION REPORT****Resident Engineer:** Pursell, Gary**Address:** 333 Burma Road**City:** Oakland, CA 94607**Report No:** WIR-013561**Date Inspected:** 21-Apr-2010**Project Name:** SAS Superstructure**OSM Arrival Time:** 630**Prime Contractor:** American Bridge/Fluor Enterprises, a JV**OSM Departure Time:** 1500**Contractor:** American Bridge/Fluor Enterprises, a JV**Location:** Job Site**CWI Name:** See Below**CWI Present:** Yes No**Inspected CWI report:** Yes No N/A**Rod Oven in Use:** Yes No N/A**Electrode to specification:** Yes No N/A**Weld Procedures Followed:** Yes No N/A**Qualified Welders:** Yes No N/A**Verified Joint Fit-up:** Yes No N/A**Approved Drawings:** Yes No N/A**Approved WPS:** Yes No N/A**Delayed / Cancelled:** Yes No N/A**Bridge No:** 34-0006**Component:** Orthotropic Box Girders (OBG)**Summary of Items Observed:**

**Field Splice 2E/3E Face C1 and C2 (first side-inside)**

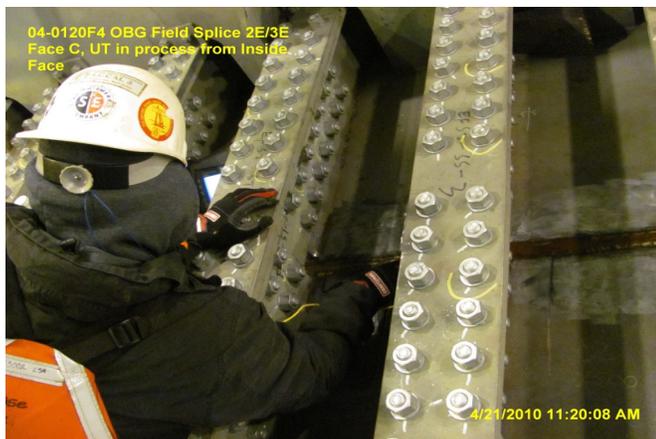
The QA inspector periodically observed QC inspectors Jessie Cayabyab and Bonafacio Daquinag performing ultrasonic testing (UT) on this date for this location. It was noted Mr. Daquinag was assisting Mr. Cayabyab and not performing the UT. The QC inspector was noted to be utilizing a 70 degree transducer and wedge combination for shear wave examination. This examination was in addition to the one performed the previous day from the outside of the OBG. During a brief discussion with the QC inspector, it was relayed to the QA inspector the contractor requested the QC personnel to identify the rejectable indications from the inside of the OBG in addition to the outside in order to facilitate the repair process from either side. This appears to be for access issues and the required depth of excavations for the repairs. A digital photo is included in the body of this report for general information.
