DEPARTMENT OF TRANSPORTATION

Contract #: 04-0120F4Cty: SF/ALA Rte: 80 PM: 13.2/13.9File #: 69.28**WELDING INSPECTION REPORT****Resident Engineer:** Pursell, Gary**Address:** 333 Burma Road**City:** Oakland, CA 94607**Report No:** WIR-013572**Date Inspected:** 23-Apr-2010**Project Name:** SAS Superstructure**OSM Arrival Time:** 700**Prime Contractor:** American Bridge/Fluor Enterprises, a JV**OSM Departure Time:** 1900**Contractor:** Zhenhua Port Machinery Company, Ltd (ZPMC), Changxing Island **Location:** Shanghai, China**CWI Name:** Xu Xian Ping**CWI Present:** Yes No**Inspected CWI report:** Yes No N/A**Rod Oven in Use:** Yes No N/A**Electrode to specification:** Yes No N/A**Weld Procedures Followed:** Yes No N/A**Qualified Welders:** Yes No N/A**Verified Joint Fit-up:** Yes No N/A**Approved Drawings:** Yes No N/A**Approved WPS:** Yes No N/A**Delayed / Cancelled:** Yes No N/A**Bridge No:** 34-0006**Component:****Summary of Items Observed:**

NDT Inspections

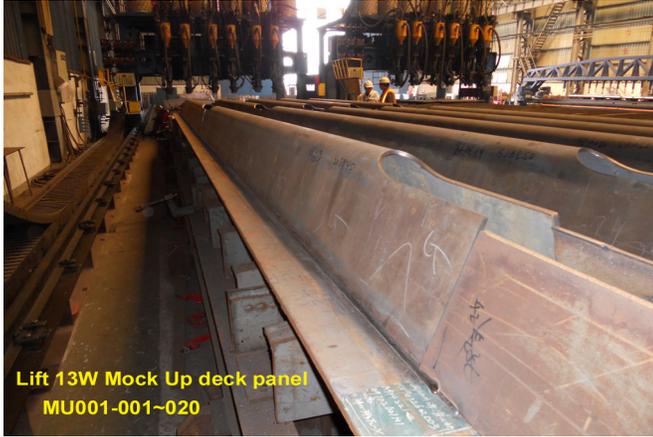
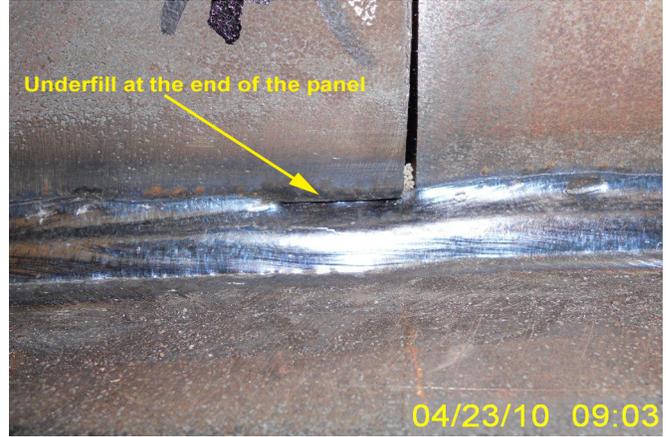
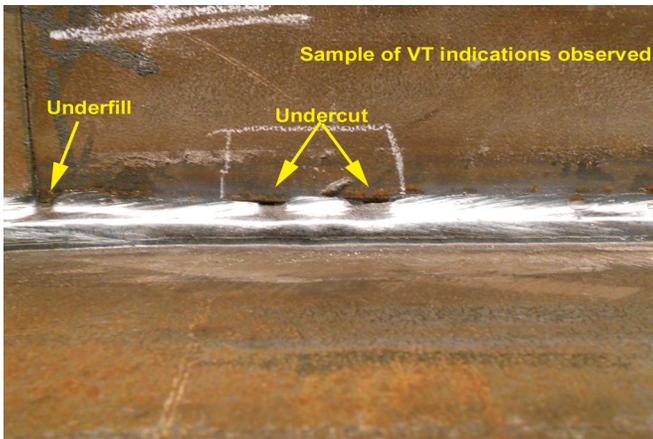
This inspector performed Visual Testing, VT, on the partial joint penetration, PJP, sub arc welds for the mock up deck panel 13MU1-001. Welds tested included welds 001~020. This inspection was in conjunction with ABF, and after the initial VT had been performed. Various areas of undercut, lack of fusion, cold lap, oversized welds, and under fill were both marked by this inspector and ABF. Photographs of a sample of common indications found during this inspection are included in this report.

This inspector monitored the repair of the indications found during this inspection in Bay 9.
