**DEPARTMENT OF TRANSPORTATION**

Contract #: 04-0120F4Cty: SF/ALA Rte: 80 PM: 13.2/13.9File #: 69.28**WELDING INSPECTION REPORT****Resident Engineer:** Pursell, Gary**Address:** 333 Burma Road**City:** Oakland, CA 94607**Report No:** WIR-013641**Date Inspected:** 21-Apr-2010**Project Name:** SAS Superstructure**OSM Arrival Time:** 1900**Prime Contractor:** American Bridge/Fluor Enterprises, a JV**OSM Departure Time:** 700**Contractor:** Zhenhua Port Machinery Company, Ltd (ZPMC), Changxing Island **Location:** Shanghai, China**CWI Name:** See Below**CWI Present:** Yes No**Inspected CWI report:** Yes No N/A**Rod Oven in Use:** Yes No N/A**Electrode to specification:** Yes No N/A**Weld Procedures Followed:** Yes No N/A**Qualified Welders:** Yes No N/A**Verified Joint Fit-up:** Yes No N/A**Approved Drawings:** Yes No N/A**Approved WPS:** Yes No N/A**Delayed / Cancelled:** Yes No N/A**Bridge No:** 34-0006**Component:** OBG**Summary of Items Observed:**

**OBG Bay 2**

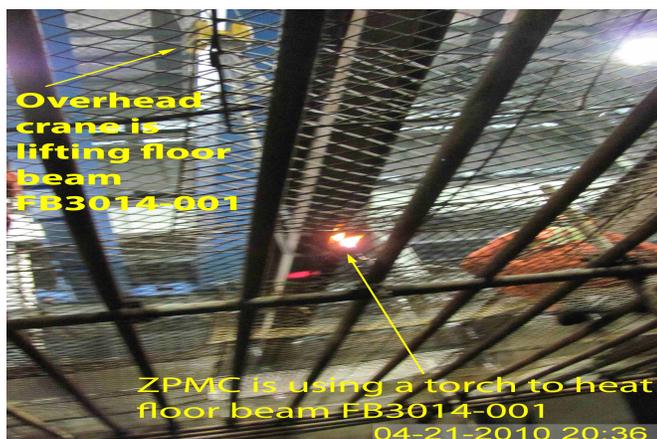
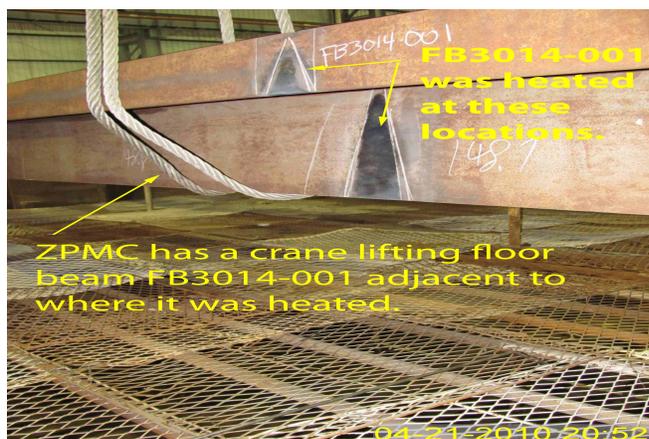
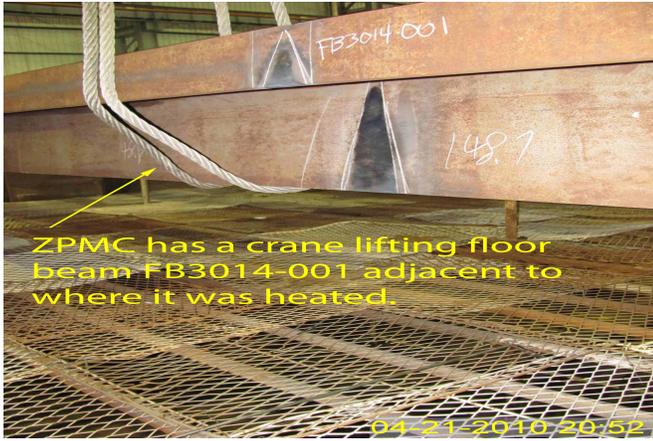
This QA Inspector observed ZPMC workers are using a torch to perform heat straightening of floor beam FB3014-001 which is located at OBG segment 12BE, near panel point 115.5. This QA Inspector observed ZPMC had a crane cable lifting upward with an unknown amount of tension on floor beam FB3014-001 adjacent to where it was heated to a bright red condition. The workers did not appear to be using any digital temperature measurement gauge, temperature indicating crayon or other similar means of monitoring the heat input, and the actual maximum attained temperature does not appear to have been measured or recorded. This QA Inspector questioned QC Certified Welding Inspector (CWI) Mr. Geng Wei and ABF representative Mr. Yang Chao and both of them said they were not aware that this heat straightening was taking place and they did not know if an approved heat straightening document had been issued. This QA Inspector informed Certified Welding Inspector (CWI) Mr. Geng Wei and ABF representative Mr. Yang Chao that an incident report is being issued to document heat straightening of floor beam FB3014-001 without any monitoring of the heat input or approved engineering document. See the photographs below for additional information.
