DEPARTMENT OF TRANSPORTATION

Quality Assurance and Source Inspection

Contract #: 04-0120F4Cty: SF/ALA Rte: 80 PM: 13.2/13.9File #: 69.28**WELDING INSPECTION REPORT****Resident Engineer:** Pursell, Gary**Address:** 333 Burma Road**City:** Oakland, CA 94607**Report No:** WIR-013778**Date Inspected:** 15-Mar-2010**Project Name:** SAS Superstructure**OSM Arrival Time:** 700**Prime Contractor:** American Bridge/Fluor Enterprises, a JV**OSM Departure Time:** 1900**Contractor:** Zhenhua Port Machinery Company, Ltd (ZPMC), Changxing Island **Location:** Shanghai, China**CWI Name:** Gong Wei**CWI Present:** Yes No**Inspected CWI report:** Yes No N/A**Rod Oven in Use:** Yes No N/A**Electrode to specification:** Yes No N/A**Weld Procedures Followed:** Yes No N/A**Qualified Welders:** Yes No N/A**Verified Joint Fit-up:** Yes No N/A**Approved Drawings:** Yes No N/A**Approved WPS:** Yes No N/A**Delayed / Cancelled:** Yes No N/A**Bridge No:** 34-0006**Component:** OBG COMPONENT**Summary of Items Observed:**

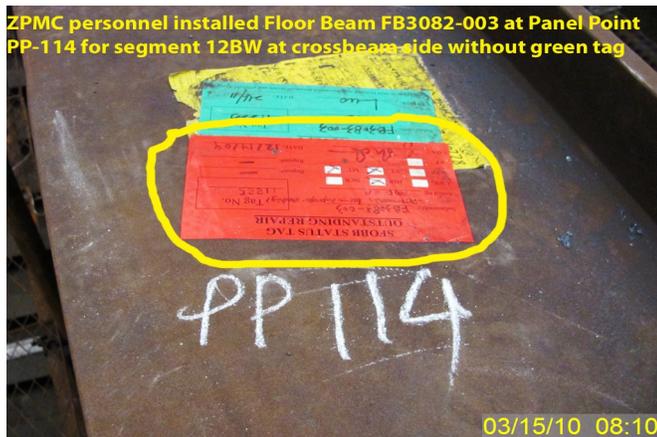
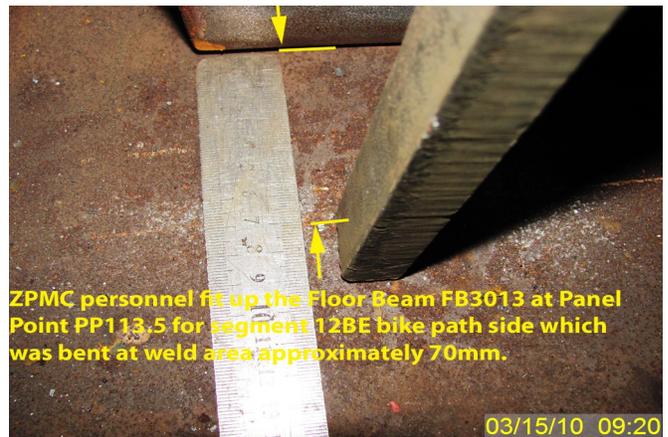
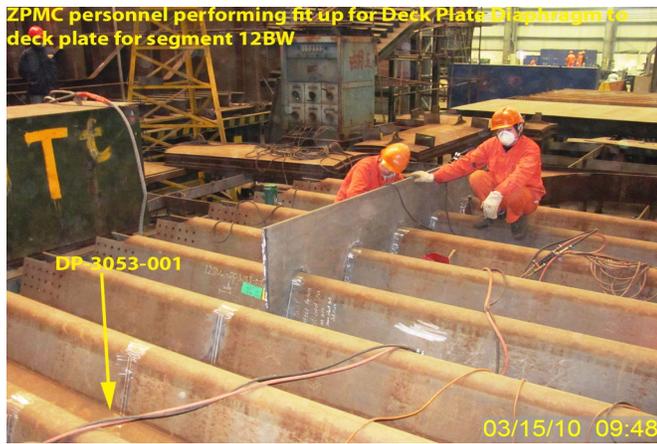
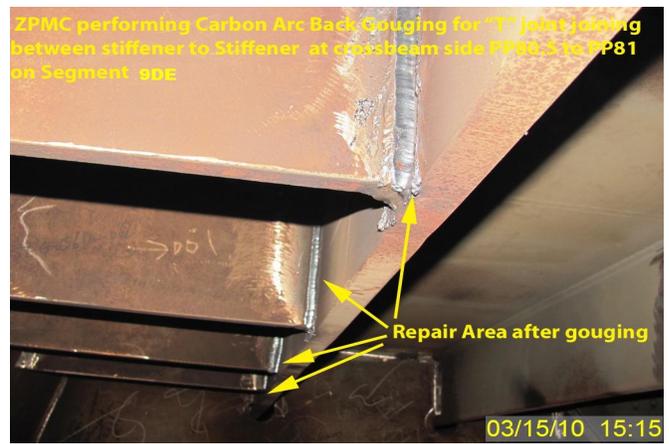
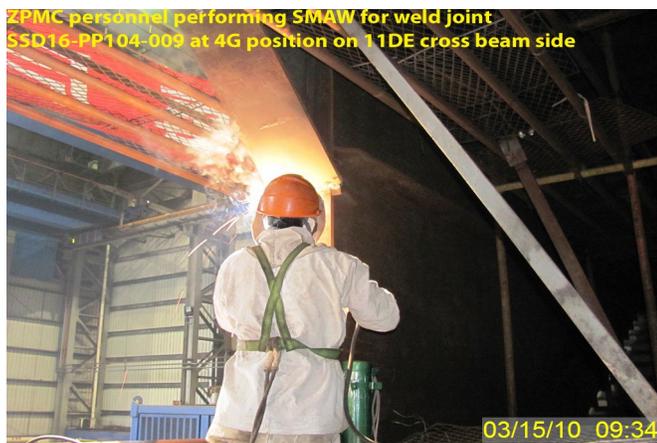
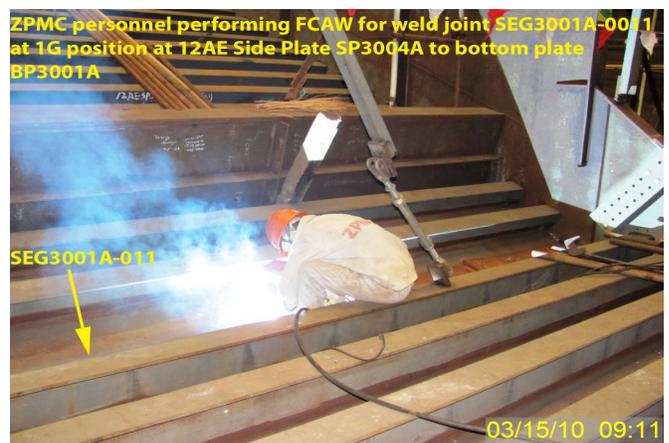
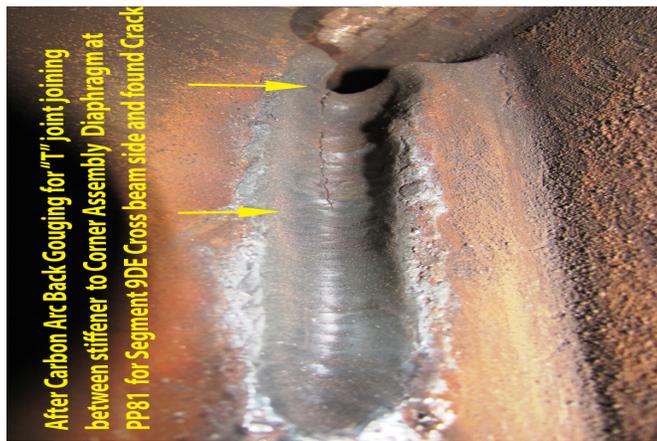
During random visual inspection the QA inspector observed in segment 12BE that ZPMC personnel fit up the Floor Beam FB3013 at Panel Point PP113.5 at bike path side which was bent from weld area approximately 70mm. The QA Inspector informed to the ZPMC QC Inspector for repair the bent area need engineer approval. For details please refer attached photo.

During random visual inspection the QA inspector observed in segment 9DE the ZPMC performing Carbon Arc Back Gouging for "T" joint joining between stiffeners to Stiffener at crossbeam side PP80.5 to PP81 without any information. After that the QA Inspector visually Checked the Gouged area and found one crack like indication in weld area .The weld number is identified as SSD17-PP81-146.This QA Inspector informed to ZPMC QC personnel to provide critical weld repair report for repair that mention weld area.For more information see the attached photo.
