Contract #: 04-0120F4Cty: SF/ALA Rte: 80 PM: 13.2/13.9File #: 13.28**WELDING INSPECTION REPORT****Resident Engineer:** Pursell, Gary**Address:** 333 Burma Road**City:** Oakland, CA 94607**Report No:** WIR-013876**Date Inspected:** 03-May-2010**Project Name:** SAS Superstructure**OSM Arrival Time:** 1000**Prime Contractor:** American Bridge/Fluor Enterprises, a JV**OSM Departure Time:** 1830**Contractor:** Oregon Iron Works Clackamas, Or.**Location:** Clackamas, OR

CWI Name:	M. Gregson, J. Salazar, G. Mundt	CWI Present:	Yes	No			
Inspected CWI report:	Yes	No	N/A	Rod Oven in Use:	Yes	No	N/A
Electrode to specification:	Yes	No	N/A	Weld Procedures Followed:	Yes	No	N/A
Qualified Welders:	Yes	No	N/A	Verified Joint Fit-up:	Yes	No	N/A
Approved Drawings:	Yes	No	N/A	Approved WPS:	Yes	No	N/A
				Delayed / Cancelled:	Yes	No	N/A
Bridge No:	34-0006	Component:	Hinge K Pipe Beams

Hinge-K Pipe Beam Assembly 101A-4:

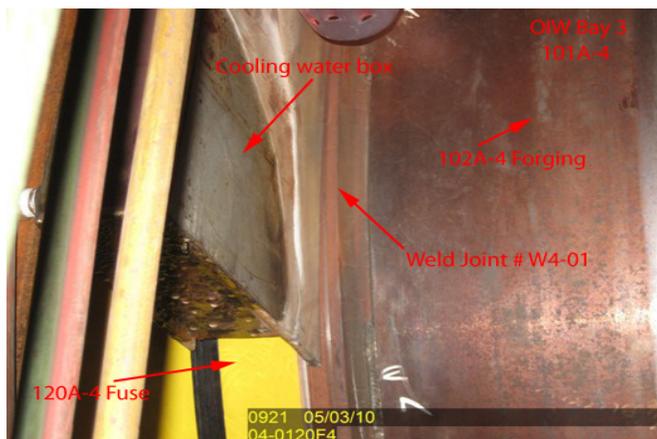
The QA Inspector was present on this swing shift and observed WID #B10 (Liem Bui) continuing to perform the SAW, on the above mentioned weld joint. The QA Inspector noted that WID #B10 was currently approved and qualified for this process and position. The QA Inspector observed that OIW QC Inspector Gary Mundt was present on this shift and QC Inspector Mundt explained that WID #B10 will continue the SAW, for the entire shift. QC Inspector Mundt explained that he had recorded welding parameters of 565 amps, 34.8 volts and a travel speed of 18 inches per minute. The QA Inspector randomly verified the parameters and they appeared to be in compliance with the applicable WPS. The QA Inspector then randomly verified the pre-heat temperature was at the minimum of 350 degrees Fahrenheit. See attached picture below of pre-heat application.
