DEPARTMENT OF TRANSPORTATION

Contract #: 04-0120F4Cty: SF/ALA Rte: 80 PM: 13.2/13.9File #: 69.28**WELDING INSPECTION REPORT****Resident Engineer:** Pursell, Gary**Address:** 333 Burma Road**City:** Oakland, CA 94607**Report No:** WIR-013881**Date Inspected:** 07-May-2010**Project Name:** SAS Superstructure**OSM Arrival Time:** 700**Prime Contractor:** American Bridge/Fluor Enterprises, a JV**OSM Departure Time:** 1900**Contractor:** Zhenhua Port Machinery Company, Ltd (ZPMC), Changxing Island **Location:** Shanghai, China**CWI Name:** Zhou zhonghai / Zhou cheng**CWI Present:** Yes No**Inspected CWI report:** Yes No N/A**Rod Oven in Use:** Yes No N/A**Electrode to specification:** Yes No N/A**Weld Procedures Followed:** Yes No N/A**Qualified Welders:** Yes No N/A**Verified Joint Fit-up:** Yes No N/A**Approved Drawings:** Yes No N/A**Approved WPS:** Yes No N/A**Delayed / Cancelled:** Yes No N/A**Bridge No:** 34-0006**Component:** OBG Components**Summary of Items Observed:**

WELDING INSPECTION REPORT

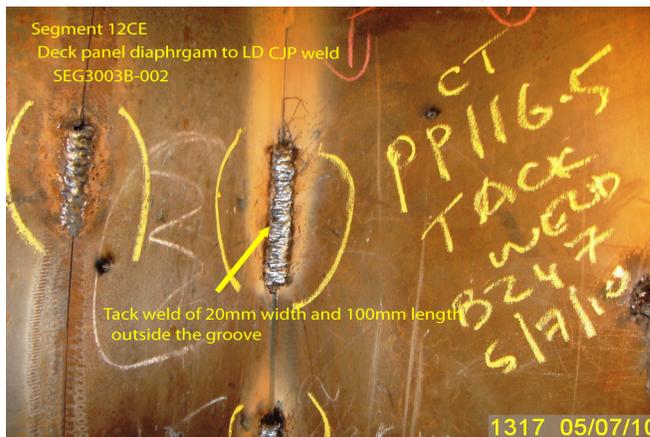
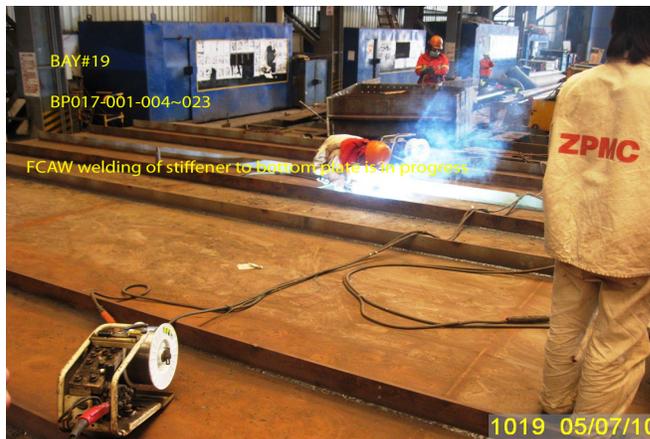
During in process inspection tack weld of weld joint fit-up is identified as SEG3003B-002 and SEG3003D-002 which is connecting Deck panel diaphragm to deck panel diaphragm complete joint penetration weld in segment 12CE, the tack weld welded outside the groove and also the width of the tack weld is 20mm in width and 100mm in length. This is informed to ABF QA Mr. Wang wei nan and ZPMC QC Mr. Guo xing hui for further grinding and MT.
