DEPARTMENT OF TRANSPORTATION

Contract #: 04-0120F4Cty: SF/ALA Rte: 80 PM: 13.2/13.9File #: 1.28**WELDING INSPECTION REPORT****Resident Engineer:** Pursell, Gary**Address:** 333 Burma Road**City:** Oakland, CA 94607**Report No:** WIR-013959**Date Inspected:** 13-May-2010**Project Name:** SAS Superstructure**OSM Arrival Time:** 1100**Prime Contractor:** American Bridge/Fluor Enterprises, a JV**OSM Departure Time:** 1930**Contractor:** American Bridge/Fluor Enterprises, a JV**Location:** Job Site**CWI Name:** See Below**CWI Present:** Yes No**Inspected CWI report:** Yes No N/A**Rod Oven in Use:** Yes No N/A**Electrode to specification:** Yes No N/A**Weld Procedures Followed:** Yes No N/A**Qualified Welders:** Yes No N/A**Verified Joint Fit-up:** Yes No N/A**Approved Drawings:** Yes No N/A**Approved WPS:** Yes No N/A**Delayed / Cancelled:** Yes No N/A**Bridge No:** 34-0006**Component:** Orthotropic Box Girders**Summary of Items Observed:**

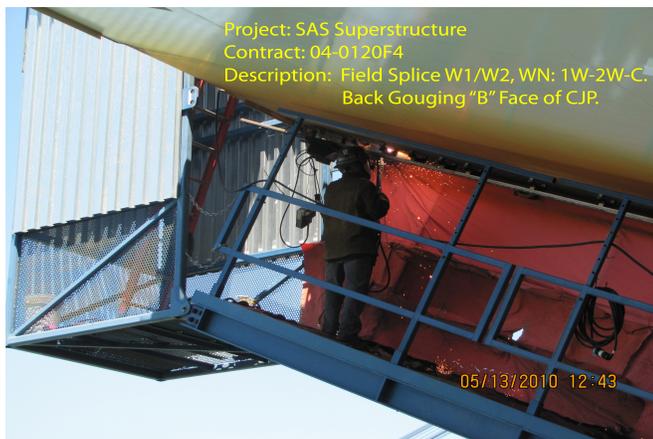
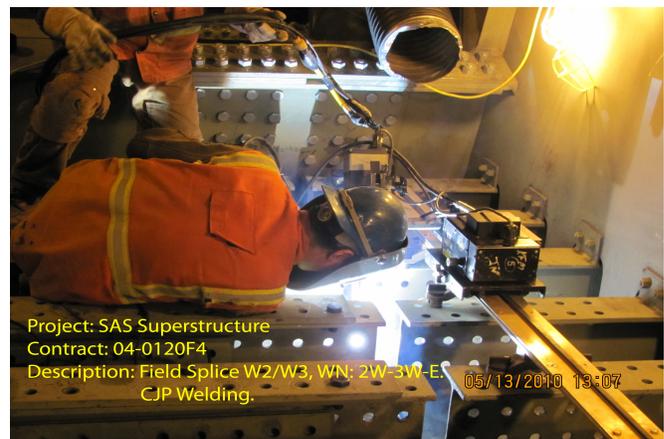
The QAI observed the continued back gouging on the "B" face of the single-v-groove identified as Weld Number (WN): 1W-W2-C. The weld joint appeared to comply with the AWS designation B-U2a-GF. The back gouging was performed by welding personnel Rory Hogan utilizing the plasma arc cutting method.

The QAI observed the automatic Flux Cored Arc Welding (FCAW-G) of the weld joint identified as Weld Number (WN) 2W-3W-E. The welding was performed by welding personnel Songtao Huang, ID-3794 utilizing the WPS ABF-D15-3042A-1 Rev. 0. The joint designation appeared to comply with AWS single-v-groove butt joint identified as B-U2a-G. The WPS was also used by the QC inspector Bernie Docena as a reference to monitor and verify the Direct Current Electrode Positive (DCEP) welding parameters which noted and recorded by the QAI as follows: 247 amps, 22.8 volts and a travel speed measured as 200mm per minute. The welding was performed in vertical position (3G) at approximate incline of 22 degrees. The QAI inspector also verified the minimum preheat temperature of 60 degrees Celsius and the maximum interpass temperature of 230 degrees Celsius. Later during the shift the QAI observed, at random intervals, the QC inspector monitoring the in process welding, the surface temperatures and verifying the DCEP welding parameters.

The digital photographs below illustrate the work observed during this scheduled shift.
