DEPARTMENT OF TRANSPORTATION

Contract #: 04-0120F4Cty: SF/ALA Rte: 80 PM: 13.2/13.9File #: 1x.28**WELDING INSPECTION REPORT****Resident Engineer:** Pursell, Gary**Address:** 333 Burma Road**City:** Oakland, CA 94607**Report No:** WIR-013981**Date Inspected:** 13-May-2010**Project Name:** SAS Superstructure**OSM Arrival Time:** 1000**Prime Contractor:** American Bridge/Fluor Enterprises, a JV**OSM Departure Time:** 1830**Contractor:** American Bridge/Fluor Enterprises, a JV**Location:** Job Site

WELDING INSPECTION REPORT

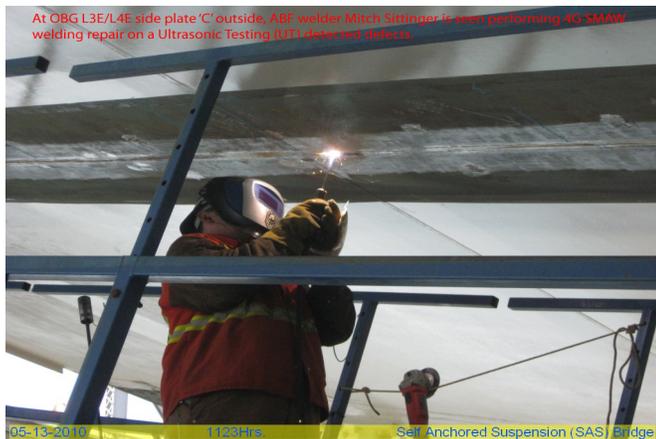
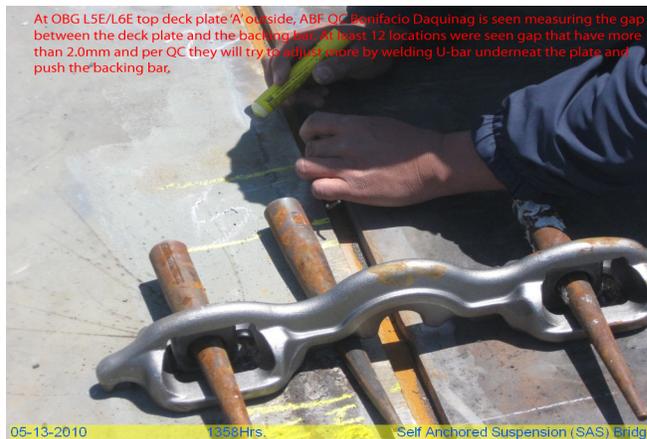
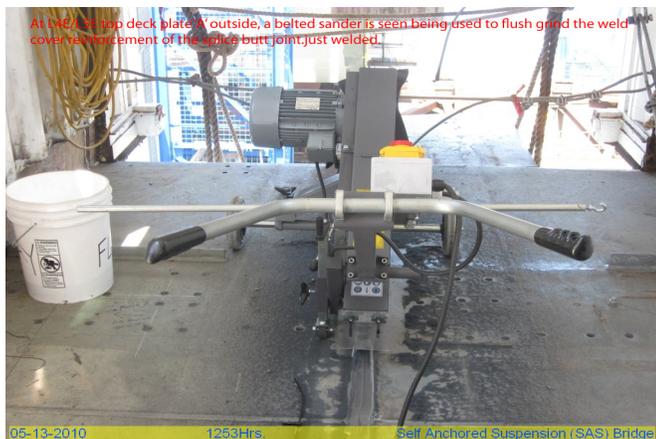
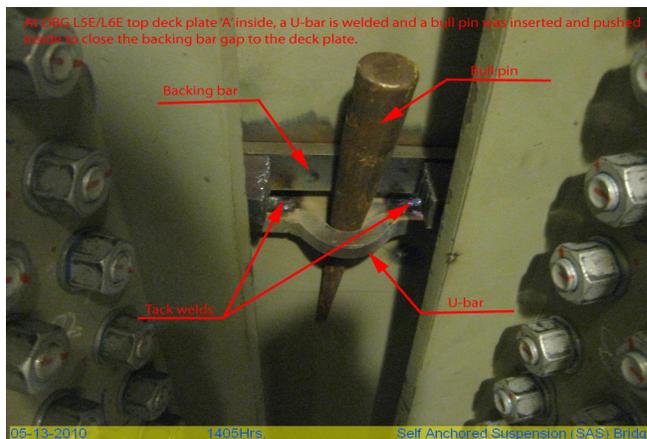
At OBG L3E/L4E side plate 'C' outside, QA randomly observed ABF/JV qualified welder Mitch Sittinger continue perform CJP groove welding repair. The welder was observed welding in the 4G (overhead) position utilizing Shielded metal Arc Welding (SMAW) with 1/8" diameter E7018H4R electrode implementing welding procedure ABF-WPS-D15-1000-Repairs. The weld repairs were excavated to a boat shape and having various dimension of (1) 270mm long X 18mm wide X 13mm deep, (2) 185mm long X 17mm wide X 13mm deep and (3) 100mm long X 19mm wide X 14mm deep. The repair excavations were preheated to more than 140 degree Fahrenheit using propane gas torch prior welding. During the shift, ABF QC William Sherwood was noted monitoring the welder. Prior welding, ABF QC William Sherwood was also observed performing Magnetic Particle Testing (MT) using Parker Contour Probe and red magnetic powder as detecting media on the repair excavation. During the shift, the welder has completed three welding repairs outside and was noted flush grinding the repaired areas and fixing the temporary welding attachment removal.

At OBG L5E/L6E bottom plate 'D' inside, ABF welder Jordan Hazelaar was noted preparing his Submerged Arc Welding (SAW) equipment. At the outside of the same OBG plate, ABF personnel have installed the Miller Proheat 35 Induction Heating System located at the opposite side of the plate for preheating and maintenance prior/during welding. At the end of the shift, the preheating system was turned on but no welding has started yet.

At OBG L5E/L6E top deck plate 'A' inside, ABF welder Rick Clayborn was observed installing the backing bar at the bottom of the plate in preparation for welding of the splice butt joint. During the installation, the welder was noted welding 'U-bar' temporary attachment using 1/8" diameter E7018H4R electrode and also pushing 2-wedges against the U-rib connection plate to put the backing bar in place. While the welder was installing the backing bar at the bottom of the deck plate, ABF QC Bonifacio Daquinag was also noted measuring the gap between the deck plate and backing bar. There were at least 14 locations found and marked by QC that have more than 2.0mm gap between the backing bar and the deck and so QC have asked the welder Rick Clayborn to adjust some more of the wedges/U-bar to minimize the gap. Installation of the backing bar was seen complete but still needs adjustment to get more acceptable readings.
