Contract #: 04-0120F4Cty: SF/ALA Rte: 80 PM: 13.2/13.9File #: 1x.28**WELDING INSPECTION REPORT****Resident Engineer:** Pursell, Gary**Address:** 333 Burma Road**City:** Oakland, CA 94607**Report No:** WIR-013982**Date Inspected:** 14-May-2010**Project Name:** SAS Superstructure**OSM Arrival Time:** 1000**Prime Contractor:** American Bridge/Fluor Enterprises, a JV**OSM Departure Time:** 1830**Contractor:** American Bridge/Fluor Enterprises, a JV**Location:** Job Site

Caltrans Office of Structural Material (OSM) Quality Assurance Inspector (QAI) Joselito Lizardo was present at the Self Anchored Suspension (SAS) job site as requested to perform observations on the welding of components for the San Francisco Oakland Bay Bridge (SFOBB) Project.

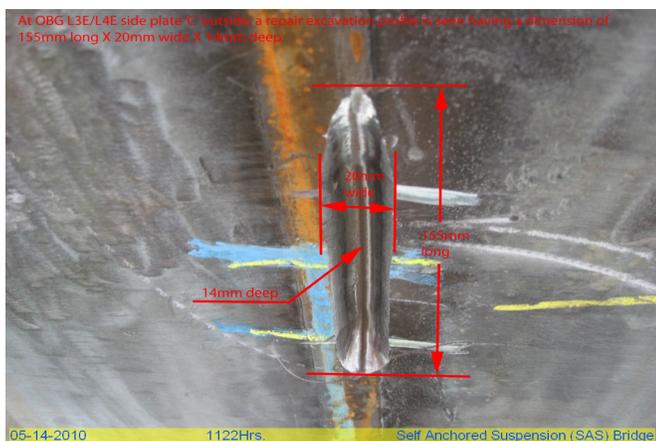
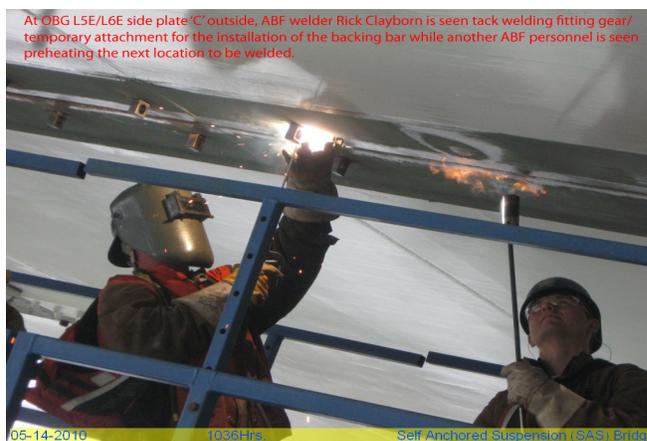
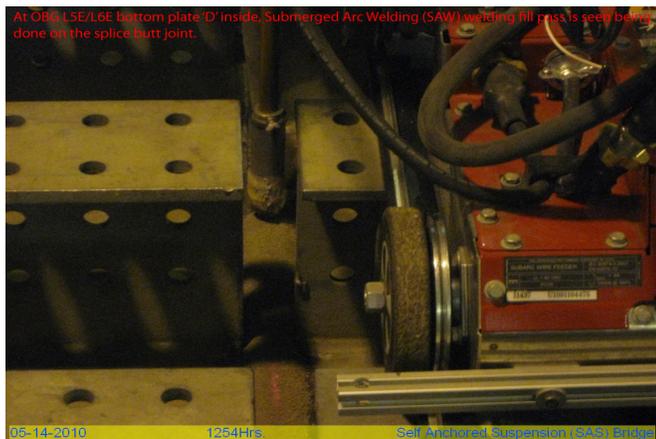
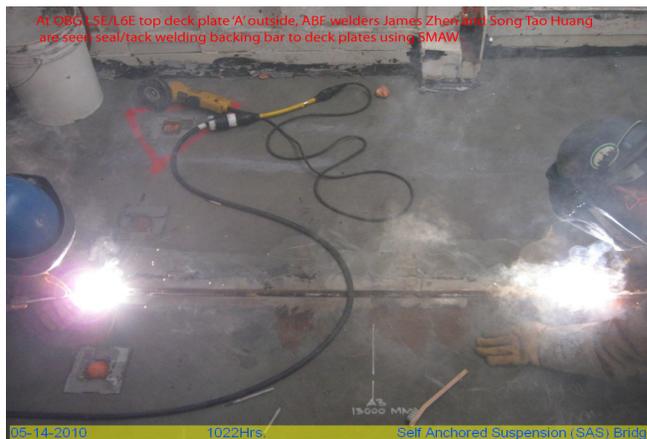
At OBG L5E/L6E bottom plate 'D' inside, certified ABF welder Jordan Hazelaar (ID #2135) was noted performing flat (1G) Submerged Arc Welding (SAW) welding fill to cover pass on the splice butt joint. The welder was utilizing F7A6-EM12K-H8, 3.2mm electrode with corresponding Esab OK Flux 10.62 flux and implementing Caltrans approved Welding Procedure Specification (WPS) ABF-WPS-D15-4042B-1. The welder was welding using a track mounted Lincoln Electric "Cruiser Tractor" wire feeder and a Lincoln Electric AC/DC 1000 SD Power Wave welding machine. The plates were preheated to >150 degree F using two Miller Proheat 35 Induction Heating System located at the opposite side of the plate prior/during welding. Welding parameters was monitored by Jim Cunningham. Parameters measured by QA during welding were 550 amperes, 32.2 volts and 355mm per minute travel speed. QA noted the welding parameters, the workmanship and appearance of the completed fill and cover passes satisfactory and were deemed acceptable to contract requirements. During the shift, the welder has completely welded the area (6300mm long) where the wire feeder could reach. At the North side of the joint, approximately 1400mm long still need to be welded either by hand SMAW/FCAW-G and at the South side of the joint there is also 800mm long still need to be welded.

At OBG L3E/L4E side plate 'C' outside, QA randomly observed ABF/JV qualified welder Mitch Sittinger continue perform CJP groove welding repair. The welder was observed welding in the 4G (overhead) position utilizing Shielded metal Arc Welding (SMAW) with 1/8" diameter E7018H4R electrode implementing welding

procedure ABF-WPS-D15-1000-Repairs. The repair excavations were preheated to more than 140 degree Fahrenheit using propane gas torch prior welding. During the shift, ABF QC William Sherwood was noted monitoring the welder. Prior welding, ABF QC William Sherwood was also observed performing Magnetic Particle Testing (MT) using Parker Contour Probe with red magnetic powder as detecting media on the repair excavation. During the shift, the welder has completed three welding repairs outside and was noted flush grinding the repaired areas and fixing the temporary welding attachment removal.

At OBG L5E/L6E side plate 'C' outside, ABF welder Rick Clayborn was observed installing fitting gear at the plate to be used as an aid in installing the backing bar of the splice butt joint. During the installation, the welder was noted welding the fitting gear/temporary attachment using 1/8" diameter E7018H4R electrode. During the installation, ABF QC Bonifacio Daquinag was noted monitoring the welder and his parameters. Installation/tack welding of the fitting gear was seen complete at the end of the shift.
