**DEPARTMENT OF TRANSPORTATION**

Contract #: 04-0120F4Cty: SF/ALA Rte: 80 PM: 13.2/13.9File #: 1x.28**WELDING INSPECTION REPORT****Resident Engineer:** Pursell, Gary**Address:** 333 Burma Road**City:** Oakland, CA 94607**Report No:** WIR-013991**Date Inspected:** 15-May-2010**Project Name:** SAS Superstructure**OSM Arrival Time:** 900**Prime Contractor:** American Bridge/Fluor Enterprises, a JV**OSM Departure Time:** 1730**Contractor:** American Bridge/Fluor Enterprises, a JV**Location:** Job Site

Caltrans Office of Structural Material (OSM) Quality Assurance Inspector (QAI) Joselito Lizardo was present at the Self Anchored Suspension (SAS) job site as requested to perform observations on the welding of components for the San Francisco Oakland Bay Bridge (SFOBB) Project.

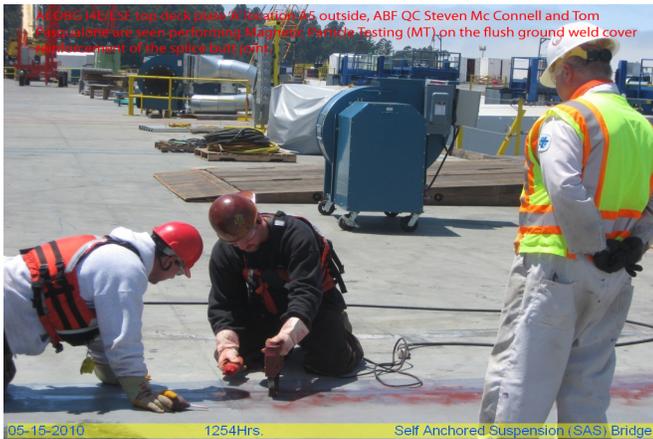
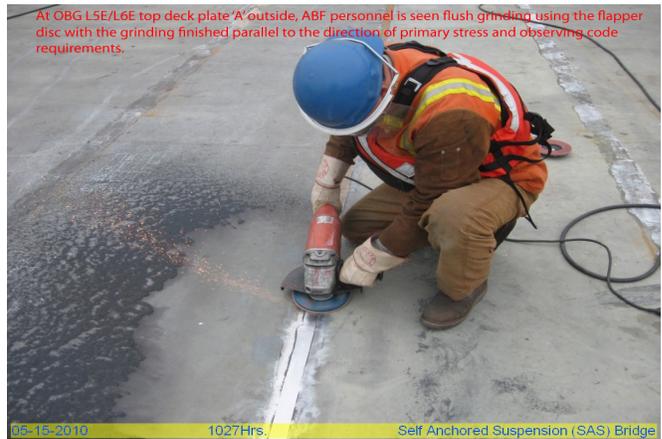
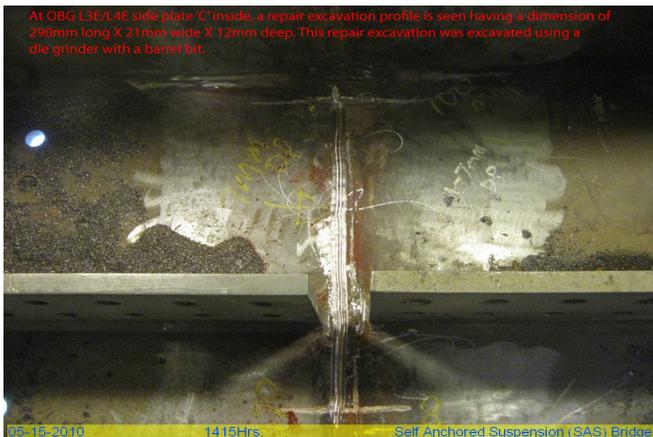
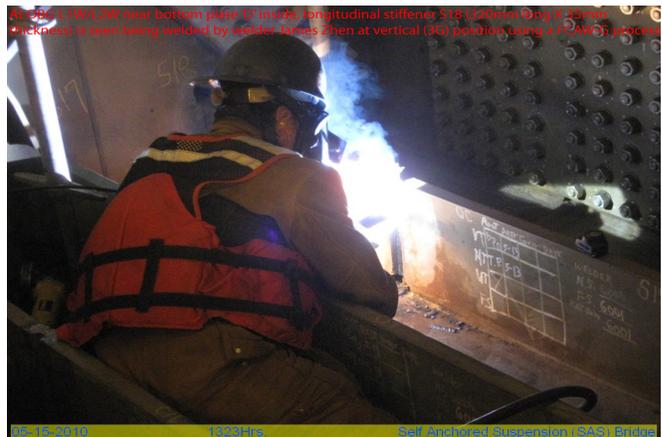
At OBG L5E/L6E top deck plate 'A' outside, QA observed ABF welder James Zhen (ID # 6001) continued seal/tack welding the backing bar to the deck plate. The welder was welding at horizontal (2F) position using a Shielded Metal Arc Welding (SMAW) with 1/8" diameter E7018H4R electrode implementing procedure ABF-WPS-D15-F1200. After completed tack welding the backing bar, the welder was seen groove welding approximately 6" long at the south end of the splice butt joint using the same process but in flat position. Welding at this location was also completed and ABF personnel were seen grinding/cleaning the backing bar tack welds and preparing their SAW welding equipment for the next process.

At OBG L4E/L5E top deck plate 'A' outside, flush grinding using a flapper disc on the cover weld reinforcement still continued. ABF QC Steven Mc Connell and Tom Pasqualone were noted performing Magnetic Particle Testing (MT) on area A5 where it is already been ground. After completing their MT on this area, the two QC started performing Ultrasonic Testing (UT).

At OBG L1W/L2W plate 'D' inside stiffener S18, ABF welder James Zhen (ID # 6001) was noted welding manually at the splice butt joint of the stiffener (320mm long X 35mm thickness). QA randomly observed the welder perform Complete Joint Penetration (CJP) welding fill pass. The welder was noted welding in the vertical (3G) position utilizing an semi-automatic dual shield Flux Cored Arc Welding (FCAW-G) with E71T-1M, 1/16"

diameter wire electrode and implementing Caltrans approved Welding Procedure Specification (WPS) ABF-WPS-D15-3110-3. The joint being welded has a double V-groove butt joint and was battered (with temporary backing bar in place) due to excessive gap. The backing bar has been removed and the surfaced was ground smooth prior welding. The splice joint was preheated and maintained to greater than 200 degree Fahrenheit using propane gas torch prior welding. During welding, ABF Quality Control (QC) Jesse Cayabyab was noted monitoring the welder and parameters of the welder. QA performed parameter readings during welding with the following results; 240 amperes, 22.0 volts. Welding parameters noted are deemed acceptable to contract specifications.

At OBG L2W/L3W plate 'C2' (7875mm to 10475mm) inside, QA randomly observed ABF/JV qualified welder Sungtao, Huang ID # 3794 perform CJP groove (splice) welding fill pass. The welder was observed perform automatic welding in the 3G (vertical) position utilizing a dual shield Flux Cored Arc Welding (FCAW-G) with E71T-1M, 1/16" diameter wire electrode and implementing Caltrans approved Welding Procedure Specification (WPS) ABF-WPS-D15-3042A-1. The joint being welded has a single V-groove butt joint with backing bar. The splice joint was preheated and maintained to greater than 150 degree Miller Proheat 35 Induction Heating System located at the opposite side of the plate. During welding, ABF Quality Control (QC) Bernie Docena was noted monitoring the welding parameters of the welder. QA performed parameter readings during welding with the following results; 250 amperes, 22.6 volts and 220mm per minute travel speed which are deemed acceptable to contract specifications.
