DEPARTMENT OF TRANSPORTATION

Contract #: 04-0120F4Cty: SF/Ala Rte: 80 PM: 13.2/13.9File #: 69.28**WELDING INSPECTION REPORT****Resident Engineer:** Pursell, Gary**Address:** 333 Burma Road**City:** Oakland, CA 94607**Report No:** WIR-014029**Date Inspected:** 09-Apr-2010**Project Name:** SAS Superstructure**OSM Arrival Time:** 1900**Prime Contractor:** American Bridge/Fluor Enterprises, a JV**OSM Departure Time:** 700**Contractor:** Zhenhua Port Machinery Company, Ltd (ZPMC), Changxing Island **Location:** Shanghai, China

OBG Assembly Yard

This QA Inspector performed random visual testing and then MT of approximately 15% of the area previously tested and accepted by ZPMC Quality Control personnel. This QA Inspector generated an MT report for this date. The member is identified as OBG Segment 9CW.

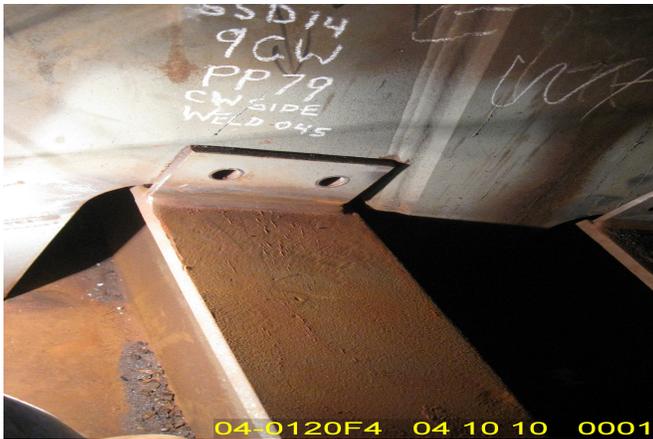
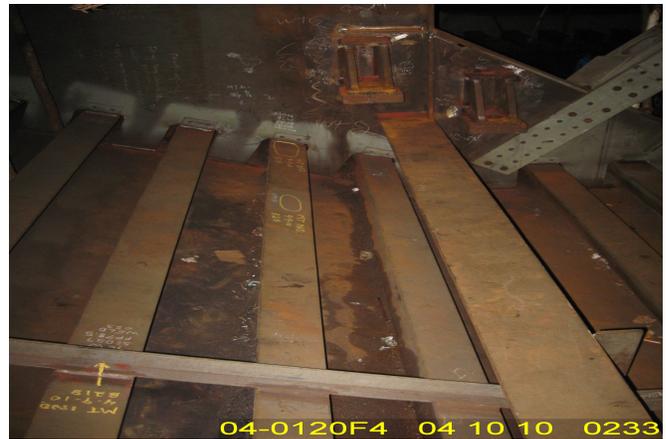
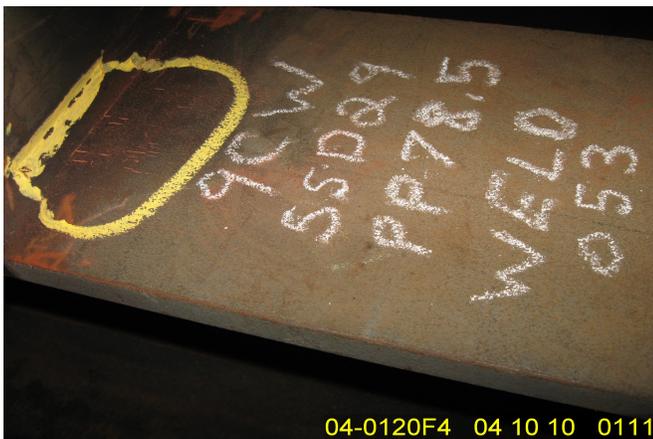
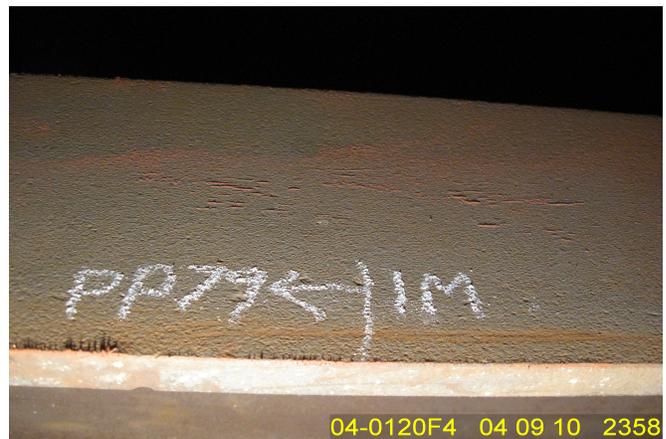
This QA Inspector observed 3 clusters of several indications each, on the second and third T-rib flanges from the longitudinal diaphragm on the side plate on the north (crossbeam) side between panel points 78.5 and 79. No other apparent indications were observed. This QA Inspector verbally reported these conditions to QA Inspector John Kinsey and provided photos. See photos below.
