**DEPARTMENT OF TRANSPORTATION**

Contract #: 04-0120F4Cty: SF/ALA Rte: 80 PM: 13.2/13.9File #: 1x.28**WELDING INSPECTION REPORT****Resident Engineer:** Pursell, Gary**Address:** 333 Burma Road**City:** Oakland, CA 94607**Report No:** WIR-014035**Date Inspected:** 17-May-2010**Project Name:** SAS Superstructure**OSM Arrival Time:** 1000**Prime Contractor:** American Bridge/Fluor Enterprises, a JV**OSM Departure Time:** 1830**Contractor:** American Bridge/Fluor Enterprises, a JV**Location:** Job Site

# WELDING INSPECTION REPORT

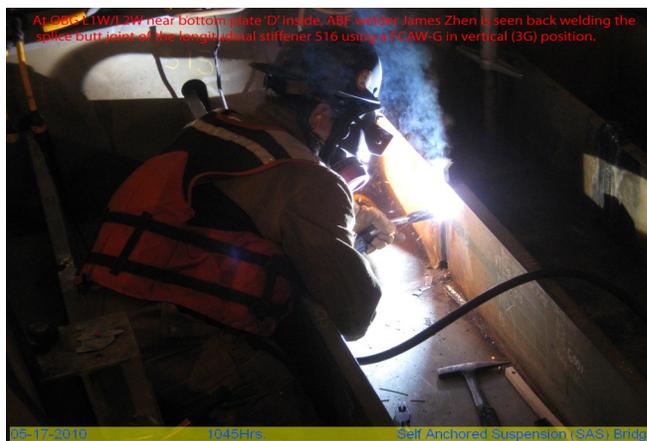
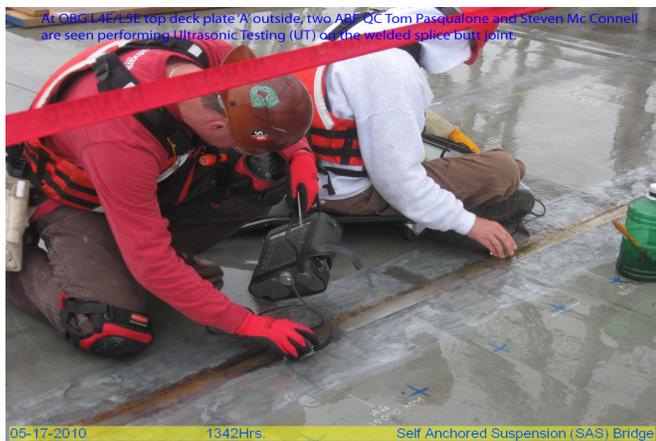
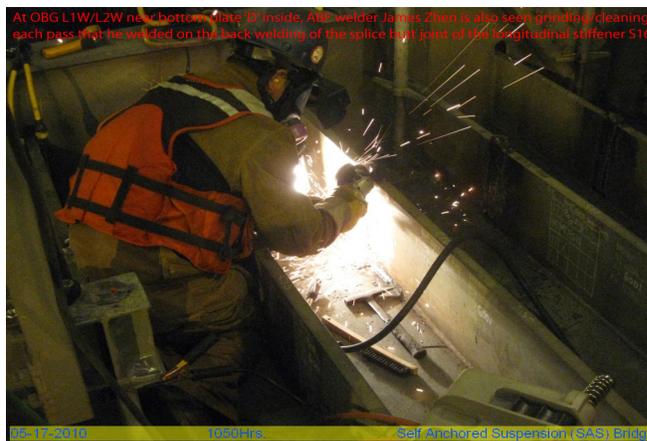
QA randomly observed ABF/JV qualified welders Rory Hogan (ID #3186) perform CJP groove (splice) back welding fill pass on Orthotropic Box Girder (OBG) L1W/L2W side plate 'C' outside. The welder was observed welding in the 4G (overhead) position utilizing a dual shield Flux Cored Arc Welding (FCAW-G) with E71T-1M, 1/16" diameter wire electrode and implementing Caltrans approved Welding Procedure Specification (WPS) ABF-WPS-D15-3110-4. The welder was using a track mounted welder holder assembly that is remotely controlled. The joint being welded has the backing bar gouged using the Esab Plasma Arc machine and was ground smooth. The gouged and ground splice butt joint was also Non Destructive Testing (NDT) tested using the Magnetic Particle Testing (MT). The splice joint was preheated and maintained to greater than 150 degree Fahrenheit using Miller Proheat 35 Induction Heating System located at the other side of the plate prior/during welding. The vicinity was also properly protected from wind and other climatic changes. During welding, ABF Quality Control (QC) Jim Cunningham was noted monitoring the welding parameters of the welder.

At OBG L3E/L4E side plate 'C' outside, QA randomly observed ABF/JV qualified welder Mitch Sittinger continue perform CJP groove welding repair. The welder was observed welding in the 3G (vertical) position utilizing Shielded metal Arc Welding (SMAW) with 1/8" diameter E7018H4R electrode implementing welding procedure ABF-WPS-D15-1000-Repairs. The repair excavations were preheated to more than 140 degree Fahrenheit using propane gas torch prior welding. During the shift, ABF QC William Sherwood was noted

monitoring the welder. Prior welding, ABF QC William Sherwood was also observed performing Magnetic Particle Testing (MT) using Parker Contour Probe with red magnetic powder as detecting media on the repair excavation. During the shift, the welder has completed two welding repairs inside and has moved to edge plate of the same splice and fixed where bad surface profile of the back weld was noted.

At OBG L4E/L5E top deck plate 'A' outside, flush grinding using a flapper disc on the cover weld reinforcement seen completed. ABF QC Steven Mc Connell and Tom Pasqualone were noted performing Ultrasonic Testing (UT) on area A4 of the same plate.
