DEPARTMENT OF TRANSPORTATION

Contract #: 04-0120F4Cty: SF/ALA Rte: 80 PM: 13.2/13.9File #: 69.28**WELDING INSPECTION REPORT****Resident Engineer:** Pursell, Gary**Address:** 333 Burma Road**City:** Oakland, CA 94607**Report No:** WIR-014161**Date Inspected:** 16-May-2010**Project Name:** SAS Superstructure**OSM Arrival Time:** 700**Prime Contractor:** American Bridge/Fluor Enterprises, a JV**OSM Departure Time:** 1900**Contractor:** Zhenhua Port Machinery Company, Ltd (ZPMC), Changxing Island **Location:** Shanghai, China**CWI Name:** Mr. Mao Bin Bin**CWI Present:** Yes No**Inspected CWI report:** Yes No N/A**Rod Oven in Use:** Yes No N/A**Electrode to specification:** Yes No N/A**Weld Procedures Followed:** Yes No N/A**Qualified Welders:** Yes No N/A**Verified Joint Fit-up:** Yes No N/A**Approved Drawings:** Yes No N/A**Approved WPS:** Yes No N/A**Delayed / Cancelled:** Yes No N/A**Bridge No:** 34-0006**Component:** Tower**Summary of Items Observed:**

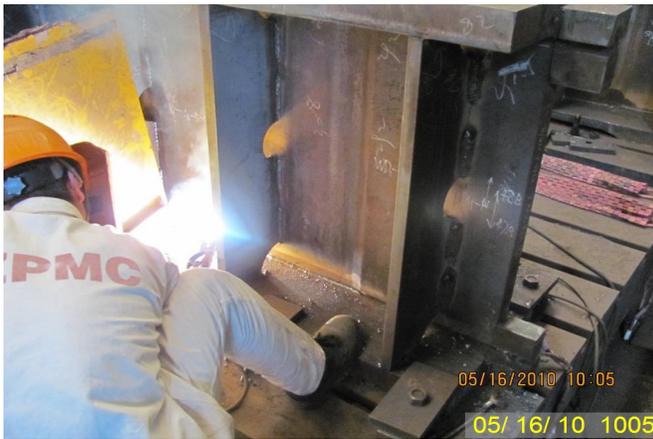
1. This QA inspector, Baskar Govindarajan, observed, ZPMC qualified welding personnel identified as 040619 perform SMAW welding on, Spare strut flange to web and the weld joint is identified as WD1-STSA4-5-119mtr.-1-5A. ZPMC CWI Identified as Mr. Yu Dong Ping. The welding parameters as measured using QC's calibrated instruments appeared to be in general compliance with WPS-B-T-3212-TC-U5B-1. (Photo attached)

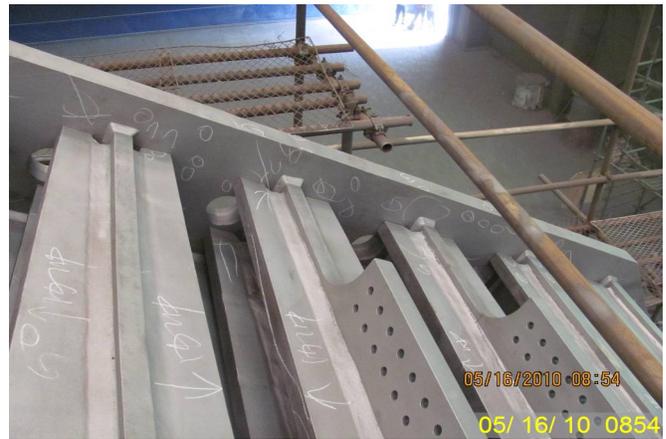
4. This QA inspector, Baskar Govindarajan, performed marking of weld spatters, Arc strikes, grinding points of external skin A, B, C, D and E during the pre blasting inspection of North shaft, Lift 1. This inspection was carried out along with QA Inspectors Mr. Umesh Gaikwad, Mr. Bera and Mr. Bera. All the marked points were shown to ZPMC for necessary works. (Photo attached)
