Contract #: 04-0120F4Cty: SF/ALA Rte: 80 PM: 13.2/13.9File #: 69.28**WELDING INSPECTION REPORT****Resident Engineer:** Pursell, Gary**Address:** 333 Burma Road**City:** Oakland, CA 94607**Report No:** WIR-014235**Date Inspected:** 19-Apr-2010**Project Name:** SAS Superstructure**OSM Arrival Time:** 700**Prime Contractor:** American Bridge/Fluor Enterprises, a JV**OSM Departure Time:** 1900**Contractor:** Zhenhua Port Machinery Company, Ltd (ZPMC), Changxing Island **Location:** Shanghai, China**CWI Name:** Mr. Tian Lei**CWI Present:** Yes No**Inspected CWI report:** Yes No N/A**Rod Oven in Use:** Yes No N/A**Electrode to specification:** Yes No N/A**Weld Procedures Followed:** Yes No N/A**Qualified Welders:** Yes No N/A**Verified Joint Fit-up:** Yes No N/A**Approved Drawings:** Yes No N/A**Approved WPS:** Yes No N/A**Delayed / Cancelled:** Yes No N/A**Bridge No:** 34-0006**Component:** Orthotropic Box Girder (OBG) / Tower**Summary of Items Observed:**

This CALTRANS OSM Quality Assurance Inspector (QA) Surendra Prabhu was present during the times noted above for observations relative to the fabrication of the Self Anchored Suspension (SAS) Superstructure being performed by Zhenhua

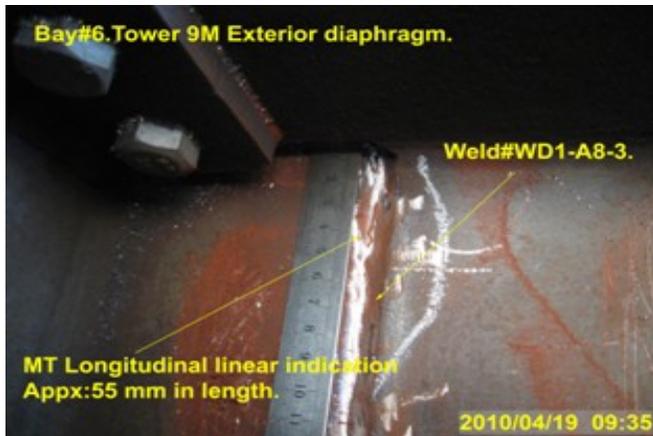
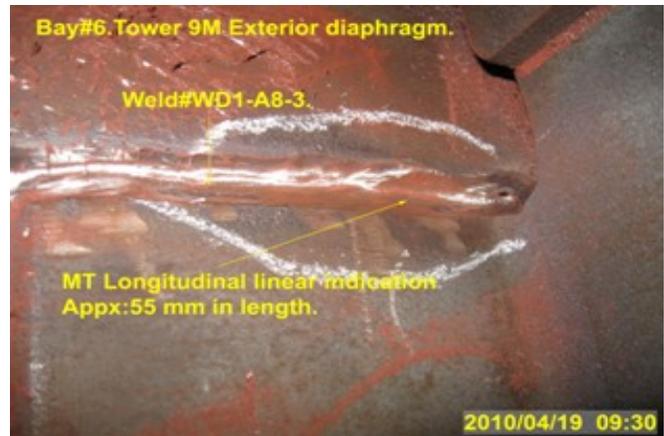
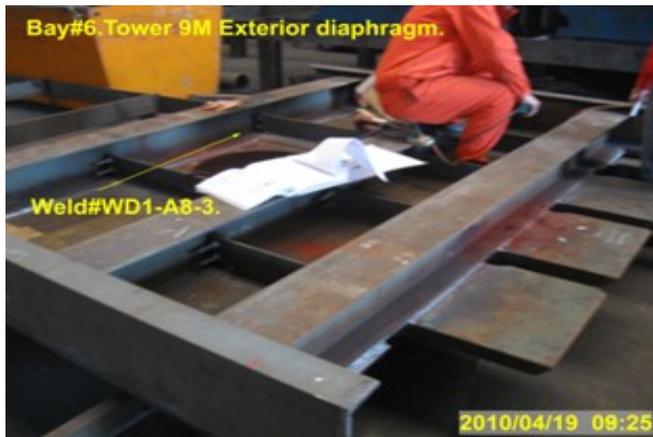
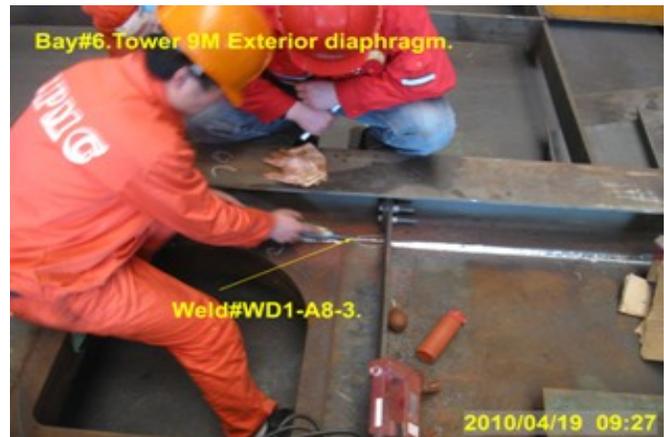
During Quality Assurance Magnetic Particle Testing (MT) review of welds located on Tower 9M Exterior diaphragm , this QA Inspector observed One (1) Longitudinal Linear indication measuring approximately 55 mm in length.The weld is identified as: WD1-A8-3.The weld measured to be an 8mm fillet weld.

This QA Inspector generated an incident report for the above issue on this date. for further information see the incident report and attached photographs.
