Contract #: 04-0120F4Cty: SF/ALA Rte: 80 PM: 13.2/13.9File #: 1x.28**WELDING INSPECTION REPORT****Resident Engineer:** Pursell, Gary**Address:** 333 Burma Road**City:** Oakland, CA 94607**Report No:** WIR-014311**Date Inspected:** 21-May-2010**Project Name:** SAS Superstructure**OSM Arrival Time:** 1000**Prime Contractor:** American Bridge/Fluor Enterprises, a JV**OSM Departure Time:** 1830**Contractor:** American Bridge/Fluor Enterprises, a JV**Location:** Job Site

WELDING INSPECTION REPORT

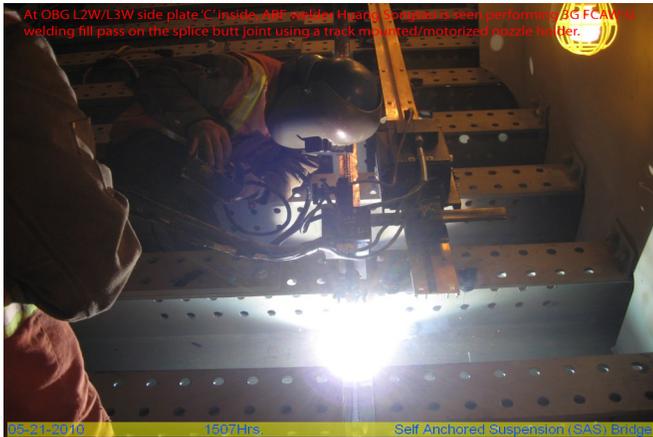
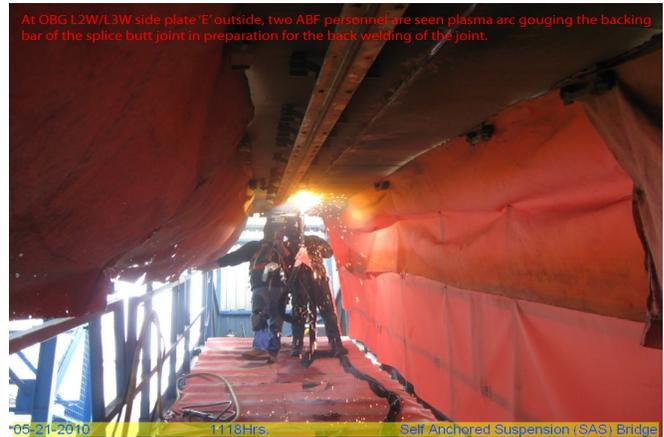
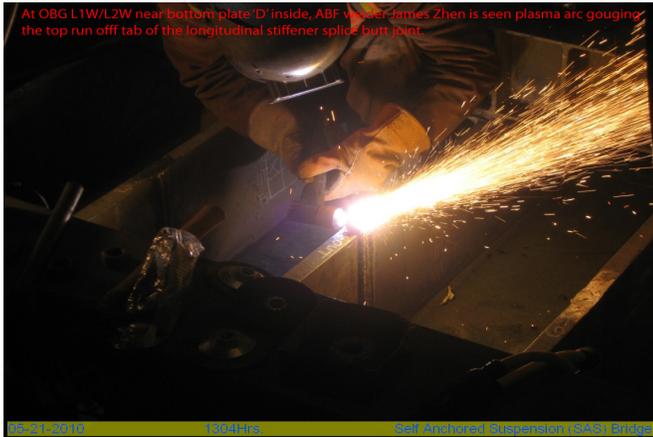
At OBG L2W/L3W side plate 'C1' (1200mm to 5280mm) inside, QA randomly observed ABF/JV qualified welder Sungtao, Huang ID # 3794 continue perform CJP groove (splice) welding root then fill pass. The welder was observed perform automatic welding in the 3G (vertical) position utilizing a dual shield Flux Cored Arc Welding (FCAW-G) with E71T-1M, 1/16" diameter wire electrode and implementing Caltrans approved Welding Procedure Specification (WPS) ABF-WPS-D15-3042A-1. The joint being welded has a single V-groove butt joint with backing bar. The splice joint was preheated and maintained to greater than 200 degree Fahrenheit using Miller Proheat 35 Induction Heating System located at the opposite side of the plate prior/during welding. During welding, ABF Quality Control (QC) Bernie Docena was noted monitoring the welding parameters of the welder. QA performed parameter readings during welding with the following results; 250 amperes, 24.0 volts and 310mm per minute travel speed which are deemed acceptable to contract specifications.

At OBG L1W/L2W near bottom plate 'D', ABF welder Huang Fai Tsui was observed plasma arc gouging the top

run off tab and the bottom cope/rat hole on various longitudinal stiffeners inside the box. After gouging, ABF welders Huang Fai Tsui and James Zhen were noted grinding the top surface of the stiffeners. Aside from grinding the top, the welders were also noted flush grinding the weld cover reinforcement of the splice butt joints.

At the same splice joint but different plate, three ABF QC were noted performing Ultrasonic Testing on the welded splice butt joint side plate 'E'. ABF QC Jesse Cayabyab and Bernie Docena were noted in the inside plate while ABF QC Steven Mc Connell was noted on the outside plate.

At OBG L2W/L3W side plate 'E' outside, ABF welder Rory Hogan with one ABF personnel were seen performing plasma arc gouging on the backing bar of the welded (from inside) splice butt joint. The welder was using A Miller plasma arc machine with the nozzle attached to the track that is remotely controlled.
