DEPARTMENT OF TRANSPORTATION

Contract #: 04-0120F4Cty: SF/ALA Rte: 80 PM: 13.2/13.9File #: 1x.28**WELDING INSPECTION REPORT****Resident Engineer:** Pursell, Gary**Address:** 333 Burma Road**City:** Oakland, CA 94607**Report No:** WIR-014315**Date Inspected:** 22-May-2010**Project Name:** SAS Superstructure**OSM Arrival Time:** 900**Prime Contractor:** American Bridge/Fluor Enterprises, a JV**OSM Departure Time:** 1730**Contractor:** American Bridge/Fluor Enterprises, a JV**Location:** Job Site

WELDING INSPECTION REPORT

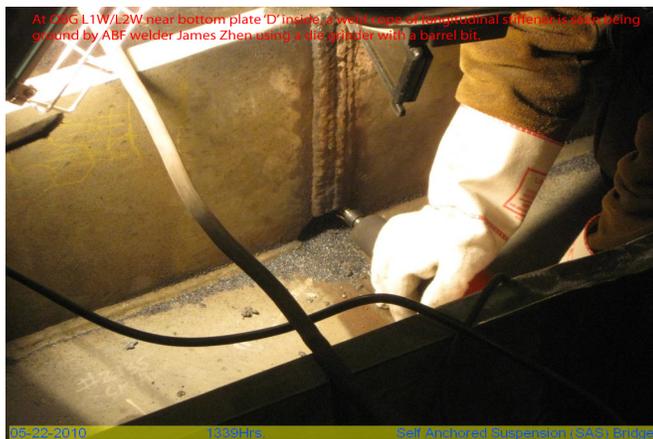
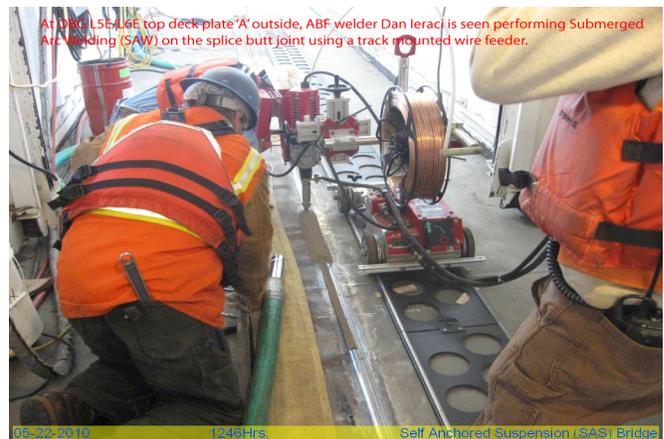
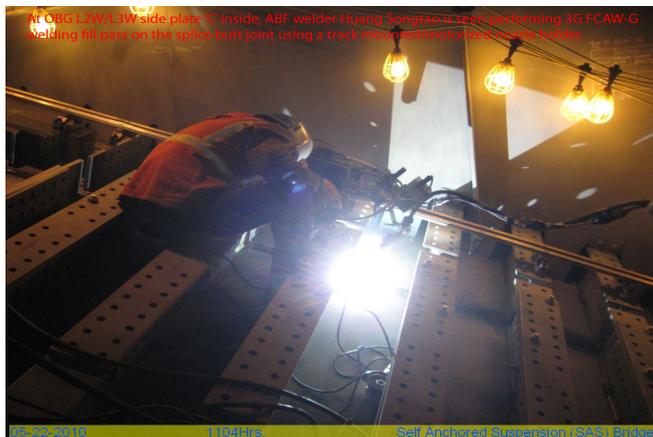
At OBG L2W/L3W side plate 'C1' (1200mm to 5280mm) inside, QA randomly observed ABF/JV qualified welder Sungtao, Huang ID # 3794 continue perform CJP groove (splice) welding root then fill pass. The welder was observed perform automatic welding in the 3G (vertical) position utilizing a dual shield Flux Cored Arc Welding (FCAW-G) with E71T-1M, 1/16" diameter wire electrode and implementing Caltrans approved Welding Procedure Specification (WPS) ABF-WPS-D15-3042A-1. The joint being welded has a single V-groove butt joint with backing bar. The splice joint was preheated and maintained to greater than 200 degree Fahrenheit using Miller Proheat 35 Induction Heating System located at the opposite side of the plate prior/during welding. During welding, ABF Quality Control (QC) Bernie Docena was noted monitoring the welding parameters of the welder. QA performed parameter readings during welding with the following results; 255 amperes, 23.6 volts and 310mm per minute travel speed which are deemed acceptable to contract specifications. The welder has completed welding the area he was welding and has moved to area 0mm to 1200mm of the same plate.

At OBG L1W/L2W near bottom plate 'D', ABF welder Huang Fai Tsui was observed plasma arc gouging the top run off tab and the bottom cope/rat hole on various longitudinal stiffeners inside the box. After gouging, ABF welders Huang Fai Tsui and James Zhen were noted grinding the top surface of the stiffeners. Aside from grinding the top, the welders were also noted grinding the bottom cope/rat hole using a die grinder with a barrel bit. The task was not completed and the welders intend to continue on Monday.

At OBG L2W/L3W side plate 'E' outside, plasma arc gouging was seen completed. ABF welders Rory Hogan and Jeremy Dolman were noted grinding the gouged area of the backing bar removal in preparation for Magnetic Particle Testing of the groove and eventual back welding of the splice butt joint.

At L5E/L6E top deck plate 'A' outside, ABF welder Jordan Hazelaar was seen completely welded the area he was welding at A1 to A3 while ABF Superintendent/welder Dan Ieraci was still welding at area A3 to A5. Mr. Dan Ieraci was noted using Submerged Arc Welding (SAW) welding the groove splice butt joint in flat (1G) position. The welder was utilizing F7A6-EM12K-H8, 3.2mm electrode with corresponding Esab OK Flux 10.62 flux and implementing Caltrans approved Welding Procedure Specification (WPS) ABF-WPS-D15-4042B-1. The plates being welded have a backing bar attached to the other side and preheated and maintained to greater than 150 degree Fahrenheit using Miller Proheat 35 Induction Heating System located on top of the plate prior welding. The welding activities and parameters were monitored by ABF QC Bonifacio Daquinag. QA performed parameter check at the time of welding and noted an ampere reading of 550 amperes, 32.3 voltages and a travel speed of 378mm per minute. The welding parameters appear in conformance to the contract requirements. SAW welding at area A3 to A5 was seen completed during the shift but it was also being welded using 1/8" diameter E7018H4R electrode where low or weld underfill were noted.
