**DEPARTMENT OF TRANSPORTATION**

Contract #: 04-0120F4Cty: SF/ALA Rte: 80 PM: 13.2/13.9File #: 69.28**WELDING INSPECTION REPORT****Resident Engineer:** Pursell, Gary**Address:** 333 Burma Road**City:** Oakland, CA 94607**Report No:** WIR-014376**Date Inspected:** 10-May-2010**Project Name:** SAS Superstructure**OSM Arrival Time:** 700**Prime Contractor:** American Bridge/Fluor Enterprises, a JV**OSM Departure Time:** 1900**Contractor:** Zhenhua Port Machinery Company, Ltd (ZPMC), Changxing Island **Location:** Shanghai, China

Orthotropic Box Girder (OBG) Trial Assembly Areas

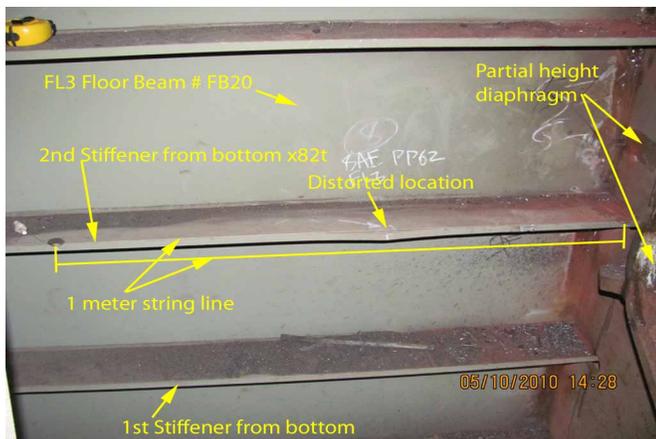
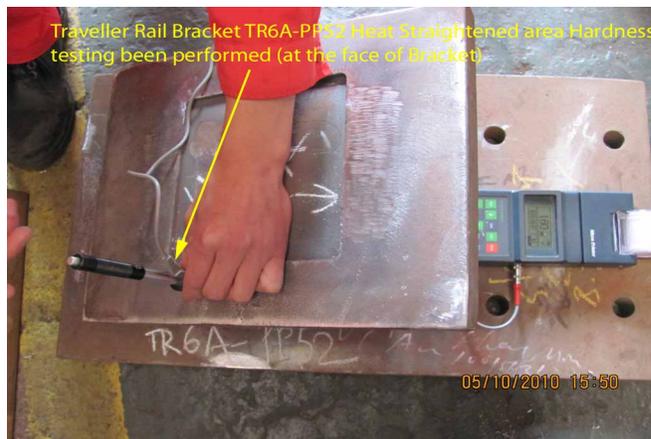
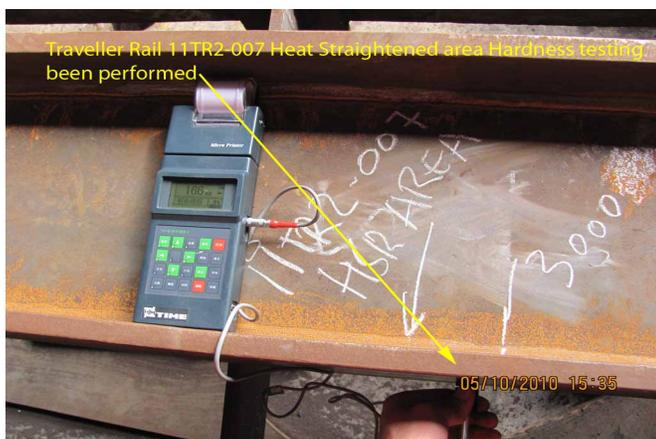
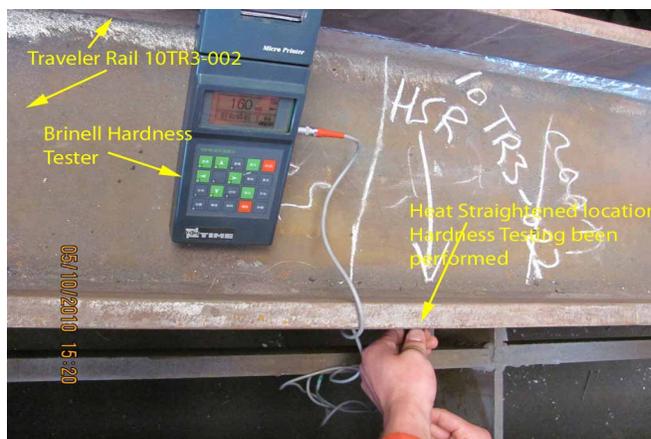
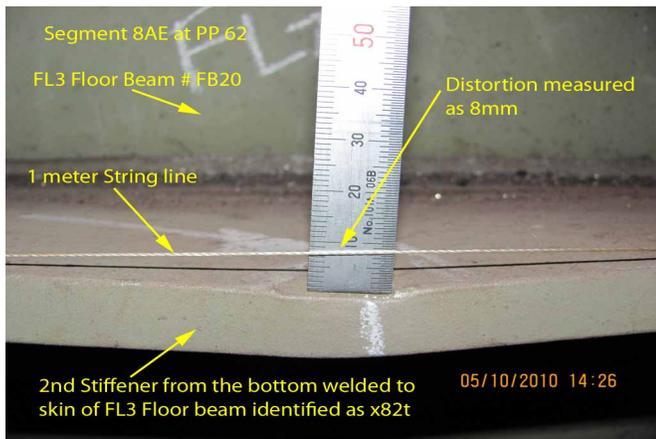
This Quality Assurance (QA) Inspector wrote an Incident Report for flatness of Stiffener at Cross Beam side for Segment 8AE Panel Point (PP) 62 for more comprehensive details please refer the Incident Report # 04-0120F4\_TL-15\_B278\_05-10-2010\_FL3 Stiffener\_8AE at PP 62 Dated May 10, 2010. Please refer the attached pictures for more comprehensive details.

Hardness test was performed at heat straightened area between Y locations 3800mm to 4000mm from one end and Hardness value was measured as 157HB, 191HB, 147HB, 160HB, 144HB, 149HB, 148HB, 144HB and 149HB. Please refer the attached pictures for more comprehensive details.

Hardness test was performed at heat straightened area between Y locations 3000mm to 3150mm from one end and Hardness value was measured as 148HB, 156HB, 164HB, 134HB, 142HB, 166HB, 151HB, 149HB and 151HB. Please refer the attached pictures for more comprehensive details.

Hardness test was performed at heat straightened area on Traveler Rail Bracket face and Hardness value was measured as 152HB, 156HB, 165HB, 152HB, 160HB, 181HB, 158HB and 152HB. Please refer the attached pictures for more comprehensive details.
