DEPARTMENT OF TRANSPORTATION

Quality Assurance and Source Inspection

Contract #: 04-0120F4Cty: SF/ALA Rte: 80 PM: 13.2/13.9File #: 1x.28**WELDING INSPECTION REPORT****Resident Engineer:** Pursell, Gary**Address:** 333 Burma Road**City:** Oakland, CA 94607**Report No:** WIR-014481**Date Inspected:** 24-May-2010**Project Name:** SAS Superstructure**OSM Arrival Time:** 1100**Prime Contractor:** American Bridge/Fluor Enterprises, a JV**OSM Departure Time:** 1800**Contractor:** American Bridge/Fluor Enterprises, a JV**Location:** Job Site**CWI Name:** Tony Sherwood**CWI Present:** Yes No**Inspected CWI report:** Yes No N/A**Rod Oven in Use:** Yes No N/A**Electrode to specification:** Yes No N/A**Weld Procedures Followed:** Yes No N/A**Qualified Welders:** Yes No N/A**Verified Joint Fit-up:** Yes No N/A**Approved Drawings:** Yes No N/A**Approved WPS:** Yes No N/A**Delayed / Cancelled:** Yes No N/A**Bridge No:** 34-0006**Component:** OBG Sections**Summary of Items Observed:**

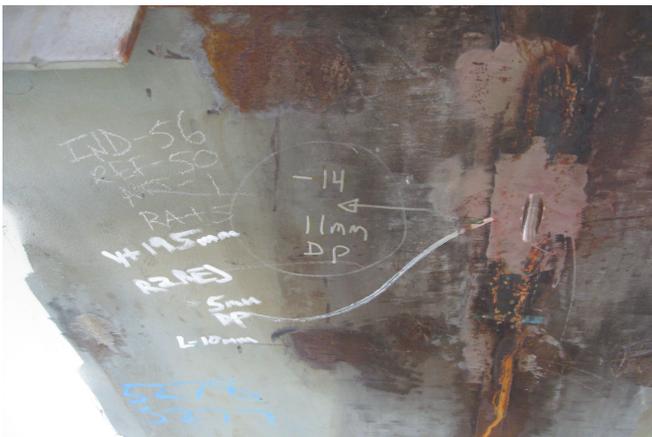
- 1) At weld joint E3/E4-C: This QA Inspector observed an area of the weld had been excavated after QC personnel had rejected the area during Ultrasonic Testing. This QA Inspector did not observe welding performed at this location this date.
- 2) At weld joint E4/E5-D-2: ABF welding personnel Jordan Hazelaar (#2135) was performing production welding with QC Inspector Bonifacio Daquinag Jr. present.
- 3) At weld joint W1/W2-E1 and E2: This QA Inspector observed ABF welding personnel Rory Hogan (#3186) and Jeremy Dolman (#5042) setting up equipment to begin production welding, but welding was not observed at this location this date.
- 4) At weld joint E5/E6-A1 thru A5: This QA Inspector observed ABF welding personnel James Zhen (#6001) was using the Shielded Metal Arc Welding Process (SMAW) to fill in low areas marked by QC personnel. QC Inspector Tony Sherwood was present.

This QA Inspector observed at weld joint E3/E4-C an excavation in the weld had been performed. QC Inspector Steve McConnell was present and stated the excavation was due to a reject during the UT inspection. ABF welding personnel Rory Hogan (#3186) and Jeremy Dolman (#5042) were also present and stated they had performed the excavation but that repair welding would not be performed this date. QC Inspector Steve McConnell stated he had performed and accepted visual and Magnetic Particle Testing (MT) of the excavation. This QA Inspector performed a visual verification and observed the excavation had the following approximate dimensions: 50 mm long, 12 mm wide and 6 mm deep. See photo below.
