Quality Assurance and Source Inspection

Contract #: 04-0120F4Cty: SF/ALA Rte: 80 PM: 13.2/13.9File #: 1.28**WELDING INSPECTION REPORT****Resident Engineer:** Pursell, Gary**Address:** 333 Burma Road**City:** Oakland, CA 94607**Report No:** WIR-014516**Date Inspected:** 02-Jun-2010**Project Name:** SAS Superstructure**OSM Arrival Time:** 1000**Prime Contractor:** American Bridge/Fluor Enterprises, a JV**OSM Departure Time:** 1830**Contractor:** American Bridge/Fluor Enterprises, a JV**Location:** Job Site

WELDING INSPECTION REPORT

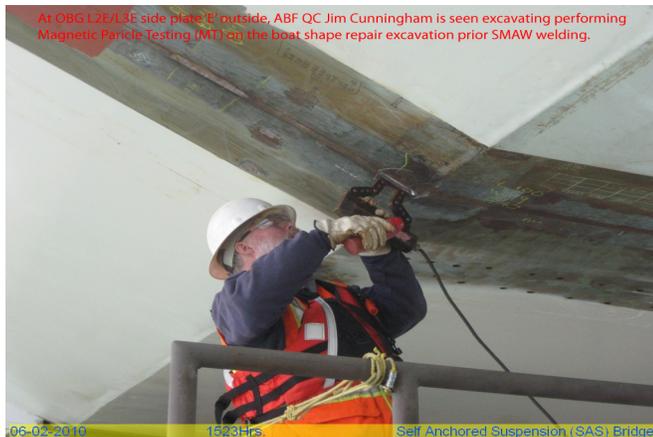
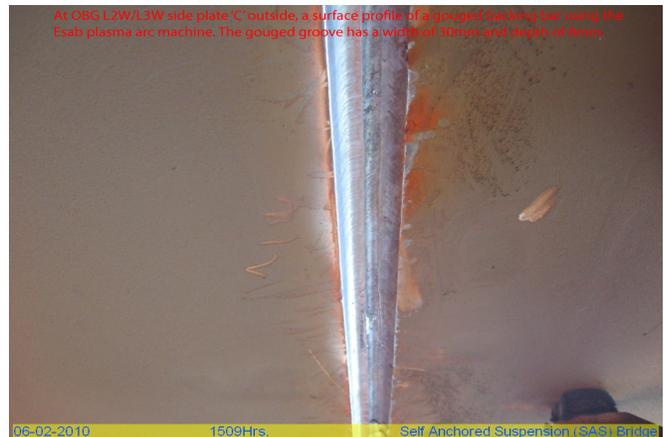
At OBG L2W/L3W side plate 'E' outside, QA randomly observed two ABF personnel flush grinding weld cover reinforcement of the back weld. The personnel were using grinding disc followed by flapper disc to make a smooth finish. Flush grinding of the whole length of the splice butt joint back weld was not completed at the end of the shift and will continue tomorrow.
