Contract #: 04-0120F4Cty: SF/ALA Rte: 80 PM: 13.2/13.9File #: 13.28**WELDING INSPECTION REPORT****Resident Engineer:** Pursell, Gary**Address:** 333 Burma Road**City:** Oakland, CA 94607**Report No:** WIR-014616**Date Inspected:** 07-Jun-2010**Project Name:** SAS Superstructure**OSM Arrival Time:** 1000**Prime Contractor:** American Bridge/Fluor Enterprises, a JV**OSM Departure Time:** 1830**Contractor:** Oregon Iron Works Clackamas, Or.**Location:** Clackamas, OR

Hinge-K Pipe Beam Assembly 101A-3:

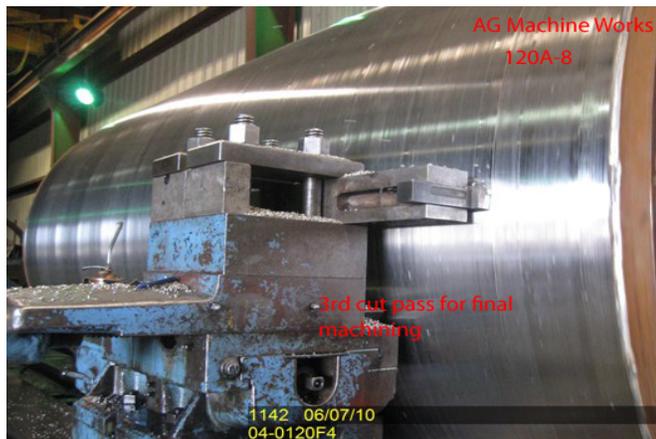
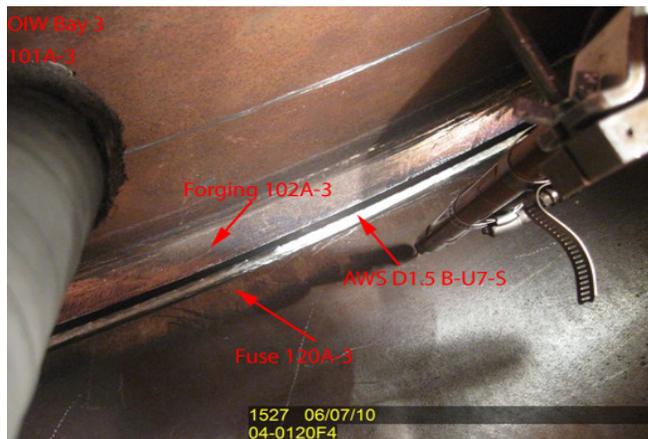
On this date, the QA Inspector arrived at AG Machine Works to witness the final machining, on this Fuse 120A-8. Upon arrival, the QA Inspector observed that the Fuse was slowly rotating in a horizontal lathe and final machining was in process. The QA Inspector observed that AG Machinist Terry Schmale was present at the time and Mr. Schmale explained that the second cut was in process, approximately 95 % complete. The QA Inspector had been previously informed by AG that a third cut pass and finish honing will be required to machine the Fuse to the top end of the required tolerance of 1920 mm +/- 1mm. See attached pictures below.
