Contract #: 04-0120F4Cty: SF/ALA Rte: 80 PM: 13.2/13.9File #: 1.28**WELDING INSPECTION REPORT****Resident Engineer:** Pursell, Gary**Address:** 333 Burma Road**City:** Oakland, CA 94607**Report No:** WIR-014681**Date Inspected:** 07-Jun-2010**Project Name:** SAS Superstructure**OSM Arrival Time:** 1000**Prime Contractor:** American Bridge/Fluor Enterprises, a JV**OSM Departure Time:** 1830**Contractor:** American Bridge/Fluor Enterprises, a JV**Location:** Job Site

Caltrans Office of Structural Material (OSM) Quality Assurance Inspector (QAI) Joselito Lizardo was present at the Self Anchored Suspension (SAS) job site as requested to perform observations on the welding of components for the San Francisco Oakland Bay Bridge (SFOBB) Project.

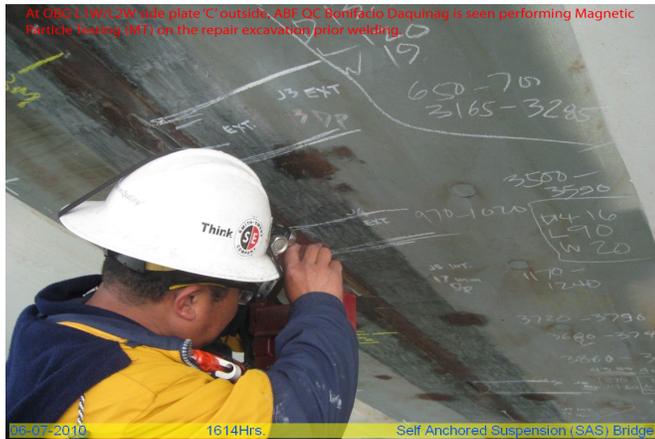
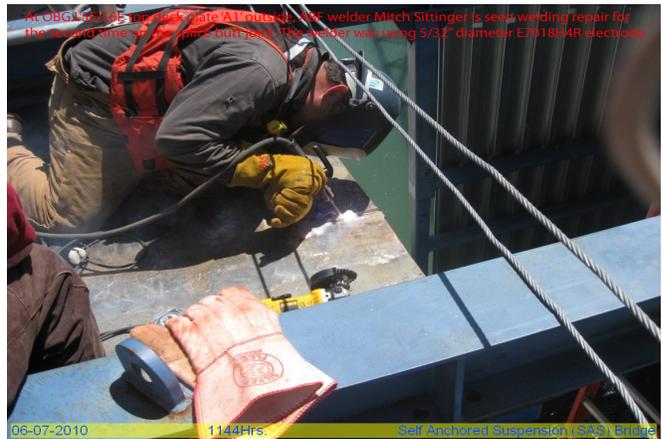
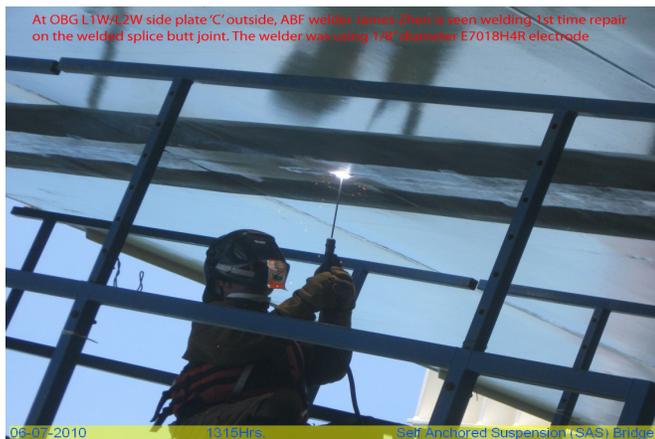
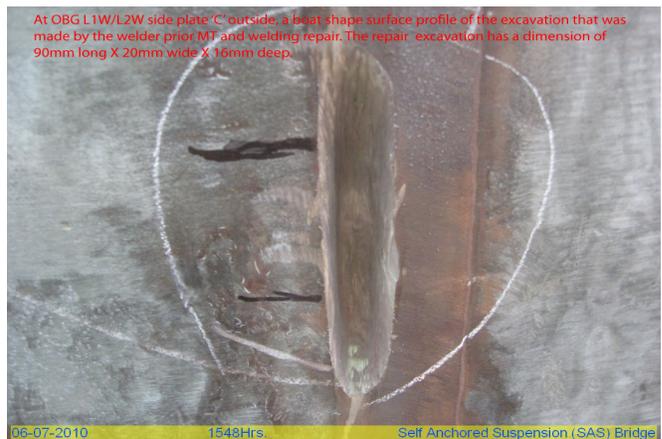
At OBG L5E/L68E top deck plate 'A' outside, QA randomly observed ABF/JV qualified welder Mitch Sittinger and Fred Kaddu perform CJP groove welding repair. The welders were observed welding in the 1G (flat) position utilizing Shielded metal Arc Welding (SMAW) with 1/8" diameter E7018H4R electrode implementing welding procedure ABF-WPS-D15-1000-Repairs. The repair excavations were preheated to more than 140 degree Fahrenheit using propane gas torch prior welding. During the shift, ABF QC Steven Mc Connell was noted monitoring the welder. Prior welding, ABF QC Steven Mc Connell was also observed performing Magnetic Particle Testing (MT) using Parker Contour Probe with red magnetic powder as detecting media on the repair excavation prior welding. During the shift, welder Fred Kaddu has completed two welding repairs at A5 and has moved inside L1E/L2E bottom plate 'D' inside while welder Mitch Sittinger has finished one repair at A1 and has moved to L1E/L2E bottom plate 'D' outside. Both welders were noted excavating more welding repairs until the end of the shift.

At OBG L1W/L2W side plate 'C' outside, QA randomly observed ABF/JV qualified welder James Zhen perform CJP groove welding repair. The welder was observed welding in the 4G (overhead) position utilizing Shielded metal Arc Welding (SMAW) with 1/8" diameter E7018H4R electrode implementing welding procedure ABF-WPS-D15-1000-Repairs. The repair excavation having a dimension of 90mm long X 20mm wide X 16mm deep was preheated to more than 140 degree Fahrenheit using propane gas torch prior welding. During the shift,

ABF QC Bonifacio Daquinag was noted monitoring the welder. Prior welding, ABF QC Bonifacio Daquinag was also observed performing Magnetic Particle Testing (MT) using Parker Contour Probe with red magnetic powder as detecting media on the repair excavation. During the shift, while welder James Zhen was welding another welder Chun Fai Tsui was noted excavating the weld repairs to a boat shape and getting ready to be welded. The welder has completed two welding repair and was working on the third repair at the end of the shift.

At OBG L2W/L3W side plate 'C' outside, ABF welders Rory Hogan and Jeremy Dolman were observed on standby due to malfunctioning welding machine. Instead, they were noted fixing their welding machine and changing some of their welding equipment.

At OBG L3E/L4E bottom plate 'D' outside, QA observed two ABF welders Bryce Howell and Mike Maday continue perform plasma arc gouging on the backing bar. The welders were noted using an Esab plasma arc machine with the cutting nozzle mounted to a motorized track.
