Contract #: 04-0120F4Cty: SF/ALA Rte: 80 PM: 13.2/13.9File #: 1.28**WELDING INSPECTION REPORT****Resident Engineer:** Pursell, Gary**Address:** 333 Burma Road**City:** Oakland, CA 94607**Report No:** WIR-014684**Date Inspected:** 10-Jun-2010**Project Name:** SAS Superstructure**OSM Arrival Time:** 1000**Prime Contractor:** American Bridge/Fluor Enterprises, a JV**OSM Departure Time:** 1830**Contractor:** American Bridge/Fluor Enterprises, a JV**Location:** Job Site

CWI Name:	Jesse Cayabyab and Bonifacio Daqui			CWI Present:	Yes	No	
Inspected CWI report:	Yes	No	N/A	Rod Oven in Use:	Yes	No	N/A
Electrode to specification:	Yes	No	N/A	Weld Procedures Followed:	Yes	No	N/A
Qualified Welders:	Yes	No	N/A	Verified Joint Fit-up:	Yes	No	N/A
Approved Drawings:	Yes	No	N/A	Approved WPS:	Yes	No	N/A
				Delayed / Cancelled:	Yes	No	N/A
Bridge No:	34-0006			Component:	Orthotropic Box Girder

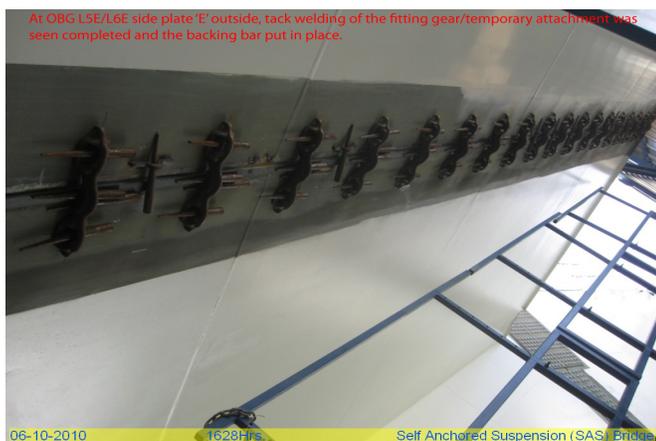
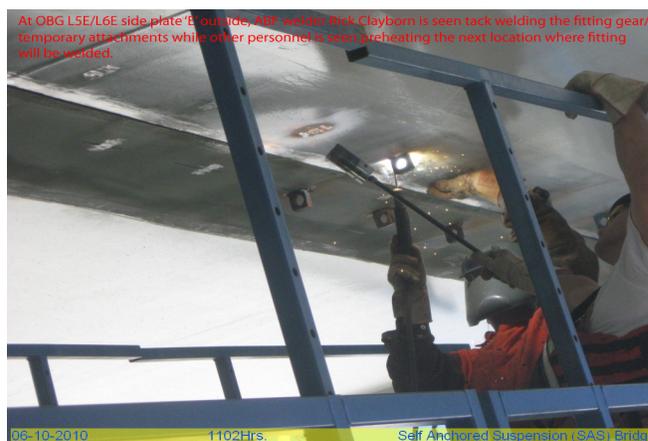
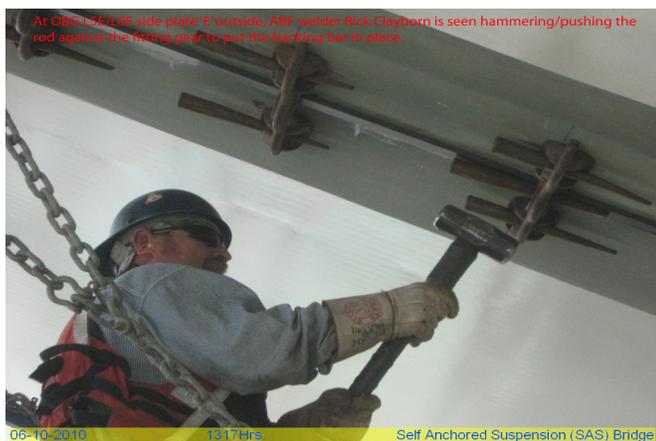
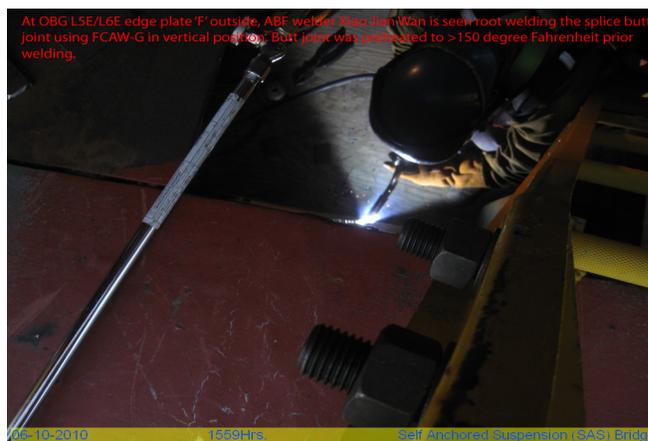
QA randomly observed ABF/JV qualified welders Rory Hogan (ID #3186) perform CJP groove (splice) back welding fill pass on Orthotropic Box Girder (OBG) L2W/L3W side plate 'C2' outside. The welder was observed back welding in the 4G (overhead) position utilizing a dual shield Flux Cored Arc Welding (FCAW-G) with E71T-1M, 1/16" diameter wire electrode and implementing Caltrans approved Welding Procedure Specification (WPS) ABF-WPS-D15-3110-4. The welder was using a track mounted welder holder assembly that is remotely controlled. The joint being welded has the backing bar gouged using the Esab Plasma Arc machine and was ground smooth. The gouged and ground splice butt joint was also Non Destructive Testing (NDT) tested using the Magnetic Particle Testing (MT). The splice joint was preheated and maintained to greater than 200 degree Fahrenheit using Miller Proheat 35 Induction Heating System located at the other side of the plate prior/during welding. The vicinity was also properly protected from wind and other climatic conditions. ABF Quality Control (QC) William Sherwood was noted monitoring the welding parameters of the welder.

At OBG L5E/L6E edge plate 'F' outside, QA randomly observed welder Xiao Jian Wan welding root pass on the splice butt joint. The welder was using FCAW-G in 3G (vertical) position. Prior to welding the fit up was inspected and accepted by ABF QC. QA performed fit up/alignment verification on the joint and noted less than 2mm offset all throughout the joint which appears acceptable to the contract requirements. Welding and welding parameters was monitored by ABF QC Steven Mc Connell. QA also performed verification on the parameter and

At OBG L4E/L5E side plate 'E' outside, QA randomly observed ABF welder Rick Clayborn tack welding fitting gear/temporary attachment. The welder was welding in 4F (overhead) position using 1/8" diameter E7018H4R electrode. QA noted ABF QC Bonifacio Daquinag monitoring the welder and his parameter. During the shift, welding of the fitting gear/temporary attachment was completed and the backing bar was also put in place. After installing the backing bar, ABF QC went inside the box and checked the alignment. QC informed QA that during the initial measurements of the alignment he was getting 4.5mm and 3.0mm misalignment on some areas which he said still need more adjustment.
