Contract #: 04-0120F4Cty: SF/ALA Rte: 80 PM: 13.2/13.9File #: 13.28**WELDING INSPECTION REPORT****Resident Engineer:** Pursell, Gary**Address:** 333 Burma Road**City:** Oakland, CA 94607**Report No:** WIR-014704**Date Inspected:** 14-Jun-2010**Project Name:** SAS Superstructure**OSM Arrival Time:** 1000**Prime Contractor:** American Bridge/Fluor Enterprises, a JV**OSM Departure Time:** 1830**Contractor:** Oregon Iron Works Clackamas, Or.**Location:** Clackamas, OR

**Hinge-K Pipe Beam Assembly 101A-3:**

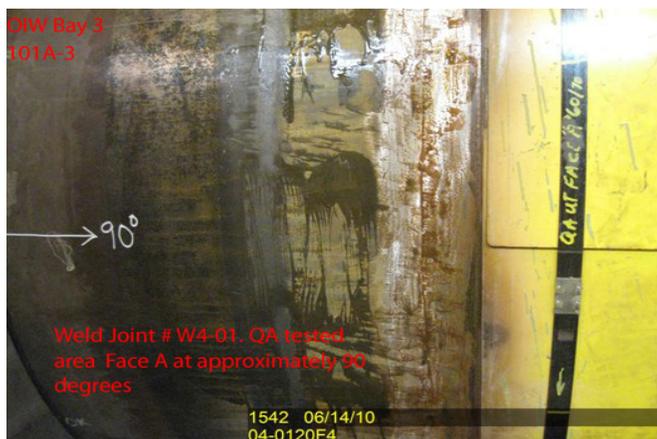
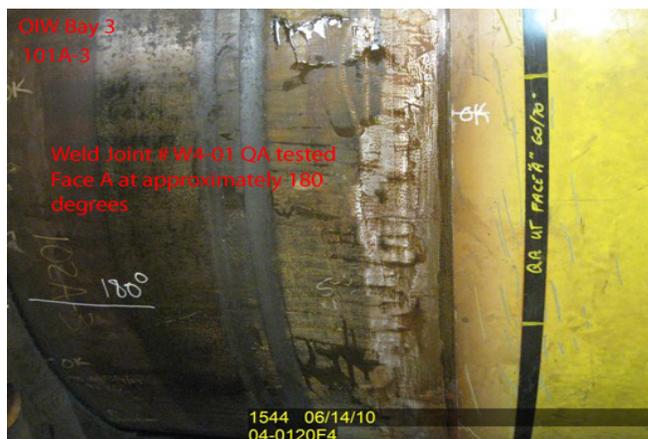
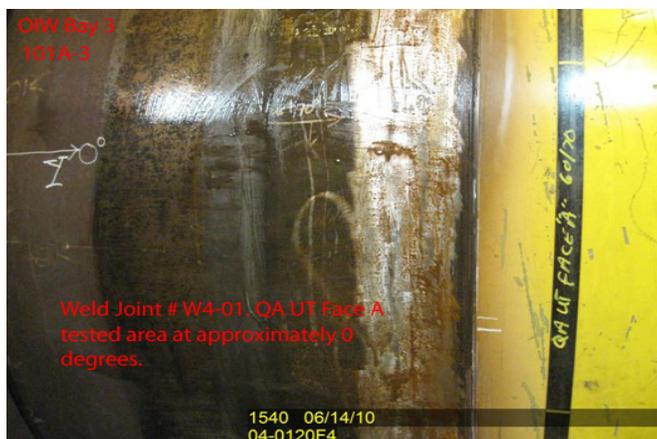
The QA Inspector observed OIW Lead QC Inspector Mike Gregson performing Ultrasonic Testing on the Weld Joint #W4-01. The QA Inspector noted that this Complete Joint Penetration (AWS D1.5 B-U7-S), was the Fuse 120A-3 to Forging 102A-3 and that QC Inspector Gregson was performing the testing from the exterior or Face "A" side of the joint. The QA Inspector observed that QC Inspector Gregson was utilizing a 70 degree Lucite wedge testing angle attached to a 2.25 MHz transducer and the testing was being performed from a scissor lift. The QA Inspector then spoke with QC Inspector Gregson and Mr. Gregson explained that prior to the testing, that a calibration was performed utilizing an AWS IIV Type 2 calibration block, with a 70 and 60 degree testing angle. QC Inspector Gregson explained that the testing being performed was in accordance to OIW UT procedure # NP-2244-(13)-01 and at this time, no rejectable and 2 recordable indications were found. The QA Inspector noted that per AWS D1.5 Sect.6.19.8 "Only those discontinuities which are rejectable need be recorded on the test report, except that for welds designated in the contract documents as being "Fracture Critical," ratings which are up to and including 6dB less critical than rejectability shall be recorded on the test report".

The QA Inspector was present on this swing shift and performed approximately 10% UT verification on the above mentioned weld joint. The QA Inspector performed the testing from Face "A", which was previously tested by QC Inspector Gregson. The QA Inspector performed the testing on 3 random areas, approximately 200 mm long each, in the same manner as mentioned above and found no rejectable or recordable indications.

Lead QC Inspector Mike Gregson explained to the QA Inspector that after the UT is complete on weld joint # W4-01, Face "B", the QA Inspector will be notified of the testing results. Once notified and OIW QC accepts the testing results, the QA Inspector will then perform the testing from Face "B".
