Contract #: 04-0120F4Cty: SF/ALA Rte: 80 PM: 13.2/13.9File #: 69.28**WELDING INSPECTION REPORT****Resident Engineer:** Pursell, Gary**Address:** 333 Burma Road**City:** Oakland, CA 94607**Report No:** WIR-014854**Date Inspected:** 21-May-2010**Project Name:** SAS Superstructure**OSM Arrival Time:** 1900**Prime Contractor:** American Bridge/Fluor Enterprises, a JV**OSM Departure Time:** 700**Contractor:** Zhenhua Port Machinery Company, Ltd (ZPMC), Changxing Island **Location:** Shanghai, China**CWI Name:** See Below**CWI Present:** Yes No**Inspected CWI report:** Yes No N/A**Rod Oven in Use:** Yes No N/A**Electrode to specification:** Yes No N/A**Weld Procedures Followed:** Yes No N/A**Qualified Welders:** Yes No N/A**Verified Joint Fit-up:** Yes No N/A**Approved Drawings:** Yes No N/A**Approved WPS:** Yes No N/A**Delayed / Cancelled:** Yes No N/A**Bridge No:** 34-0006**Component:** OBG**Summary of Items Observed:**

OBG Bay 13

OBG Segment Assembly

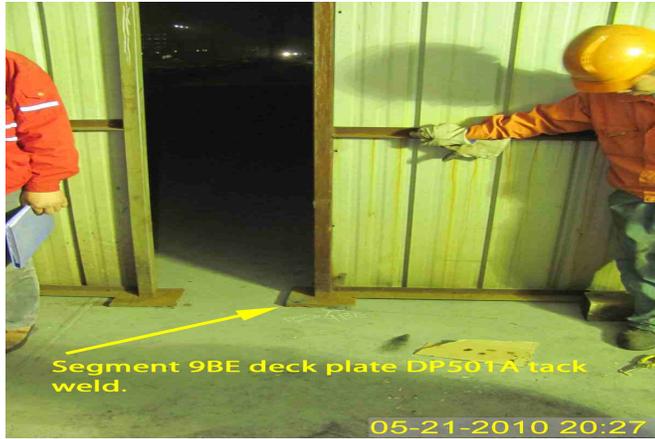
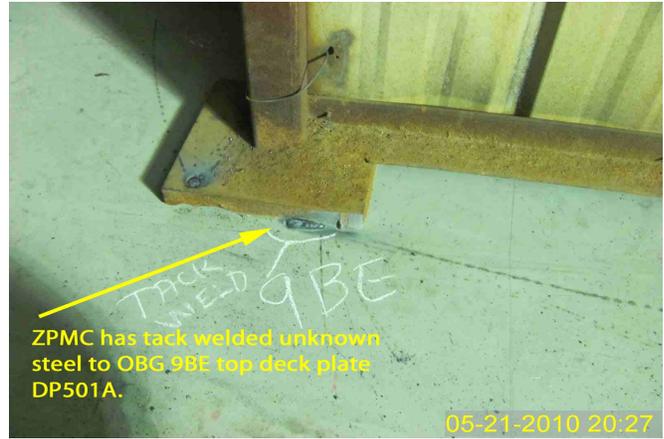
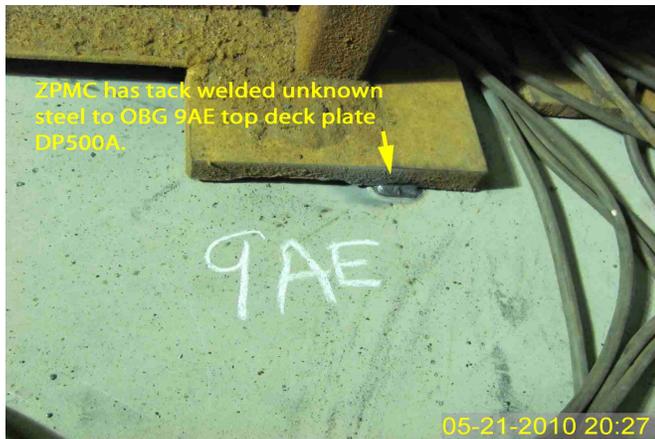
During random Quality Assurance (QA) visual inspection of top deck plate weld OBE9-003 joining OBG segments 9AE and 9BE this Quality Assurance Inspector (QA) discovered ZPMC has temporarily welded two wind screen / roof structure support leg base plates to top deck plates on OBG segments 9AE and 9BE. One tack weld is on segment 9AE deck plate DP500A and one tack weld is on segment 9BE deck plate DP501A. Each of the temporary welds is located approximately 2 meters away from either side of top deck plate weld OBE9-003.

This Caltrans Quality Assurance Inspector (QA) observed ZPMC has temporarily welded two wind screen / roof structure support leg base plates to top deck plates on OBG segments 9AE and 9BE. One tack weld is on segment 9AE deck plate DP500A and one tack weld is on segment 9BE deck plate DP501A. Each of the temporary welds is located approximately 2 meters away from either side of top deck plate weld OBE9-003 which joins OBG segments 9AE and 9BE. This QA Inspector asked ZPMC CWI Mr. Li Yang if ZPMC has approval to make these temporary welds and Mr. Li Yang said he does not know if engineering approval has been submitted for these welds. This QA Inspector informed ZPMC QC CWI Mr. Li Yang and ABF representative Mr. Zou Hu that an incident report is being issued to document these tack welds being made without engineering approval. See the photographs below for additional information.
