**DEPARTMENT OF TRANSPORTATION**

Contract #: 04-0120F4Cty: SF/ALA Rte: 80 PM: 13.2/13.9File #: 69.28**WELDING INSPECTION REPORT****Resident Engineer:** Pursell, Gary**Address:** 333 Burma Road**City:** Oakland, CA 94607**Report No:** WIR-014861**Date Inspected:** 27-May-2010**Project Name:** SAS Superstructure**OSM Arrival Time:** 1900**Prime Contractor:** American Bridge/Fluor Enterprises, a JV**OSM Departure Time:** 700**Contractor:** Zhenhua Port Machinery Company, Ltd (ZPMC), Changxing Island **Location:** Shanghai, China**CWI Name:** See Below**CWI Present:** Yes No**Inspected CWI report:** Yes No N/A**Rod Oven in Use:** Yes No N/A**Electrode to specification:** Yes No N/A**Weld Procedures Followed:** Yes No N/A**Qualified Welders:** Yes No N/A**Verified Joint Fit-up:** Yes No N/A**Approved Drawings:** Yes No N/A**Approved WPS:** Yes No N/A**Delayed / Cancelled:** Yes No N/A**Bridge No:** 34-0006**Component:** OBG**Summary of Items Observed:**

## WELDING INSPECTION REPORT

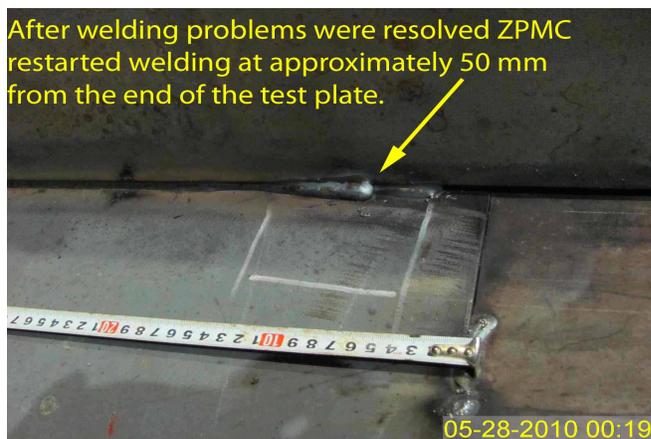
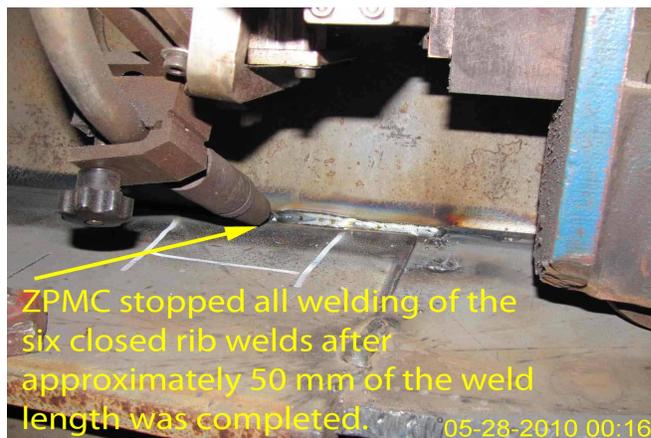
This QA Inspector monitored welding of closed rib Production Monitoring Test (PMT) representing OBG segment 13AE deck plates DP3080-001 and DP3074-001 which were welded using one single base plate starting at around 0010 hours using gantry #1. This QA Inspector observed six ZPMC welders using welding procedure specification WPS-B-T-2342-U1(Urib)-5 using the gas metal arc welding process for the root pass and submerged arc welding process for the cover pass of partial penetration groove welds on six PMT closed rib welds at the same time. Approximately ten seconds after the GMAW welding started ZPMC stopped all welding due to a failure of GMAW welding machine #6 to feed out the welding wire properly. Welding machines #1 through #5 had welded for a distance of approximately 50 mm length on each of the production test plates. These first 50 mm lengths of these welds were not selected as part of the 500 mm weld sample that was later identified by ZPMC QC as representing the sample to be tested. PMC resolved the GMAW wire feed problem and welding commenced at approximately 0015 hours. ZPMC has multiple welding manipulators attached to a movable gantry that runs on a track along the length of the stiffener plates. This QA Inspector observed a welding travel speed of approximately 537 mm per minute for the root passes and 515 mm per minute for the cover passes. As the welding commences, each of the welders is responsible for one of the welding heads. Welder Mr. Hu Yongchang, stencil 203805 completed the root pass of weld #1 with a welding current of approximately 340 amps and 31.2 volts and the cover pass welding current of approximately 680 amps and 25.0 volts. Welder Mr. Xiang Jie, stencil 059378, completed the root pass of weld #2 with a welding current of approximately 340 amps and 30.5 volts and the cover pass welding current of approximately 690 amps and 25.3 volts. Welder Mr. Yang Yongzeng, stencil 059418 completed the root pass of weld #3 with a welding current of approximately 359 amps and 31.6 volts and the cover pass welding current of approximately 685 amps and 24.7 volts. Welder Mr. Song Yinshu, stencil 059421 completed the root pass of weld #4 with a welding current of approximately 348 amps and 30.6 volts and the cover pass welding current of approximately 690 amps and 25.2 volts. Welder Mr. Xiang Huan Feng, stencil 59416 completed the root pass of weld #5 with a welding current of approximately 350 amps and 30.7 volts and the cover pass welding current of approximately 685 amps and 25.0 volts. Welder Ms. Jiang Shuangchen, stencil 201788 completed the root pass of weld #6 with a welding current of approximately 360 amps and 30.6 volts and the cover pass welding current of approximately 685 amps and 25.5 volts. This QA Inspector performed random visual inspection of the weld joint fitups, root passes and cover passes and items observed appear to comply with project specifications. Following completion of the welding, ZPMC QC CWI Inspector Mr. Guo Yan Fei marked a 500 mm length on each of the welds as being the areas that are to be representative of this PMT test. This QA Inspector observed ZPMC NDE Inspector Mr. Xu Wei performing ultrasonic inspections of each of the six welds in the areas where Mr. Guo Yan Fei had marked for PMT testing. Following ZPMC's UT acceptance the QA Inspector marked a total of 15 locations where macroetch samples are to be obtained. ZPMC then cut and prepared macroetch samples. ZPMC QC CWI Inspector Mr. Guo Yan Fei and ABF representative Mr. Wang Wan Jueng visually inspected these macroetch samples and documented their acceptance on the ZPMC Production

Monitoring Test Plate Inspection Report sheet dated May 28, 2010. This QA Inspector visually inspected each of these macroetch samples and items observed by the QA Inspector appear to comply with project specifications and the QA Inspector documented this inspection on the "Production Monitoring Test Plate Inspection Report".
