**DEPARTMENT OF TRANSPORTATION**

Contract #: 04-0120F4Cty: SF/ALA Rte: 80 PM: 13.2/13.9File #: 69.28**WELDING INSPECTION REPORT****Resident Engineer:** Pursell, Gary**Address:** 333 Burma Road**City:** Oakland, CA 94607**Report No:** WIR-014866**Date Inspected:** 04-Jun-2010**Project Name:** SAS Superstructure**OSM Arrival Time:** 1900**Prime Contractor:** American Bridge/Fluor Enterprises, a JV**OSM Departure Time:** 700**Contractor:** Zhenhua Port Machinery Company, Ltd (ZPMC), Changxing Island **Location:** Shanghai, China**CWI Name:** See Below**CWI Present:** Yes No**Inspected CWI report:** Yes No N/A**Rod Oven in Use:** Yes No N/A**Electrode to specification:** Yes No N/A**Weld Procedures Followed:** Yes No N/A**Qualified Welders:** Yes No N/A**Verified Joint Fit-up:** Yes No N/A**Approved Drawings:** Yes No N/A**Approved WPS:** Yes No N/A**Delayed / Cancelled:** Yes No N/A**Bridge No:** 34-0006**Component:** OBG**Summary of Items Observed:**

**OBG Segment Trial Assembly**

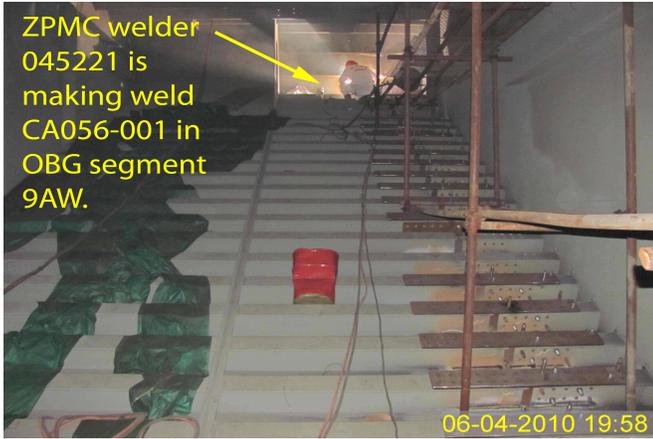
This QA Inspector observed ZPMC welder Mr. Yun Chuansheng, stencil 045221 is using shielded metal arc welding procedure WPS-B-P-2212-TC-U4b-FCM-1 to make hold back weld CA056-001. This welding is located between the side and edge plates on the interior of OBG segment 9AW adjacent to where OBG segment 8CW is to be joined to 9AW. This QA Inspector observed Mr. Yun Chuansheng has a welding current of approximately 195 amps and Mr. Yun Chuansheng appears to be certified to make this weld. This QA Inspector observed the welding electrodes are being stored in a heated portable electrode storage oven and the base material appears to have been preheated with a torch. Items observed on this date appeared to generally comply with applicable contract documents. See the photograph below for additional information.
