DEPARTMENT OF TRANSPORTATION

Contract #: 04-0120F4Cty: SF/ALA Rte: 80 PM: 13.2/13.9File #: 69.28**WELDING INSPECTION REPORT****Resident Engineer:** Pursell, Gary**Address:** 333 Burma Road**City:** Oakland, CA 94607**Report No:** WIR-014872**Date Inspected:** 11-Jun-2010**Project Name:** SAS Superstructure**OSM Arrival Time:** 1900**Prime Contractor:** American Bridge/Fluor Enterprises, a JV**OSM Departure Time:** 700**Contractor:** Zhenhua Port Machinery Company, Ltd (ZPMC), Changxing Island **Location:** Shanghai, China**CWI Name:** See Below**CWI Present:** Yes No**Inspected CWI report:** Yes No N/A**Rod Oven in Use:** Yes No N/A**Electrode to specification:** Yes No N/A**Weld Procedures Followed:** Yes No N/A**Qualified Welders:** Yes No N/A**Verified Joint Fit-up:** Yes No N/A**Approved Drawings:** Yes No N/A**Approved WPS:** Yes No N/A**Delayed / Cancelled:** Yes No N/A**Bridge No:** 34-0006**Component:** OBG**Summary of Items Observed:**

OBG Segment Trial Assembly

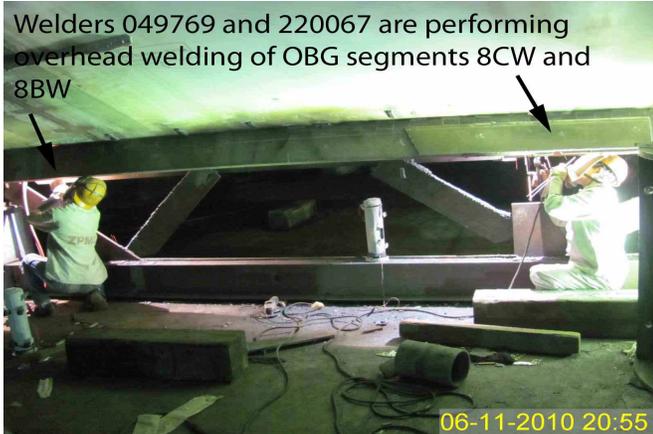
This QA Inspector observed ZPMC welder Mr. Chen Zheng Hua, stencil 220067 is using flux cored welding procedure WPS-345-SMAW-4G(4F)-Repair-1 to perform OBG segment 8BW weld repair SEG045A-012. This work is being performed to resolve excessive distortion and weld repair document B-WR13500 was issued to remove straighten and reinstall various welds. This QA Inspector measured a welding current of approximately 150 amps and Mr. Chen Zheng Hua appears to be certified to make this weld. Items observed on this date appeared to generally comply with applicable contract documents. See the photograph below for additional information.

This QA Inspector observed ZPMC welder Mr. Zhang Feng, stencil 049769 is using flux cored welding procedure WPS-345-SMAW-4G(4F)-Repair-1 to perform OBG segment 8CW weld repair SEG047B-049. This work is being performed to resolve excessive distortion and weld repair document B-WR13500 was issued to remove straighten and reinstall various welds. This QA Inspector measured a welding current of approximately 155 amps and Mr. Zhang Feng appears to be certified to make this weld. Items observed on this date appeared to generally

comply with applicable contract documents. See the photograph below for additional information.
