**DEPARTMENT OF TRANSPORTATION**

Quality Assurance and Source Inspection

Contract #: 04-0120F4Cty: SF/ALA Rte: 80 PM: 13.2/13.9File #: 69.28**WELDING INSPECTION REPORT****Resident Engineer:** Pursell, Gary**Address:** 333 Burma Road**City:** Oakland, CA 94607**Report No:** WIR-014926**Date Inspected:** 21-May-2010**Project Name:** SAS Superstructure**OSM Arrival Time:** 700**Prime Contractor:** American Bridge/Fluor Enterprises, a JV**OSM Departure Time:** 1900**Contractor:** Zhenhua Port Machinery Company, Ltd (ZPMC), Changxing Island **Location:** Shanghai, China**CWI Name:** Zhou zhong hai**CWI Present:** Yes No**Inspected CWI report:** Yes No N/A**Rod Oven in Use:** Yes No N/A**Electrode to specification:** Yes No N/A**Weld Procedures Followed:** Yes No N/A**Qualified Welders:** Yes No N/A**Verified Joint Fit-up:** Yes No N/A**Approved Drawings:** Yes No N/A**Approved WPS:** Yes No N/A**Delayed / Cancelled:** Yes No N/A**Bridge No:** 34-0006**Component:** OBG Components**Summary of Items Observed:**

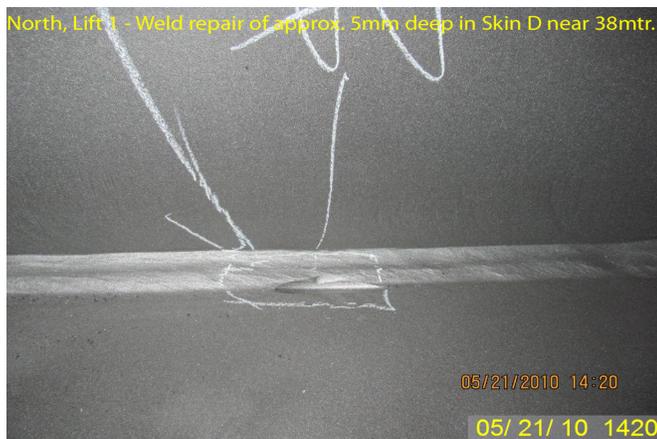
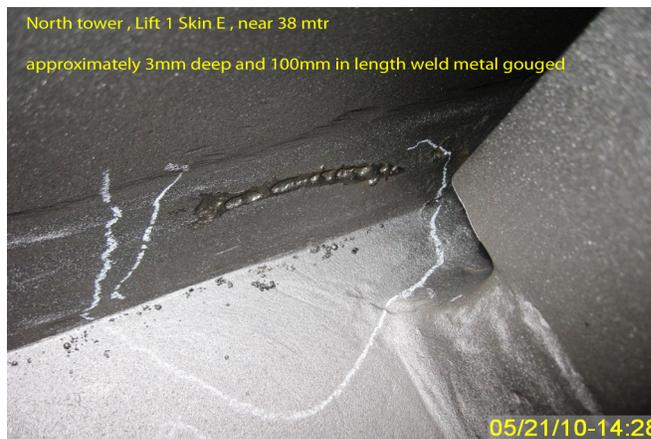
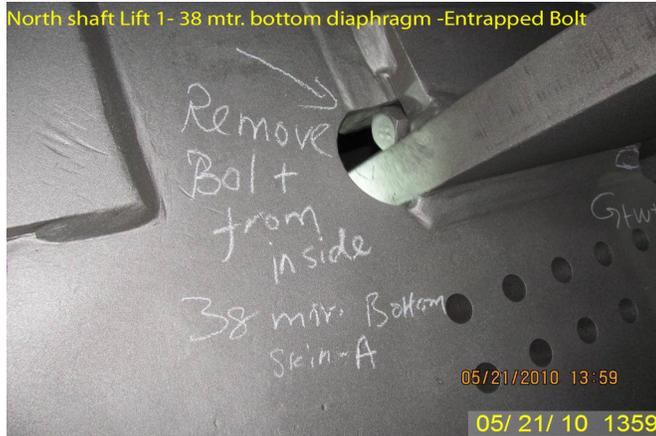
Caltrans Quality Assurance (QA) Inspectors performed random visual inspection of Lift 1, North tower internal surfaces from 38m Top diaphragm to 50.3m tail end of the shaft surface after grit blasting. Several weld repair points for porosity, dent have been marked by ABF Inspectors and CT Inspector Mr. Chandra (B 247). This has to be marked for Magnetic particle testing (MT) after welding. One photo which shows the weld repair for a dent of approximately 5 mm deep in Skin D, near 38m and approximately 3mm deep weld metal gouged for 100mm in length. In Skin E, near 38m. Elevation is attached with this report. It was observed that, a Bolt was entrapped in between fit lug in Skin A (AE Corner) near 38m Bottom diaphragm. Photo of the same is attached with this report. This Visual Inspection carried out along with ABF QA inspectors Mr. Don Walton, Mr. Sun and Mr. Shi stone.
