Contract #: 04-0120F4Cty: SF/ALA Rte: 80 PM: 13.2/13.9File #: 69.28**WELDING INSPECTION REPORT****Resident Engineer:** Pursell, Gary**Address:** 333 Burma Road**City:** Oakland, CA 94607**Report No:** WIR-014982**Date Inspected:** 23-May-2010**Project Name:** SAS Superstructure**OSM Arrival Time:** 700**Prime Contractor:** American Bridge/Fluor Enterprises, a JV**OSM Departure Time:** 1900**Contractor:** Zhenhua Port Machinery Company, Ltd (ZPMC), Changxing Island **Location:** Shanghai, China**CWI Name:** Xu Tao**CWI Present:** Yes No**Inspected CWI report:** Yes No N/A**Rod Oven in Use:** Yes No N/A**Electrode to specification:** Yes No N/A**Weld Procedures Followed:** Yes No N/A**Qualified Welders:** Yes No N/A**Verified Joint Fit-up:** Yes No N/A**Approved Drawings:** Yes No N/A**Approved WPS:** Yes No N/A**Delayed / Cancelled:** Yes No N/A**Bridge No:** 34-0006**Component:** OBG COMPONENT**Summary of Items Observed:**

WELDING INSPECTION REPORT

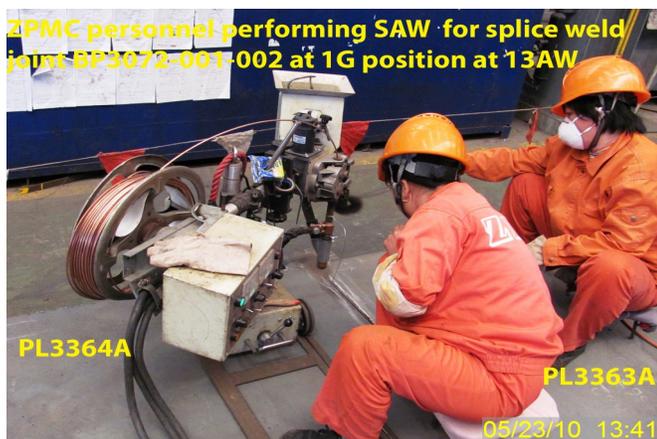
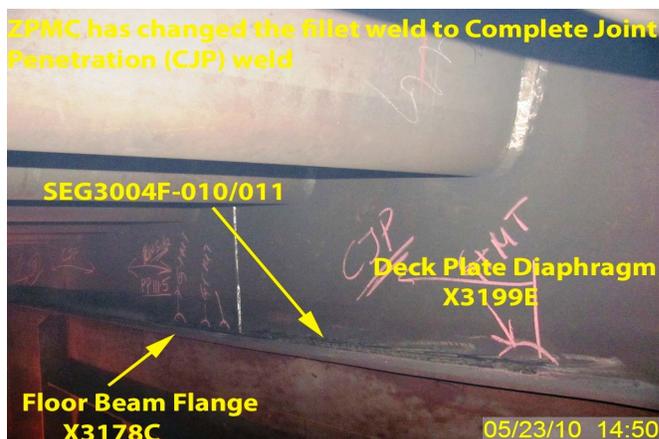
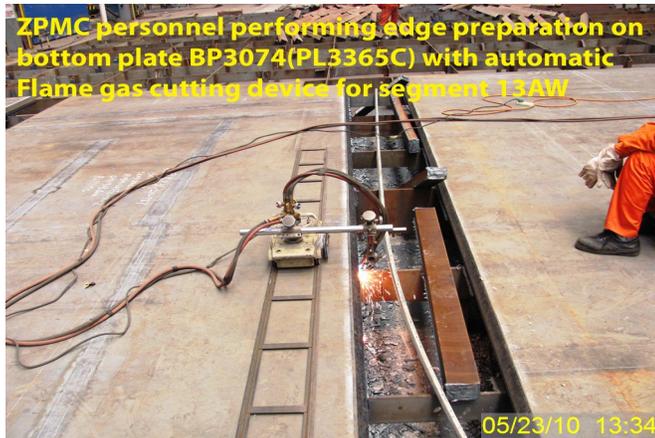
SAW in the 1G position for the OBG Segment 13AE bottom plate, weld No. BP3032-001-002. The welder is identified as #044771. ZPMC QC is identified as Mr. Guo Xing Hui. The welding variables recorded by QC appear to comply with WPS-B-T-2221-B-U3-F.

FCAW in the 1G position for the OBG Segment 12AE, weld No. SEG-3001J-240. The welder is identified as #055564. ZPMC QC is identified as Mr. Zhong Guo Hai. The welding variables recorded by QC appear to comply with WPS-B-T-2231-Tc-U4b-F.

FCAW in the 3G position for the OBG Segment 12CE, weld No. SEG-3003N-003. The welder is identified as #044790. ZPMC QC is identified as Mr. Zhong Guo Hai. The welding variables recorded by QC appear to comply with WPS-B-T-2233-B-U2-F.

FCAW in the 1G position for the OBG Segment 12BE , weld No. SEG-3002F-250. The welder is identified as #044774. ZPMC QC is identified as Mr. Zhong Guo Hai . The welding variables recorded by QC appear to comply with WPS-B-T-2231-Tc-U4c-F.

FCAW in the 3G position for the OBG Segment 12CE , weld No. SEG-3003B-002. The welder is identified as #044830. ZPMC QC is identified as Mr. Zhong Guo Hai . The welding variables recorded by QC appear to comply with WPS-B-T-2233-B-U2-F.

SAW in the 1G position for the OBG Segment 13AW bottom plate , weld No. BP3072-001-002. The welder is identified as #045265. ZPMC QC is identified as Mr. Tao Wei . The welding variables recorded by QC appear to comply with WPS-B-T-2221-B-U2c-S-2.

During Quality Assurance random in-process observations of the assembly of Orthotropic Box Girder (OBG) segments 12AW, this Quality Assurance Inspector (QA) discovered the following issues that ZPMC has deviated from the approved weld joint design without the Engineers approval. ZPMC has changed the fillet welds to Complete Joint Penetration (CJP) welds. The affected joints on segment 12AW are identified as SEG3004G-008/009 and SEG3004F-010/011. According to the approved drawings (SEG3004G & SEG3004F) the joints are designated as fillet weld joints. The length of mention affected area for joint SEG3004G-008/009 is approximately 4100mm. And the length of mention affected area for joint SEG3004F-010/011 is approximately 5700mm. The welds are located in Panel Point PP111.5. The weld SEG3004G-008/009 is joining Floor Beam Flange (FB3078A) X3177D to Deck Plate Diaphragm X3199B. The weld SEG3004F-010/011 is joining Floor Beam Flange (FB3079A) X3178C to Deck Plate Diaphragm X3199B. OBG Segments 12AW are located in the Bay 14.
