DEPARTMENT OF TRANSPORTATION

Contract #: 04-0120F4Cty: SF/ALA Rte: 80 PM: 13.2/13.9File #: 1.28**WELDING INSPECTION REPORT****Resident Engineer:** Pursell, Gary**Address:** 333 Burma Road**City:** Oakland, CA 94607**Report No:** WIR-014985**Date Inspected:** 15-Jun-2010**Project Name:** SAS Superstructure**OSM Arrival Time:** 1000**Prime Contractor:** American Bridge/Fluor Enterprises, a JV**OSM Departure Time:** 1830**Contractor:** American Bridge/Fluor Enterprises, a JV**Location:** Job Site

WELDING INSPECTION REPORT

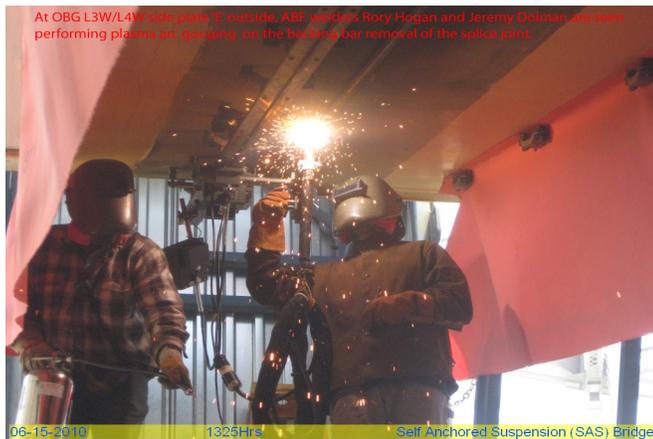
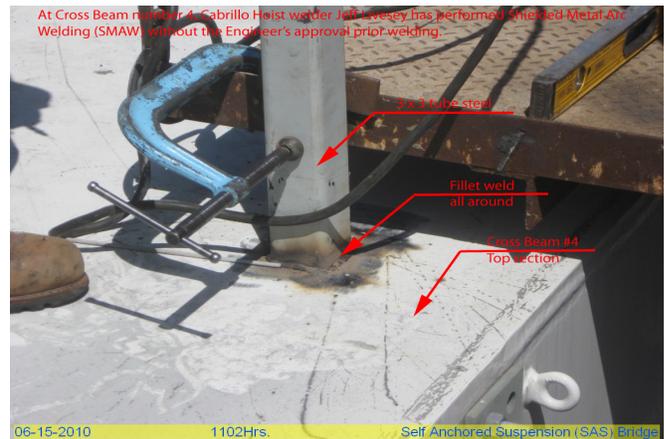
At Cross Beam number 4, QA observed Cabrillo Hoist (Elevator) welder Jeff Livesey perform Shielded Metal Arc Welding (SMAW) fillet welding between the 3" x 3" x 3/16" tube steel to the top section of the cross beam under the direction of ABF Bolting Crew Superintendent David Mache. The welder was using 1/8" diameter E7018H4R electrode. ABF QC Bernie Docena saw the new welder welding and asked ABF Superintendent Dan Ieraci if he knew the new welder. Dan Ieraci responded that he is unaware of the new welder and he stopped him from doing more welding. Due to miscommunication between the two superintendents, Mr. David Mache called Mr. Jim Davidson who came to site while Dan Ieraci called QC Manager Jim Bowers. They had a conversation and they decided to replace the Cabrillo Hoist welder with ABF certified welder. ABF QC William Sherwood instructed ABF welder to grind off the weld that the Cabrillo welder has welded which Mr. David Mache objected and called Mr. Jim Davidson again who also called Jim Bowers. According to their conversation, Mr. Jim Davidson informed QA that Mr. Jim Bowers advised him that the weld could stay but need to be visually and Magnetic Particle Testing (MT) tested which the QC did. Since the Cabrillo Hoist welder Jeff Livesey has welded in this job without the proper submittal and approval of his qualification papers prior to welding which is in contrary to the requirements of the Special Provisions, an Incident Report was generated due to this occurrence.

At OBG L4W/L5W bottom plate 'D' inside, QA randomly observed welder ABF welder Mike Maday continue welding fill pass on the splice butt joint. The welder was noted using Submerged Arc Welding (SAW) welding the

groove splice butt joint in flat (1G) position. The welder was utilizing F7A6-EM12K-H8, 3.2mm electrode with corresponding Esab OK Flux 10.62 flux and implementing Caltrans approved Welding Procedure Specification (WPS) ABF-WPS-D15-4042B-1. The plates being welded have a backing bar attached to the other side and preheated and maintained to greater than 150 degree Fahrenheit using Miller Proheat 35 Induction Heating System located on the opposite side of the plate prior welding. The welding parameters were monitored by ABF QC Bernie Docena. QA performed parameter check at the time of welding and noted an ampere reading of 545 amperes, 32.4 voltages and a travel speed of 400mm per minute. The welding parameters appear in conformance to the contract requirements. SAW welding was not completed during the shift and should continue tomorrow.

QA randomly observed ABF/JV qualified welder Mitch Sittinger perform CJP groove (splice) back welding fill pass on Orthotropic Box Girder (OBG) L3E/L4E plate 'D' outside. The welder was observed welding in the 4G (overhead) position utilizing a dual shield Flux Cored Arc Welding (FCAW-G) with E71T-1M, 1/16" diameter wire electrode and implementing Caltrans approved Welding Procedure Specification (WPS) ABF-WPS-D15-3040A-4. The welder was using a track mounted welder holder assembly that is remotely controlled. The joint being welded has the backing bar gouged using the Esab Plasma Arc machine and was ground smooth. The splice joint was preheated to greater than 150 degree Fahrenheit prior welding and the vicinity was properly protected from wind and other weather conditions. During welding, ABF Quality Control (QC) Jim Cunningham was noted monitoring the welder and his welding parameters.
