**DEPARTMENT OF TRANSPORTATION**

Quality Assurance and Source Inspection

Contract #: 04-0120F4Cty: SF/ALA Rte: 80 PM: 13.2/13.9File #: 69.28**WELDING INSPECTION REPORT****Resident Engineer:** Pursell, Gary**Address:** 333 Burma Road**City:** Oakland, CA 94607**Report No:** WIR-014998**Date Inspected:** 25-May-2010**Project Name:** SAS Superstructure**OSM Arrival Time:** 700**Prime Contractor:** American Bridge/Fluor Enterprises, a JV**OSM Departure Time:** 1900**Contractor:** Zhenhua Port Machinery Company, Ltd (ZPMC), Changxing Island **Location:** Shanghai, China**CWI Name:** Xu Tao**CWI Present:** Yes No**Inspected CWI report:** Yes No N/A**Rod Oven in Use:** Yes No N/A**Electrode to specification:** Yes No N/A**Weld Procedures Followed:** Yes No N/A**Qualified Welders:** Yes No N/A**Verified Joint Fit-up:** Yes No N/A**Approved Drawings:** Yes No N/A**Approved WPS:** Yes No N/A**Delayed / Cancelled:** Yes No N/A**Bridge No:** 34-0006**Component:** OBG COMPONENT**Summary of Items Observed:**

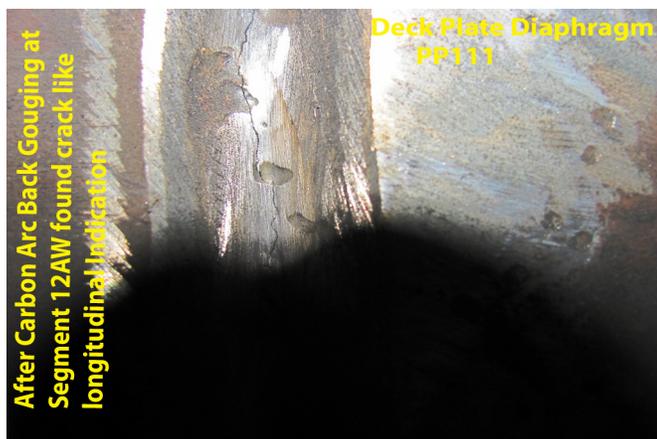
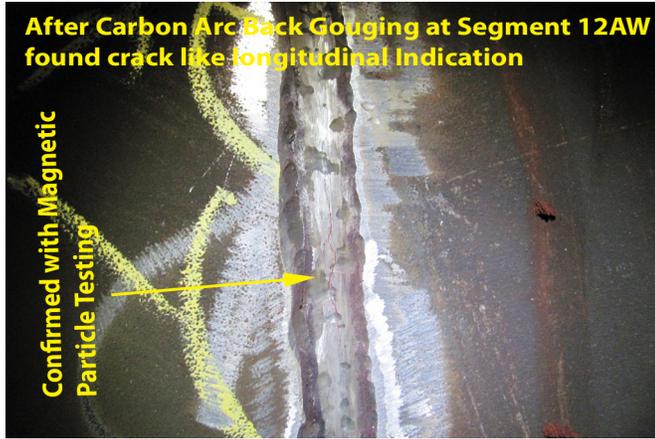
During Quality Assurance random in-process observations of the assembly of Orthotropic Box Girder (OBG) segments 12AW, this Quality Assurance Inspector (QA) discovered that after Carbon Arc Back Gouging at vertical joint joining between deck plate diaphragms to deck plate diaphragm found crack like longitudinal Indications. The effected joints are identified as SEG3004J-002,003,004,005 & SEG3004H-001 at PP111 and SEG3004G-001,003,004 & SEG3004F-001,004 at PP111.5. The QA inspector informed the ZPMC QC Mr. Li Ming Yang and ABF QA Mr. Liy Jin Ping to remove the indication and do Magnetic Particle Testing for confirmation at those mention area.

Segments 12AW are located in the Bay 14.
