DEPARTMENT OF TRANSPORTATION

Quality Assurance and Source Inspection

Contract #: 04-0120F4Cty: SF/Ala Rte: 80 PM: 13.2/13.9File #: 69.28**WELDING INSPECTION REPORT****Resident Engineer:** Pursell, Gary**Address:** 333 Burma Road**City:** Oakland, CA 94607**Report No:** WIR-015016**Date Inspected:** 02-May-2010**Project Name:** SAS Superstructure**OSM Arrival Time:** 1900**Prime Contractor:** American Bridge/Fluor Enterprises, a JV**OSM Departure Time:** 700**Contractor:** Zhenhua Port Machinery Company, Ltd (ZPMC), Changxing Island **Location:** Shanghai, China**CWI Name:** See below**CWI Present:** Yes No**Inspected CWI report:** Yes No N/A**Rod Oven in Use:** Yes No N/A**Electrode to specification:** Yes No N/A**Weld Procedures Followed:** Yes No N/A**Qualified Welders:** Yes No N/A**Verified Joint Fit-up:** Yes No N/A**Approved Drawings:** Yes No N/A**Approved WPS:** Yes No N/A**Delayed / Cancelled:** Yes No N/A**Bridge No:** 34-0006**Component:** Tower and OBG Components**Summary of Items Observed:**

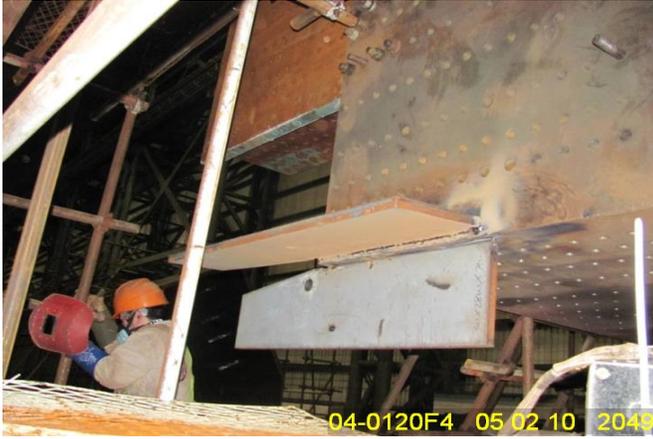
SMAW welding of temporary alignment plates located outside at the top of PCMK south tower, lift 3, at the C/D corner. Welder was identified as 500373. QC was identified as QC1. Assisting QC1 at this location and appearing to be monitoring the welding and recording data was ZPMC QC Sun Tian Liang, who was not a CWI. The welding variables recorded by QC1's assistant appeared to comply with WPS-B-P-2214-TC-U5b. See photo below.
