**DEPARTMENT OF TRANSPORTATION**

Contract #: 04-0120F4Cty: SF/ALA Rte: 80 PM: 13.2/13.9File #: 1.28**WELDING INSPECTION REPORT****Resident Engineer:** Pursell, Gary**Address:** 333 Burma Road**City:** Oakland, CA 94607**Report No:** WIR-015023**Date Inspected:** 18-Jun-2010**Project Name:** SAS Superstructure**OSM Arrival Time:** 1000**Prime Contractor:** American Bridge/Fluor Enterprises, a JV**OSM Departure Time:** 1830**Contractor:** American Bridge/Fluor Enterprises, a JV**Location:** Job Site

# WELDING INSPECTION REPORT

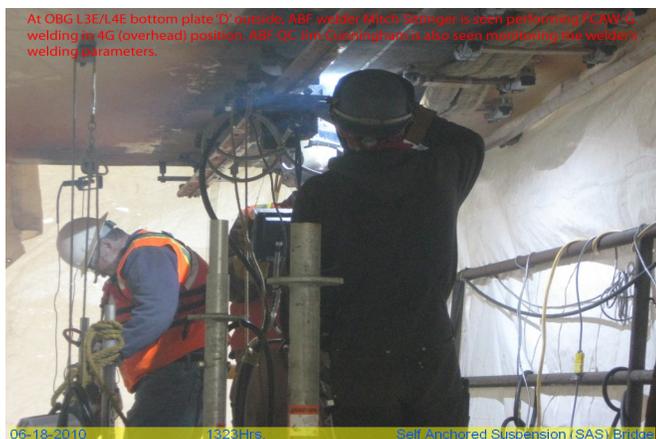
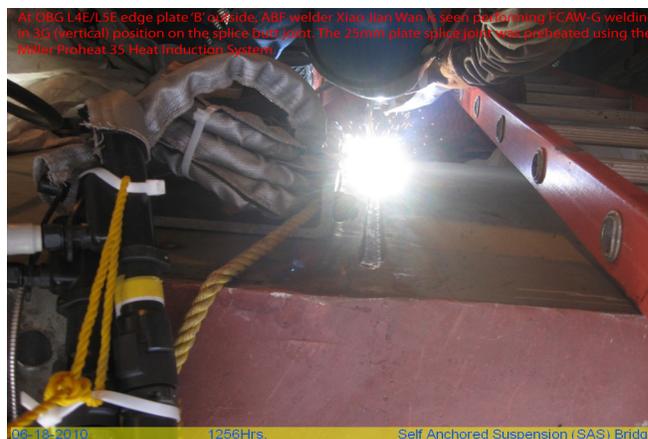
At OBG L4E/L5E bottom plate 'D' outside, ABF welder Howell Bryce was observed perform back gouging on the splice butt joint of 'D' plate. The welder was using Esab plasma arc gouging machine mounted to a track. During the shift, gouging of the backing bar and some of the base metal was not completed and should continue tomorrow.
