Contract #: 04-0120F4Cty: SF/ALA Rte: 80 PM: 13.2/13.9File #: 13.28**WELDING INSPECTION REPORT****Resident Engineer:** Pursell, Gary**Address:** 333 Burma Road**City:** Oakland, CA 94607**Report No:** WIR-015025**Date Inspected:** 16-Jun-2010**Project Name:** SAS Superstructure**OSM Arrival Time:** 1000**Prime Contractor:** American Bridge/Fluor Enterprises, a JV**OSM Departure Time:** 1830**Contractor:** Oregon Iron Works Clackamas, Or.**Location:** Clackamas, OR

CWI Name:	M. Gregson, J. Salazar, G. Mundt	CWI Present:	Yes	No			
Inspected CWI report:	Yes	No	N/A	Rod Oven in Use:	Yes	No	N/A
Electrode to specification:	Yes	No	N/A	Weld Procedures Followed:	Yes	No	N/A
Qualified Welders:	Yes	No	N/A	Verified Joint Fit-up:	Yes	No	N/A
Approved Drawings:	Yes	No	N/A	Approved WPS:	Yes	No	N/A
				Delayed / Cancelled:	Yes	No	N/A
Bridge No:	34-0006	Component:	Hinge K Pipe Beams

AG Machining (Boring,OR)

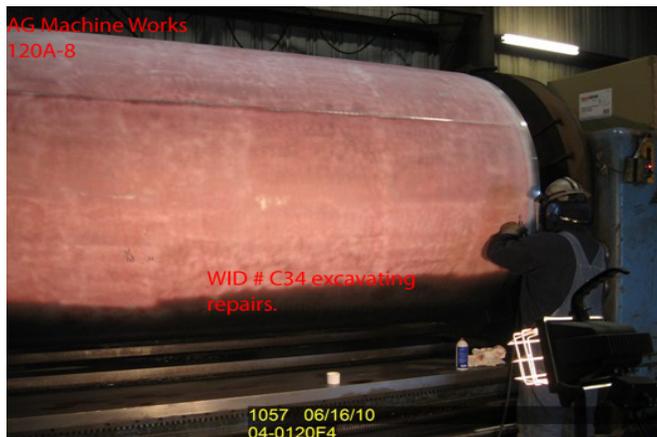
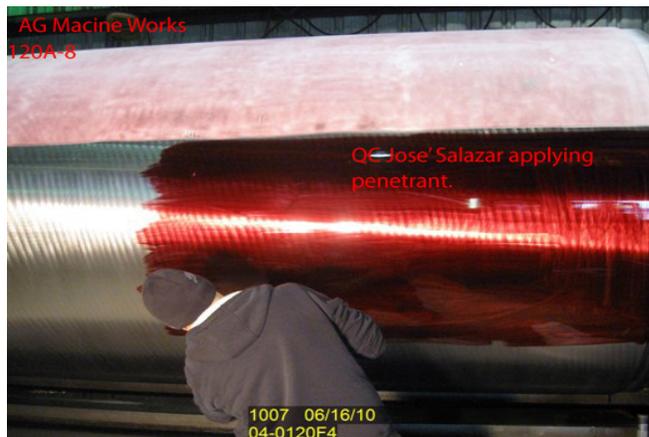
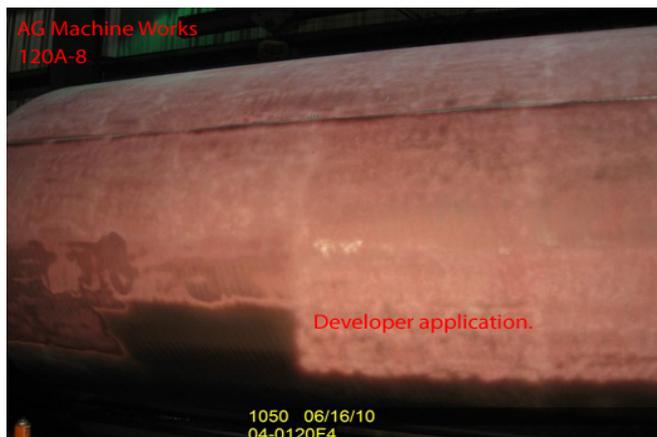
The QA Inspector witnessed QC Inspector Jose Salazar in process of cleaning areas on the overlay with acetone/cleaner and also later applying penetrant and developer. The QA Inspector spoke with QC Inspector Salazar, who explained that any surface indications that were present, during the informational PT testing, would

be marked for repairing and OIW welder Mark Craig would then grind out and perform GTAW on the repairs. QC Inspector Salazar informed the QA Inspector that multiple indications were present, during the PT testing, which appeared to be small clusters of slag inclusions.

The QA Inspector then witnessed WID #C34 grinding out the indications which were marked by QC Inspector Salazar, during the testing. The QA Inspector noted that WID #C34, was performing the grinding utilizing a mechanical grinder with a stainless steel burring bit. The QA Inspector noted that during the grinding, that some of the indications, which initially measured approximately 3 mm in length, had appeared to be longer, during the grinding process.

After witnessing WID #C34 complete several excavations, the QA Inspector then measured lengths of the excavations to be 5mm-20 mm in length, 3 mm wide and approximately 1 mm deep. The QA Inspector observed that there were approximately 30 repairs at this time.

The QA Inspector was later informed by QC Inspector Salazar the informal PT was complete and that the repairs will continue at AG the following day, 6/17/10. QC Inspector Salazar explained that the Gas Tungsten Arc welding (GTAW) will be performed on this date by WID #C34, to repair the excavated areas. See attached pictures below.
