Contract #: 04-0120F4Cty: SF/ALA Rte: 80 PM: 13.2/13.9File #: 13.28**WELDING INSPECTION REPORT****Resident Engineer:** Pursell, Gary**Address:** 333 Burma Road**City:** Oakland, CA 94607**Report No:** WIR-015026**Date Inspected:** 17-Jun-2010**Project Name:** SAS Superstructure**OSM Arrival Time:** 1000**Prime Contractor:** American Bridge/Fluor Enterprises, a JV**OSM Departure Time:** 1830**Contractor:** Oregon Iron Works Clackamas, Or.**Location:** Clackamas, OR

WELDING INSPECTION REPORT

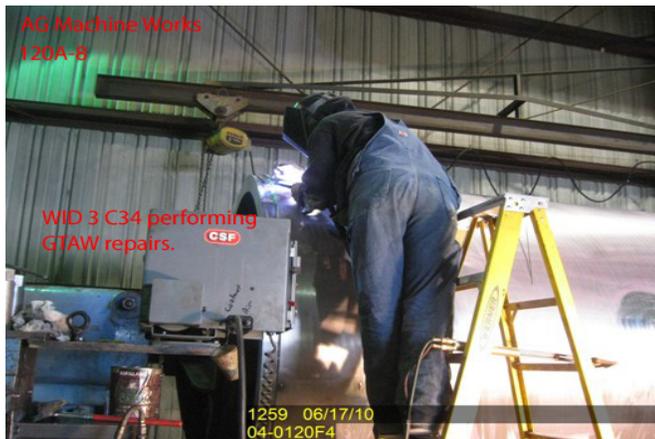
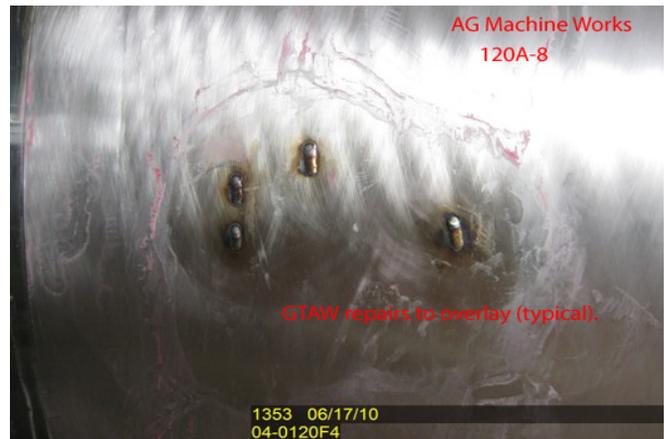
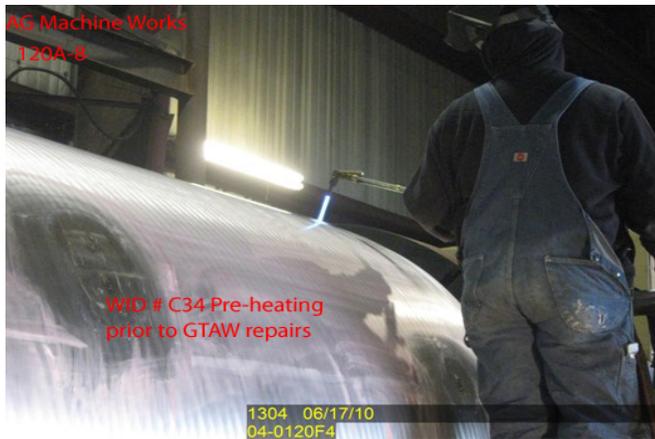
On this date, the QA Inspector arrived at AG Machine to observe OIW perform the weld repairs, on the finished overlay surface, on this Fuse 120A-8. Upon arrival, the QA Inspector met with OIW QC Inspector Jose Salazar, OIW welder (WID# C34) Mark Craig and AG Machinist, Terry Schmale.

QC Inspector Salazar explained that WID #C34 will be performing the Gas Tungsten Arc Welding (GTAW), on the previously excavated areas, on the finished overlay. QC Inspector Salazar explained that WID #C34 is currently qualified to perform these repairs and will be utilizing welding procedure specification (WPS 8022). The QA Inspector then witnessed WID #C34 performing the pre-heat required, utilizing a torch and then observed QC Inspector Salazar perform a pre-heat check, utilizing a digital thermometer, of approximately 200 degrees Fahrenheit, after the pre-heat was complete. The QA Inspector noted that 125 degrees Fahrenheit minimum was required, per WPS 8022. The QA Inspector then witnessed AG Machinist, Terry Schmale, rotating the fuse assembly in the horizontal lathe, to access the weld repair areas in the flat position. The QA Inspector then observed WID #C34 continue to perform the GTAW on the previously excavated repair areas and observed QC Inspector Jose Salazar, recording in-process welding parameters of 123 amps and 16 volts. The QA Inspector also verified these welding parameters.

At approximately 1400, QC Inspector Salazar explained that the GTAW was complete and that the areas which

were repaired, will require grinding flush to the overlay surface. QC Inspector Salazar explained that he wasn't sure when the grinding will be performed.

On this date, the QA Inspector noted that the above mentioned grinding, the final FARO testing (cylindricity and diameter), final PT and surface finish checks by OIW, was still pending. See attached pictures below.
