Contract #: 04-0120F4Cty: SF/ALA Rte: 80 PM: 13.2/13.9File #: 13.28**WELDING INSPECTION REPORT****Resident Engineer:** Pursell, Gary**Address:** 333 Burma Road**City:** Oakland, CA 94607**Report No:** WIR-015096**Date Inspected:** 24-Jun-2010**Project Name:** SAS Superstructure**OSM Arrival Time:** 700**Prime Contractor:** American Bridge/Fluor Enterprises, a JV**OSM Departure Time:** 1530**Contractor:** Oregon Iron Works Clackamas, Or.**Location:** Clackamas, OR**CWI Name:****CWI Present:**

Bridge No: 34-0006**Component:** Hinge K**Summary of Items Observed:**

On this date, Caltrans Quality Assurance Lead Inspector (QA) Joe Adame was present at Oregon Iron Works, Inc. (OIW) to perform observations relative to the fabrication of the Hinge K Pipe Beams and related activities. The following was documented:

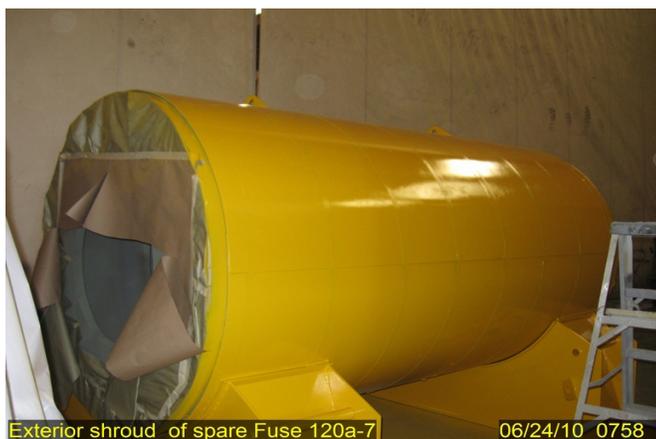
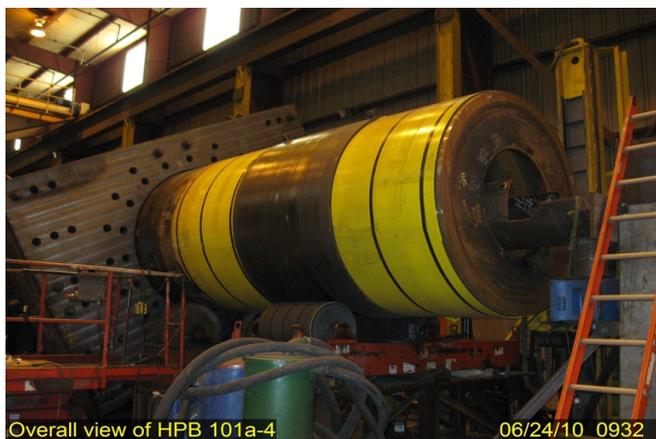
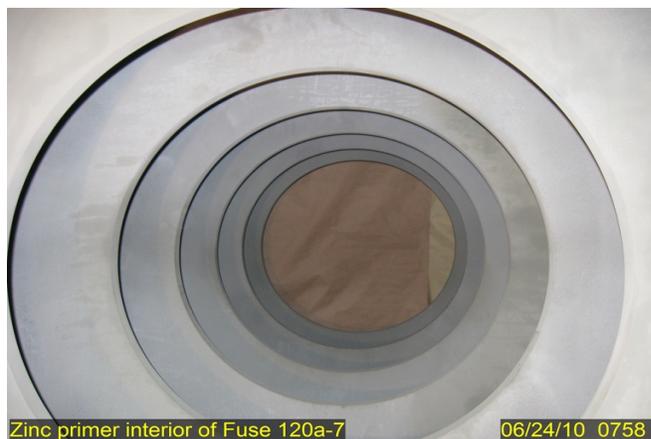
The QA Inspector was present as requested at OIW in Vancouver, WA to perform a paint inspection of Spare Fuse Assy 120a-7. The QA Inspector met with OIW NACE Inspector Mike Clark and OIW (QC) Quality Control Inspector Steve Barnett. The QA Inspector had previously performed paint inspections on the primer to this Fuse. Due to machining and additional processing OIW project management decided that additional paint touch up repairs would be necessary after the Fuse is completed with fabrication. The QA Inspector was present to verify that the areas had been addressed. The OIW NACE Inspector stated that he had visually inspected the surface and verified dry film thickness (DFT) of the Carbozinc 11hs to ensure that it complied with the project requirements. The QA Inspector also performed a visual observation of the spare Fuse interior and performed verification on dry film thickness (DFT's) with a Defelsko PosiTector 6000 digital paint meter. The QA Inspector observed average paint thickness readings of the primer on the interior at 4.6 to 5.2 mls on the Fuse. The paint thickness appeared to be within the range of 90um to 150um as described in the project special provisions. Mr. Clark and the QA Inspector had a discussion regarding the cosmetic appearance of areas on the interior of the Fuse. Mr. Clark stated that since this Fuse and others have set in OIW's storage yard the zinc coating had spots with dust and moisture stains that are not damaging to the coating. Mr. Clark expressed that he could have production work additional man-hours to make the Fuse cosmetically more appealing but the integrity of the coating is not affected at all. The NACE III Inspector concluded by stating that this particular zinc coating if applied as OIW has done, is very affective in repelling the elements and protecting the substrate material.

The QA Inspector returned to OIW Clackamas to observe remaining work being performed on Hinge K Pipe Beam (HPB) Assy 101a-4. The QA Inspector was informed by OIW QC Inspector Mike Gregson that OIW would be submitting a Critical Weld Repair request (CWR #27) to perform a 3rd time repair to remove a rejectable indication on the forging to base CJP butt weld (WJ# 4-01). OIW attempted two non-critical weld repairs on this location with unsuccessful results. Mr. Gregson also stated that preliminary UT testing on three additional non-critical weld repairs were performed and he did not discover rejects. The QA Inspector observed that OIW QC Inspector Jose Salazar was performing VT on exterior PJP welds of the forging base. Mr. Salazar stated that he has high weld reinforcement on areas of the weld surface that will require additional grinding.

The QA Inspector met with OIW Project Manager Bill Pender to discuss current issues or project concerns. Mr. Pender stated that OIW QCM Tom Tomovick is currently drafting the request for Critical Weld Repair #27. Mr. Pender also stated that he will ensure that the QCM provides QA METS rep Robert Mertz and SMR Mohammad Fatemi with an informal copy to perform a courtesy review. Mr. Pender expressed that he would appreciate a verbal approval to proceed with the work as soon as possible. The QA Inspector also discussed a situation regarding the expiration of the primer used to paint the spare Fuses and the HPB's. Mr. Pender stated that he was aware of the situation and will discuss it with the OIW paint dept. Mr. Pender informed the QA Inspector that he would possibly be drafting a letter to seek approval to continue with the primer.(Attached photos from this observation.)
