DEPARTMENT OF TRANSPORTATION

Contract #: 04-0120F4Cty: SF/ALA Rte: 80 PM: 13.2/13.9File #: 13.28**WELDING INSPECTION REPORT****Resident Engineer:** Pursell, Gary**Address:** 333 Burma Road**City:** Oakland, CA 94607**Report No:** WIR-015164**Date Inspected:** 25-Jun-2010**Project Name:** SAS Superstructure**OSM Arrival Time:** 700**Prime Contractor:** American Bridge/Fluor Enterprises, a JV**OSM Departure Time:** 1530**Contractor:** Oregon Iron Works Clackamas, Or.**Location:** Clackamas, OR**CWI Name:** Jose Salazar**CWI Present:** Yes No**Inspected CWI report:** Yes No N/A**Rod Oven in Use:** Yes No N/A**Electrode to specification:** Yes No N/A**Weld Procedures Followed:** Yes No N/A**Qualified Welders:** Yes No N/A**Verified Joint Fit-up:** Yes No N/A**Approved Drawings:** Yes No N/A**Approved WPS:** Yes No N/A**Delayed / Cancelled:** Yes No N/A**Bridge No:** 34-0006**Component:** Hinge K Pipe Beams**Summary of Items Observed:**

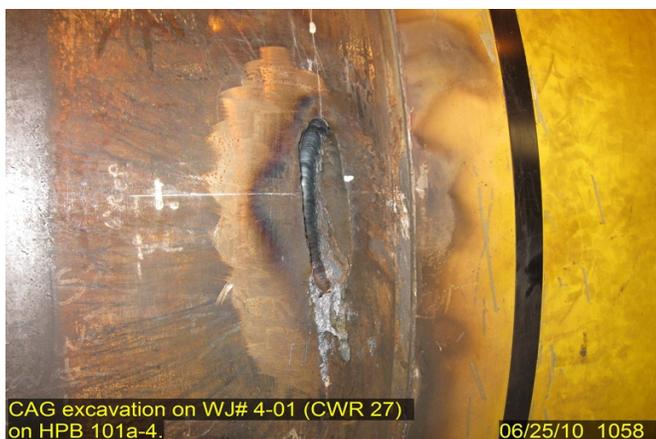
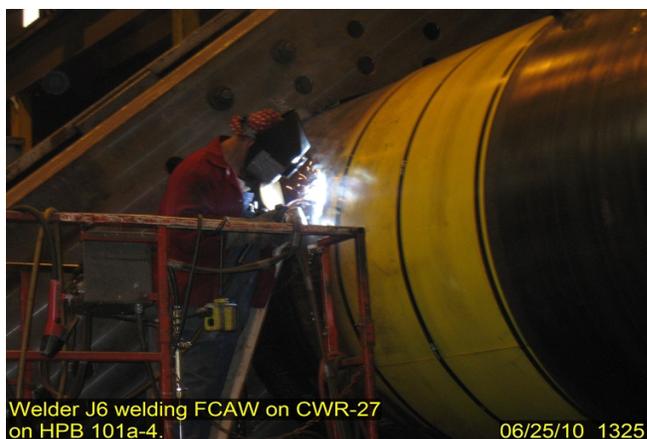
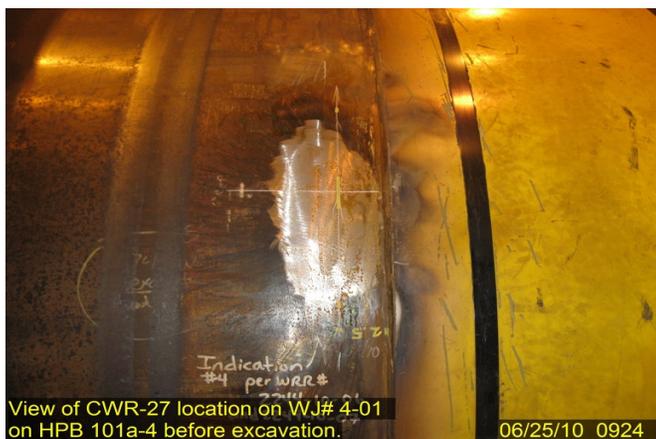
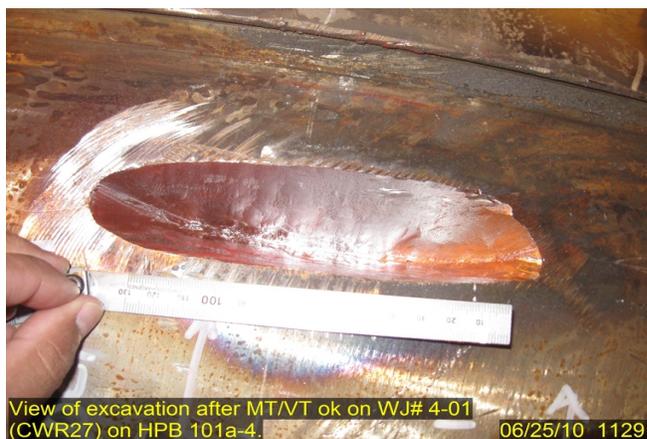
The QA Inspector was present to observe OIW preparing to start work on OIW Critical Weld Repair (CWR) #27 on Hinge K Pipe Beam (HPB) 101a-3. On 6/24/10 OIW was given a verbal approval to proceed with the CWR by METS Representative Robert Mertz. OIW Production Leadman Troy Smith informed the QA Inspector that welder Craig Jacobsen (WID# J6) was in the process of preheating with a gas torch to commence air carbon arc gouging. The QA Inspector was informed that the repair work would be easier to access from the exterior of HPB. The QA Inspector later observed OIW WID# J6 performing the air carbon arc gouging. OIW QC Inspector Jose Salazar was also present and stated that he had verified the preheat at 150° degrees Fahrenheit prior to commencing the gouging. Mr. Salazar also stated that the welder observed a slag inclusion approx 48 mm deep and 15 mm in length. The excavation was then ground to bright metal and cleaned of visible contaminants. The QA Inspector then observed Mr. Salazar perform MT to ensure the removal of the weld discontinuity. The QA Inspector measured the weld excavation at: 56 mm deep by 42mm wide and 165 mm long. No rejectable indications were observed.

After the excavation was accepted by OIW QC, the QA Inspector observed Welder J6 performing FCAW in the vertical position (3G) in using approved welding procedure specification (WPS) 3048 Revision 1. The location of the welding is on weld joint#4-01 R2. QC Inspector Jose Salazar stated that he had verified the in-process welding parameters and pre-heat temperature. The QC Inspector stated that he had observed the average welding

parameters at 235 amps and 24 volts with a pre-heat temperature of 400 degrees Fahrenheit (204° C). Travel speed was measured at 170 mm/min. The QA Inspector verified the welding parameters and observed a reading of 241 amps and 25 volts. The QA Inspector also verified the preheat temperature with a 204° Celsius temperature indicator. Preheat was sufficient. Welder J6 continued welding on the CWR until the end of the shift. Mr. Salazar stated that OIW swingshift would continue with the repair and take over with the post heat. The affected repair location will be post heated at 230° Celsius for approximately 2 hours. Final inspection of the CWR repair will be on 6/29/10. Items observed appear to be in general compliance with the applicable WPS and CWR# 27 specific instructions.
