**DEPARTMENT OF TRANSPORTATION**

Contract #: 04-0120F4Cty: SF/ALA Rte: 80 PM: 13.2/13.9File #: 1.28**WELDING INSPECTION REPORT****Resident Engineer:** Pursell, Gary**Address:** 333 Burma Road**City:** Oakland, CA 94607**Report No:** WIR-015166**Date Inspected:** 24-Jun-2010**Project Name:** SAS Superstructure**OSM Arrival Time:** 1000**Prime Contractor:** American Bridge/Fluor Enterprises, a JV**OSM Departure Time:** 1830**Contractor:** American Bridge/Fluor Enterprises, a JV**Location:** Job Site

# WELDING INSPECTION REPORT

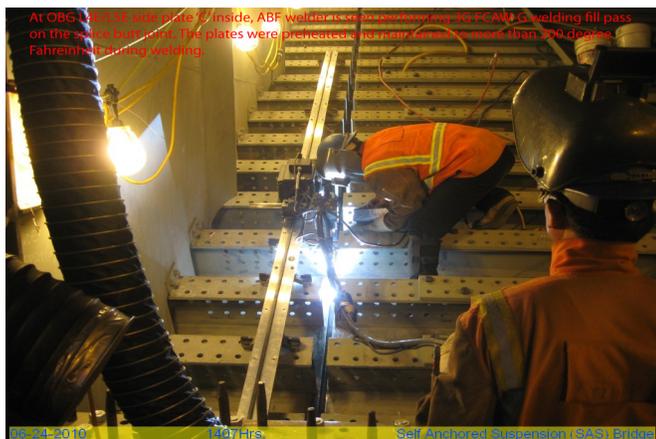
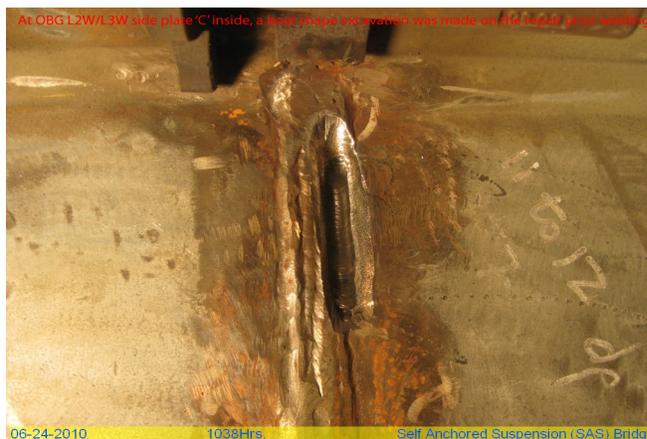
At OBG L4E/L5E side plate 'C' (7400mm to 9855mm) inside, QA randomly observed ABF/JV qualified welder Sungtao, Huang ID # 3794 perform CJP groove (splice) welding root then fill pass. The welder was observed perform automatic welding in the 3G (vertical) position utilizing a dual shield Flux Cored Arc Welding (FCAW-G) with E71T-1M, 1/16" diameter wire electrode and implementing Caltrans approved Welding Procedure Specification (WPS) ABF-WPS-D15-3042A-1. The joint being welded has a single V-groove butt joint with backing bar. The splice joint was preheated and maintained to greater than 200 degree Fahrenheit using Miller Proheat 35 Induction Heating System located at the opposite side of the plate prior/during welding. During welding, ABF Quality Control (QC) Bernie Docena was noted monitoring the welding parameters of the welder. At the end of the shift, welding of the fill passes on the splice butt joint was not completed and should continue tomorrow.

QA randomly observed ABF/JV qualified welder Mitch Sittinger perform CJP groove (splice) back welding fill pass on Orthotropic Box Girder (OBG) L4E/L5E bottom plate 'D' outside. The welder was observed welding in the 4G (overhead) position utilizing a dual shield Flux Cored Arc Welding (FCAW-G) with E71T-1M, 1/16" diameter wire electrode and implementing Caltrans approved Welding Procedure Specification (WPS) ABF-WPS-D15-3040A-4. The welder was using a track mounted welder holder assembly that was remotely controlled. The joint being welded has the backing bar gouged using the Esab Plasma Arc machine and was

ground smooth. The gouged and ground splice butt joint was also Non Destructive Testing (NDT) tested using the Magnetic Particle Testing (MT) which was performed and accepted by ABF QC Jim Cunningham. The splice joint was preheated to greater than 150 degree Fahrenheit prior welding and the vicinity was properly protected from wind and other deleterious environmental conditions. During welding, ABF Quality Control (QC) Jim Cunningham was noted monitoring the welding parameters of the welder. At the end of the shift, the fill pass welding of the splice butt joint back weld was not completed and should continue tomorrow.

At OBG L2W/L3W side plate 'E' inside, QA performed 100% visual on the completely welded cover reinforcement. The weld was noted having no surface profile defects such as undercut, underfill, excessive reinforcement etc. and it appears in compliance to the contract requirements.
