Contract #: 04-0120F4Cty: SF/ALA Rte: 80 PM: 13.2/13.9File #: 69.28**WELDING INSPECTION REPORT****Resident Engineer:** Pursell, Gary**Address:** 333 Burma Road**City:** Oakland, CA 94607**Report No:** WIR-015307**Date Inspected:** 19-Jun-2010**Project Name:** SAS Superstructure**OSM Arrival Time:** 700**Prime Contractor:** American Bridge/Fluor Enterprises, a JV**OSM Departure Time:** 1900**Contractor:** Zhenhua Port Machinery Company, Ltd (ZPMC), Changxing Island **Location:** Shanghai, China**CWI Name:** Qiu Wen**CWI Present:** Yes No**Inspected CWI report:** Yes No N/A**Rod Oven in Use:** Yes No N/A**Electrode to specification:** Yes No N/A**Weld Procedures Followed:** Yes No N/A**Qualified Welders:** Yes No N/A**Verified Joint Fit-up:** Yes No N/A**Approved Drawings:** Yes No N/A**Approved WPS:** Yes No N/A**Delayed / Cancelled:** Yes No N/A**Bridge No:** 34-0006**Component:** Tower Components**Summary of Items Observed:**

TOWER JETTY

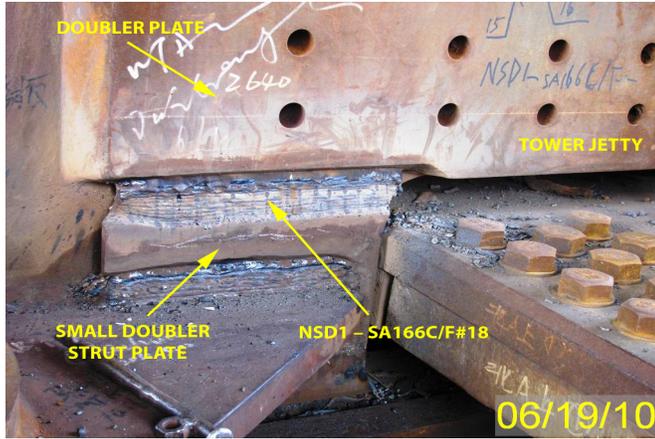
Weld joint # 18 located on North tower Lift-2 doubler plate to small doubler strut plate NSD1 – SA166C/F.

Welder is identified as 040365. ZPMC Quality Control (QC) Inspector is identified Fu Wei Min. The welding variables recorded by QC appeared to comply with the WPS – B – T – 3212 – B – U2a – 2. (See attached photo)

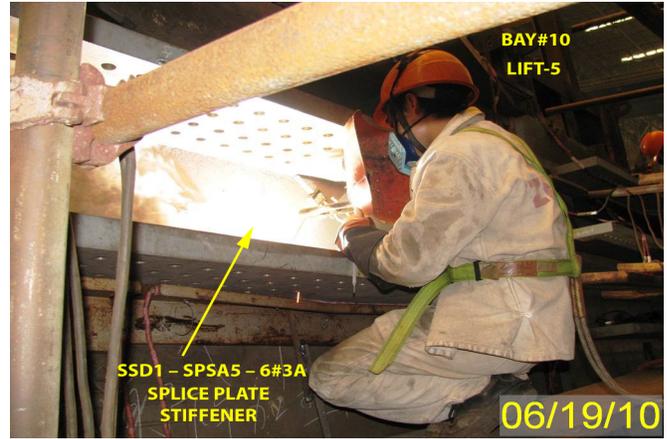
Weld joint # 3A located on Lift-5 Splice Plate Stiffener SSD1 – SPSA5 – 6. Welder is identified as 050266. ZPMC Quality Control (QC) Inspector is identified as Li Jun. The welding variables recorded by QC appeared to comply with the WPS – B – T – 3211 – Tc – U5b – 1. (See attached photo)
