**DEPARTMENT OF TRANSPORTATION**

Contract #: 04-0120F4Cty: SF/ALA Rte: 80 PM: 13.2/13.9File #: 69.28**WELDING INSPECTION REPORT****Resident Engineer:** Pursell, Gary**Address:** 333 Burma Road**City:** Oakland, CA 94607**Report No:** WIR-015314**Date Inspected:** 24-Jun-2010**Project Name:** SAS Superstructure**OSM Arrival Time:** 700**Prime Contractor:** American Bridge/Fluor Enterprises, a JV**OSM Departure Time:** 1900**Contractor:** Zhenhua Port Machinery Company, Ltd (ZPMC), Changxing Island **Location:** Shanghai, China**CWI Name:** Zhu Feng**CWI Present:** Yes No**Inspected CWI report:** Yes No N/A**Rod Oven in Use:** Yes No N/A**Electrode to specification:** Yes No N/A**Weld Procedures Followed:** Yes No N/A**Qualified Welders:** Yes No N/A**Verified Joint Fit-up:** Yes No N/A**Approved Drawings:** Yes No N/A**Approved WPS:** Yes No N/A**Delayed / Cancelled:** Yes No N/A**Bridge No:** 34-0006**Component:** Tower Components**Summary of Items Observed:**

**TOWER JETTY**

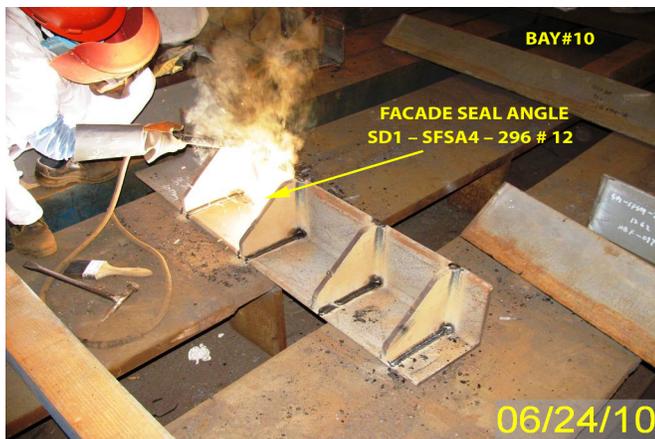
Weld joint # 12 located on Façade Seal Angle SD1 – SFSA4 – 296. Welder is identified as 053829. ZPMC Quality Control (QC) Inspector is identified as Yu Zhi Lai. The welding variables recorded by QC appeared to comply with the WPS – B – P – 2111. (See attached photo)

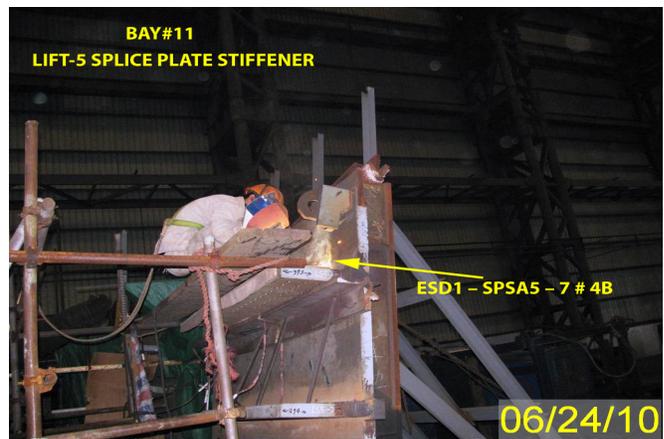
Weld joint # 4B located on Lift-5 Splice Plate Stiffener ESD1 – SPSA5 – 7. Welder is identified as 046709. ZPMC Quality Control (QC) Inspector is identified as Xu Jie. The welding variables recorded by QC appeared to comply with the WPS – B – T – 3211 – Tc – U5b – 1. (See attached photo)
