Quality Assurance and Source Inspection

Contract #: 04-0120F4Cty: SF/ALA Rte: 80 PM: 13.2/13.9File #: 69.28**WELDING INSPECTION REPORT****Resident Engineer:** Pursell, Gary**Address:** 333 Burma Road**City:** Oakland, CA 94607**Report No:** WIR-015331**Date Inspected:** 01-Jul-2010**Project Name:** SAS Superstructure**OSM Arrival Time:** 700**Prime Contractor:** American Bridge/Fluor Enterprises, a JV**OSM Departure Time:** 1900**Contractor:** Zhenhua Port Machinery Company, Ltd (ZPMC), Changxing Island **Location:** Shanghai, China**CWI Name:** Mr. Gao Zhi Chun**CWI Present:** Yes No**Inspected CWI report:** Yes No N/A**Rod Oven in Use:** Yes No N/A**Electrode to specification:** Yes No N/A**Weld Procedures Followed:** Yes No N/A**Qualified Welders:** Yes No N/A**Verified Joint Fit-up:** Yes No N/A**Approved Drawings:** Yes No N/A**Approved WPS:** Yes No N/A**Delayed / Cancelled:** Yes No N/A**Bridge No:** 34-0006**Component:** Tower**Summary of Items Observed:**

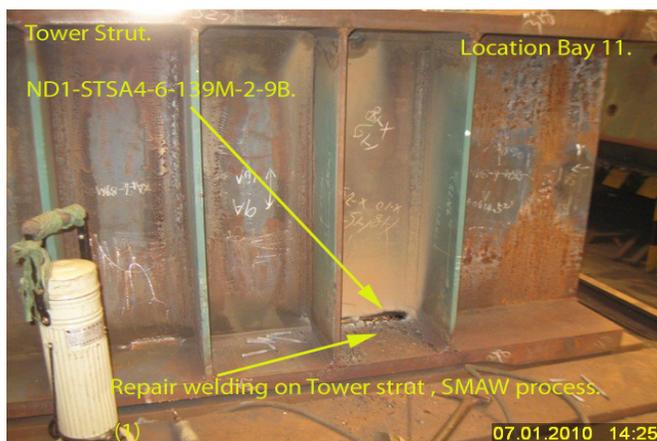
This QA Inspector observed ZPMC qualified welding personnel identified as 044541, Perform Shielded Metal Arc Welding (SMAW) on Tower strut. Joint identified as ND1-STSA4-6-139M-2-9B, ZPMC QC Identified as Mao Bin Bin, with temporary welding repair report. The welding parameters as measured using QC's calibrated instrument appeared to be in general compliance with WPS-345-SMAW-2G (2F)-Repair-1. For more information see below attached picture number 1.

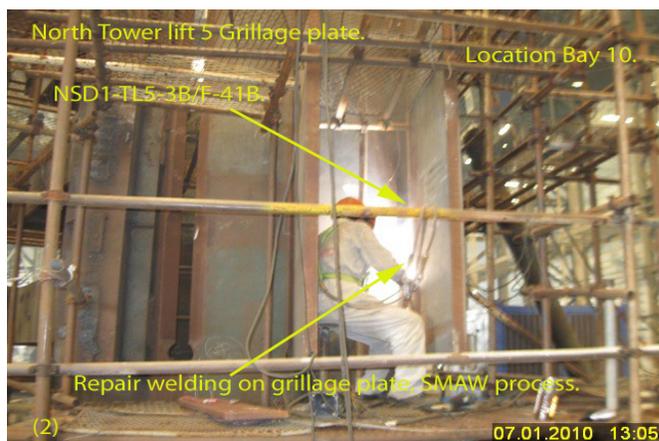
This QA Inspector observed ZPMC qualified welding personnel identified as 052930 Perform Shielded Metal Arc Welding (SMAW) on North Tower lift 5 Grillage plate. Joint identified as NSD1-TL5-3B/F-41B. ZPMC QC Identified as Li Peng Fei, with temporary welding repair report. The welding parameters as measured using QC's calibrated instrument appeared to be in general compliance with WPS-485-SMAW-3G (3F)-Repair. For more information see below attached picture number 2.
