Contract #: 04-0120F4Cty: SF/ALA Rte: 80 PM: 13.2/13.9File #: 69.28**WELDING INSPECTION REPORT****Resident Engineer:** Pursell, Gary**Address:** 333 Burma Road**City:** Oakland, CA 94607**Report No:** WIR-015351**Date Inspected:** 05-Jul-2010**Project Name:** SAS Superstructure**OSM Arrival Time:** 700**Prime Contractor:** American Bridge/Fluor Enterprises, a JV**OSM Departure Time:** 1900**Contractor:** Zhenhua Port Machinery Company, Ltd (ZPMC), Changxing Island **Location:** Shanghai, China**CWI Name:** Li Yang**CWI Present:** Yes No**Inspected CWI report:** Yes No N/A**Rod Oven in Use:** Yes No N/A**Electrode to specification:** Yes No N/A**Weld Procedures Followed:** Yes No N/A**Qualified Welders:** Yes No N/A**Verified Joint Fit-up:** Yes No N/A**Approved Drawings:** Yes No N/A**Approved WPS:** Yes No N/A**Delayed / Cancelled:** Yes No N/A**Bridge No:** 34-0006**Component:** OBG Segment**Summary of Items Observed:**

## WELDING INSPECTION REPORT

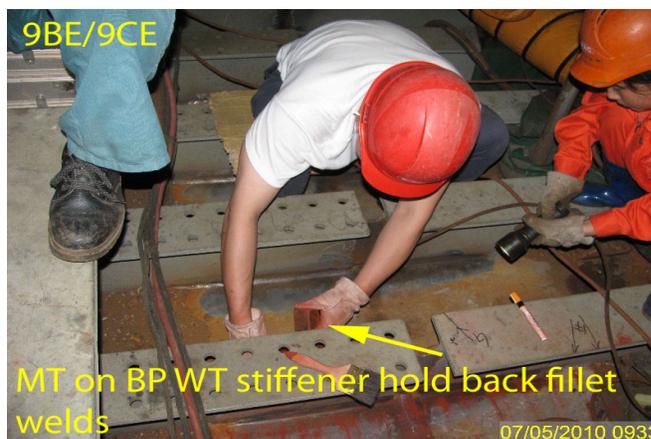
This QA Inspector observed Shielded Metal Arc Welding (SMAW) in progress of a Complete Joint Penetration (CJP) weld joint. The Weld joint is designated as OBE9B-009. The welder is identified as #048659 and was observed welding in the 3G (vertical) position using approved Welding Procedure Specification WPS-345-SMAW-3G (3F)-FCM-repair-1.

This QA Inspector observed buttering in progress using the Flux Cored Arc Welding (FCAW) process on the web of Longitudinal Diaphragm LD12B. The welder is identified as #220069 and was observed welding in the 1G (flat) position using approved Welding Procedure Specification WPS-345-FCAW-1G (1F)-repair-1 for WR13818.

This QA Inspector observed ZPMC personnel performing Magnetic Particle Testing on the Bottom Plate WT stiffener hold back fillet welds.

This QA Inspector observed fit up of the FL3 Bottom panel to FL3 Bottom flange at panel points 80-82.

This QA Inspector observed ABF personnel performing Ultrasonic Testing on the Deck Panel to Side Panel CJP connection, west side of cross beam.

This QA Inspector observed QC Inspector Zhang Hai Jun select M24x65 A325 high strength bolt assemblies (bolt, nut and washer) for Pre-tension verification of required tension testing, five (5) assemblies from lot # DHGM240013 and 5 from lot # DHGM240002.

- The Skidmore-Wilhelm Bolt Tension Calibrator Model HT Serial Number 1015 calibration date had expired.
- Valid Dates of calibration are from 06/04/2009 thru 06/04/2010.
- Calibration dates are displayed on the Bolt Tension Calibrator.
- M24x65 Lot Number DHGM240013, M24x65 Lot Number DHGM240002
