Contract #: 04-0120F4Cty: SF/ALA Rte: 80 PM: 13.2/13.9File #: 69.28**WELDING INSPECTION REPORT****Resident Engineer:** Pursell, Gary**Address:** 333 Burma Road**City:** Oakland, CA 94607**Report No:** WIR-015366**Date Inspected:** 24-Jun-2010**Project Name:** SAS Superstructure**OSM Arrival Time:** 700**Prime Contractor:** American Bridge/Fluor Enterprises, a JV**OSM Departure Time:** 1900**Contractor:** Zhenhua Port Machinery Company, Ltd (ZPMC), Changxing Island **Location:** Shanghai, China**CWI Name:** Le Zhi Jiang**CWI Present:** Yes No**Inspected CWI report:** Yes No N/A**Rod Oven in Use:** Yes No N/A**Electrode to specification:** Yes No N/A**Weld Procedures Followed:** Yes No N/A**Qualified Welders:** Yes No N/A**Verified Joint Fit-up:** Yes No N/A**Approved Drawings:** Yes No N/A**Approved WPS:** Yes No N/A**Delayed / Cancelled:** Yes No N/A**Bridge No:** 34-0006**Component:** Orthotropic Box Girder (OBG)**Summary of Items Observed:**

OBG # CROSSBEAM CB13

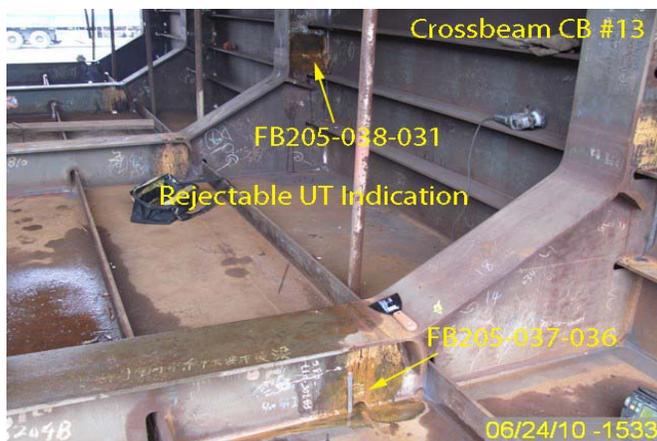
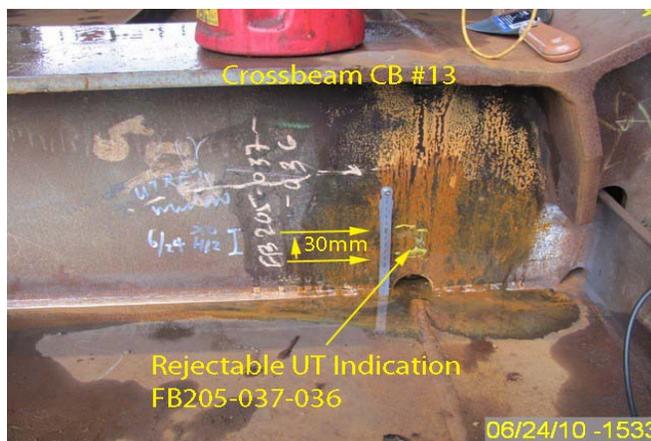
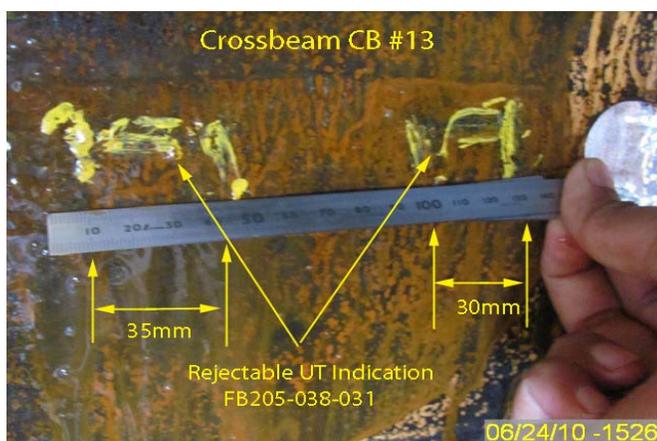
(FB205-037-036) Non compliant indication

(FB205-038-031) Non compliant indication

During the Quality Assurance Ultrasonic Testing (UT) review of welds located on Orthotropic Box Girder (OBG) Crossbeam CB 13, this Quality Assurance Inspector (QA) discovered the following issues. Three (3) longitudinal linear indication measuring approximately 35mm, 30mm and 30mm in length. The indication dbfs rating is a +1, +7 and +6. Material thickness is 12 and 14mm. The depth of the indication is approximately 8mm, 9mm and 6mm. The welds are identified as: FB205-038-031 and FB205-037-036. These welds are Complete Joint Penetration (CJP) splice weld joints. The welds are designated as Non Seismic Performance Critical Material (Non SPCM). These indications are clearly marked on or near the weld. This QA notified ZPMC QA identified as Mr. Zhang wei of this issue and that an incident report would be generated. For more information refer Ultrasonic test report for this date. See attached picture.
