DEPARTMENT OF TRANSPORTATION

Quality Assurance and Source Inspection

Contract #: 04-0120F4Cty: SF/ALA Rte: 80 PM: 13.2/13.9File #: 1.28**WELDING INSPECTION REPORT****Resident Engineer:** Pursell, Gary**Address:** 333 Burma Road**City:** Oakland, CA 94607**Report No:** WIR-015379**Date Inspected:** 02-Jul-2010**Project Name:** SAS Superstructure**OSM Arrival Time:** 700**Prime Contractor:** American Bridge/Fluor Enterprises, a JV**OSM Departure Time:** 1530**Contractor:** American Bridge/Fluor Enterprises, a JV**Location:** Jobsite**CWI Name:** See below**CWI Present:** Yes No**Inspected CWI report:** Yes No N/A**Rod Oven in Use:** Yes No N/A**Electrode to specification:** Yes No N/A**Weld Procedures Followed:** Yes No N/A**Qualified Welders:** Yes No N/A**Verified Joint Fit-up:** Yes No N/A**Approved Drawings:** Yes No N/A**Approved WPS:** Yes No N/A**Delayed / Cancelled:** Yes No N/A**Bridge No:** 34-0006**Component:** SAS OBG**Summary of Items Observed:**

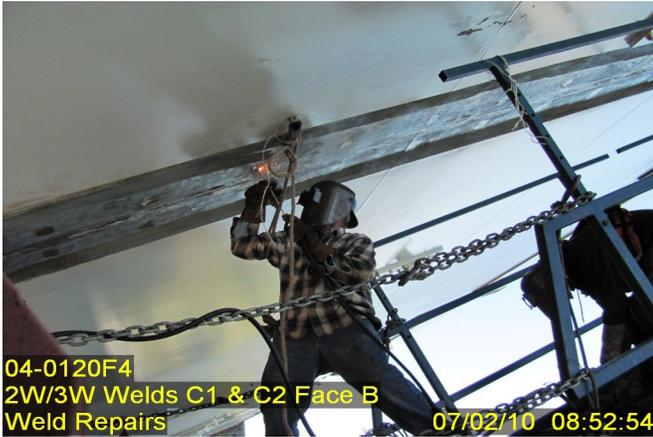
- 1). OBG Field Splice 2W/3W Welds C1 & C2, Face B

The QAI periodically observed the in process welding of repairs at temporary attachment removal areas with associated with OBG Field Splice OBG Field Splice 2W/3W Welds C1 & C2, Face B per the Shielded Metal Arc Welding (SMAW) process in the 3G/4G position by ABF welding personnel Rory Hogan (ID 3186). See photo below. SE QC Inspector Jim Cunningham was present to monitor the progress and verify that the preheat & welding parameters were within the limits established by the approved welding Procedure Specification (WPS) identified as ABF-WPS-D1.5-1000-Repair. The work at this location was completed during this shift. The QAI observed that the welding parameters and the final weld repairs appeared to be in general compliance with the contract documents.

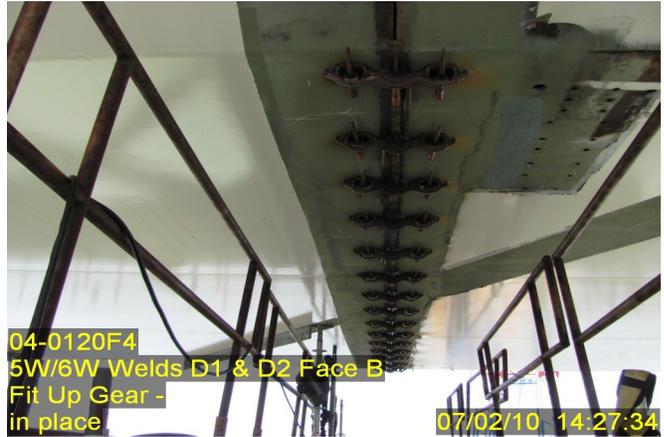
3). OBG Field Splice 5W/6W Weld ID: D1 & D2, Face B

The QAI periodically observed AB/F personnel installing fit-up gear on the OBG Field Splice 5W/6W Weld ID: D1 & D2, Face B. The Blank Nuts were welded to Face B per the SMAW process in the 4G position by approved welders Kenneth Chappell (ID 3833) and Mike Maday (ID 3391). QC Inspector Bonafacio Daquinag was present to monitor the progress and verify that the welding parameters were within the limits established by the approved welding Procedure Specification (WPS) identified as ABF-WPS-D1.5-F1200-A. Joint alignment was in process at this location for the remainder of the QA Inspector's shift. See photo below of fit-up gear in place.
