DEPARTMENT OF TRANSPORTATION

Quality Assurance and Source Inspection

Contract #: 04-0120F4Cty: SF/ALA Rte: 80 PM: 13.2/13.9File #: 69.28**WELDING INSPECTION REPORT****Resident Engineer:** Pursell, Gary**Address:** 333 Burma Road**City:** Oakland, CA 94607**Report No:** WIR-015393**Date Inspected:** 28-Jun-2010**Project Name:** SAS Superstructure**OSM Arrival Time:** 700**Prime Contractor:** American Bridge/Fluor Enterprises, a JV**OSM Departure Time:** 1900**Contractor:** Zhenhua Port Machinery Company, Ltd (ZPMC), Changxing Island **Location:** Shanghai, China**CWI Name:** Chen Shi Gang**CWI Present:** Yes No**Inspected CWI report:** Yes No N/A**Rod Oven in Use:** Yes No N/A**Electrode to specification:** Yes No N/A**Weld Procedures Followed:** Yes No N/A**Qualified Welders:** Yes No N/A**Verified Joint Fit-up:** Yes No N/A**Approved Drawings:** Yes No N/A**Approved WPS:** Yes No N/A**Delayed / Cancelled:** Yes No N/A**Bridge No:** 34-0006**Component:** Bay 9, Bay4**Summary of Items Observed:**

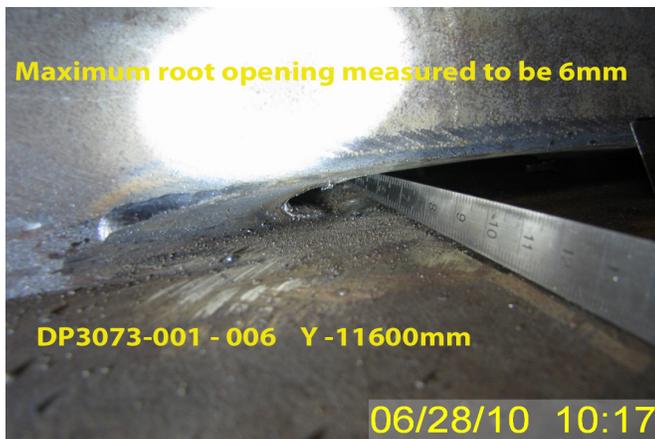
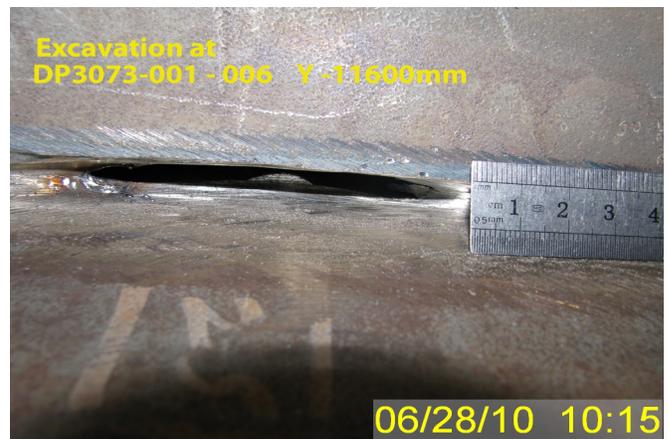
This Inspector performed In- Process inspections of production welding of deck panels in Bay 9. Welding was being performed on panel DP 3092 – 001 (PL 3199A, PL 3199B). The weld procedure was found to be WPS-B-T-2342-U1-(U-rib)-5. The welding operators were identified as follows:

This QA Inspector observed ZPMC welding personals identified as 059440 performing Gas Metal Arc welding (GMAW) tack welding on DP3103-001(PL3199 A/B/C) deck plate to U-rib. ZPMC QC is identified as Zhu Zhong Jie. The welding variables recorded by QC appeared to comply with the WPS-345-B-T-2342 U5b (U-Rib).

This QA Inspector observed ZPMC welding personals identified as 062265 performing Flux Cored Arc welding (FCAW) on DP3073-001 U-rib to deck plate PJP weld. ZPMC QC is identified as Zhang Qiao ABF QC Inspector is identified as Lv Yin. The welding variables recorded by QC appeared to comply with the WPS – 345 – FCAW – 2G(2F) – FCM - Repair

QA Inspector observed that excavation depth exceeded thickness of U-rib. Repair procedure available on shop does not cover “Open Root” repair where root gap exceeds 3.5mm

Root gap measured at the above location was 6mm

Approximately 58% of this weld was rejected by PAUT, excavation was performed to identify if indications were due to poor fit up. Magnetic particle Testing (MT) was performed on these excavations, Three (3) longitudinal indications approximately 10mm, 8mm and 4mm in length were observed.
