Quality Assurance and Source Inspection

Contract #: 04-0120F4Cty: SF/ALA Rte: 80 PM: 13.2/13.9File #: 69.28**WELDING INSPECTION REPORT****Resident Engineer:** Pursell, Gary**Address:** 333 Burma Road**City:** Oakland, CA 94607**Report No:** WIR-015413**Date Inspected:** 27-Jun-2010**Project Name:** SAS Superstructure**OSM Arrival Time:** 700**Prime Contractor:** American Bridge/Fluor Enterprises, a JV**OSM Departure Time:** 1900**Contractor:** Zhenhua Port Machinery Company, Ltd (ZPMC), Changxing Island **Location:** Shanghai, China

WELDING INSPECTION REPORT

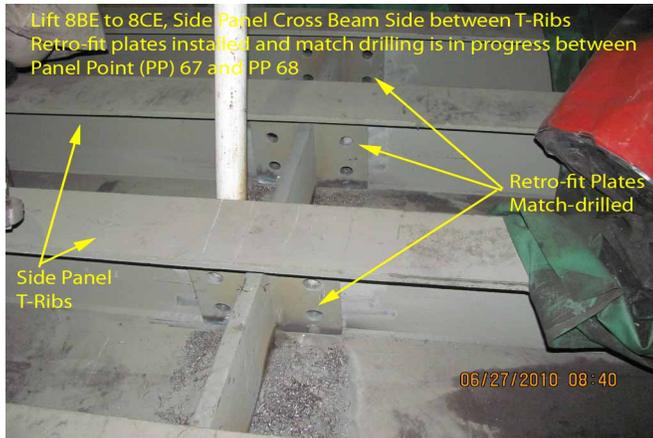
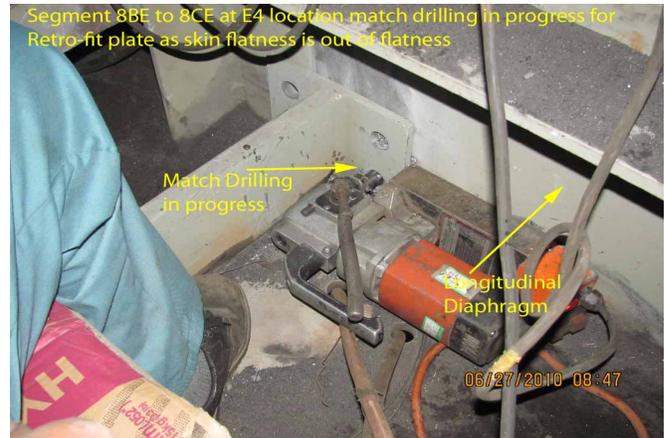
This QA Inspector observed during random visual Inspection that ZPMC personnel Installed the Retro-fit plates between the Side Panel T-Ribs for the Segment 8BE to 8CE between Panel Point 67 and PP 68 Cross Beam Side. The Installed of the Retro-fit Flange to T-Rib Web match drilling in been performed against the ZPMC Doc. No. GGL-MQ-1666. The Retro-fit is Installed as the Skin Flatness at location recorded at B1=1 0mm, B1-1=6mm and B2=6mm.

Please refer the pictures attached for more comprehensive details.

This QA Inspector observed during random visual Inspection that ZPMC personnel Installed the Retro-fit plates between the Side Panel T-Ribs for the Segment 8AE to 8BE between Panel Point 64 and PP 65 Cross Beam Side. The Installed of the Retro-fit Flange to T-Rib Web match drilling is been performed against the ZPMC Doc. No. GGL-MQ-1666. The Retro-fit is Installed as the Skin Flatness at location recorded at B1=6mm and B2=9mm.
